AIRPROX REPORT No 2021073

Date: 06 Jun 2021 Time: 1159Z Position: 5052N 00006W Location: 2.5NM NE of Brighton

PART A: SUMMARY OF INFORMATION REPORTED TO UKAB

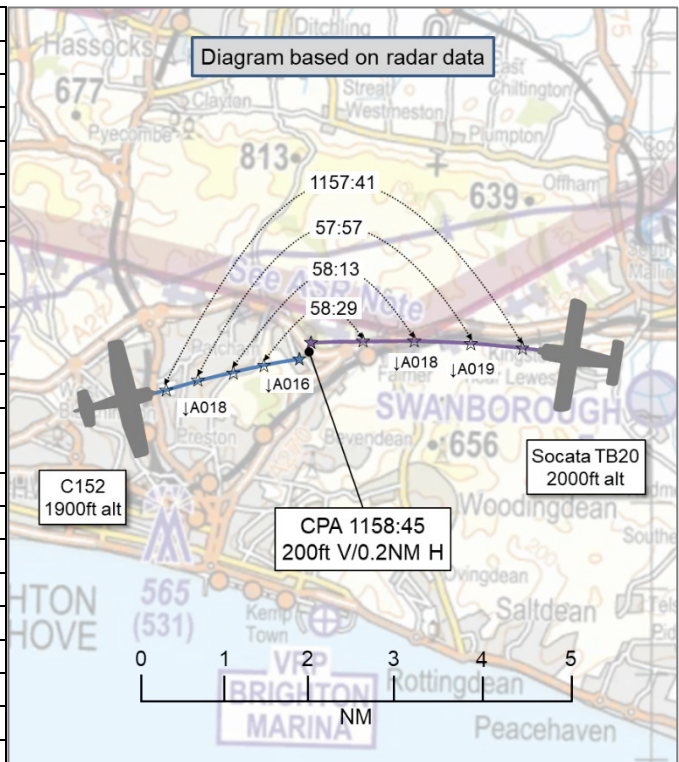
Recorded	Aircraft 1	Aircraft 2
Aircraft	C152	Socata TB20
Operator	Civ FW	Civ FW
Airspace	London FIR	London FIR
Class	G	G
Rules	VFR	VFR
Service	AGCS	Listening Out
Provider	Shoreham Radio	Shoreham Radio
Altitude/FL	A016	A018
Transponder	A, C, S	A, C, S
Reported		
Colours	White	Blue, white
Lighting	Beacon, anti-colls, nav lights	Tailfin strobe, nav, landing, taxi lights
Conditions	VMC	VMC
Visibility	5-10km	>10km
Altitude/FL	1800ft	1800ft
Altimeter	QNH	QNH (1025hPa)
Heading	060°	270°
Speed	90kt	140kt
ACAS/TAS	TAS	Not fitted
Alert	Information	N/A
Separation		
Reported	0ft V/150m H	0ft V/200m H
Recorded	200ft V/0.2NM H

Finally, the Board considered the risk involved in this Airprox. Members noted that both pilots reported a vertical separation of 0ft but that the NATS radar recording displayed a height difference of 200ft. The Board understands that there are tolerances within not only the radar equipment but also transponder equipment, and so concluded that, although the radar displayed a height difference of 200ft at CPA, in reality it is feasible that it could have been closer to the figures reported independently by both pilots. That said, the Board also noted that the recorded lateral radar separation had been 0.2NM (~370m), and that both pilots had estimated a lateral separation of 150m or more. Consequently, members
