## AIRPROX REPORT No 2021080

Date: 11 Jun 2021 Time: 1329Z Position: 5121N 00032W Location: Fair Oaks

### PART A: SUMMARY OF INFORMATION REPORTED TO UKAB

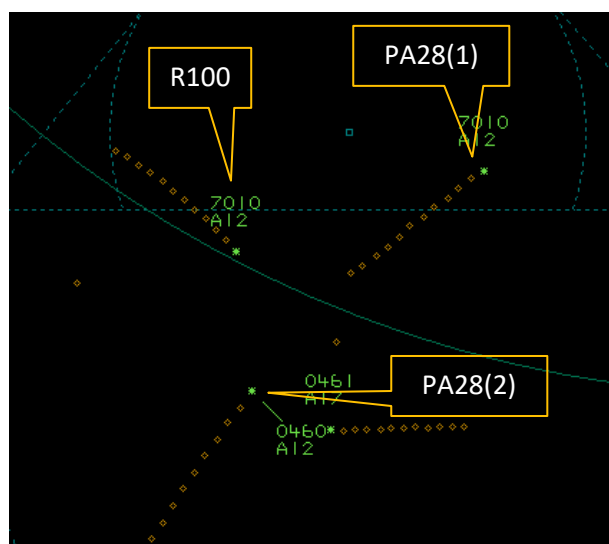
Figure 1:1327:40

Although Fair Oaks is not equipped with radar, the incident could be seen on the NATS radars. At Figure 1, the PA28(1) was late downwind, with the R100 approximately crosswind and the PA28(2) joining from the south-west.

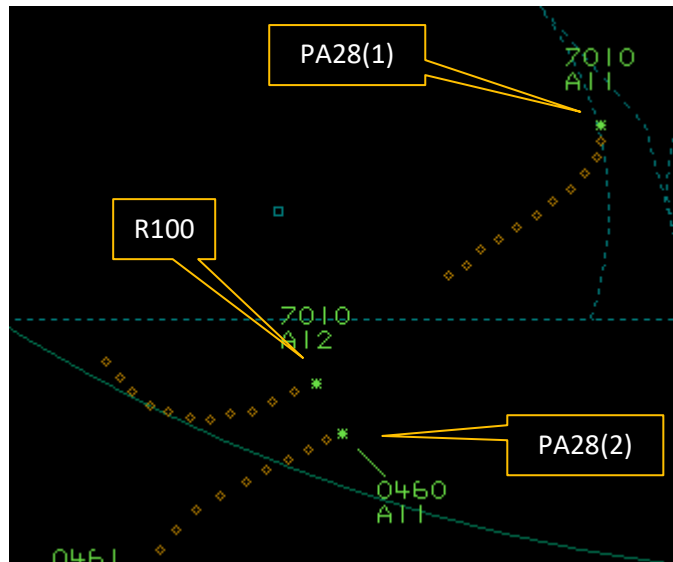
Figure 2:1328:20

At 1328:20 (Figure 2) the PA28(2) was joining alongside the R100 as described by the R100 pilot.

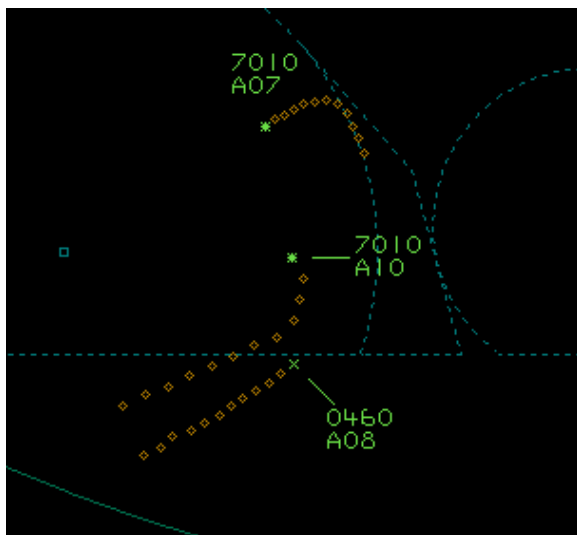
Figure 3:1329:09

By Figure 3, the PA28(2) had slowed down to fit in behind the R100, who had turned onto base-leg. PA28(1) had also turned onto final. The R100 then continued on base whilst the PA28(1) was on final, until at CPA, Figure 5 the two aircraft were 200ft and 0.1NM apart.

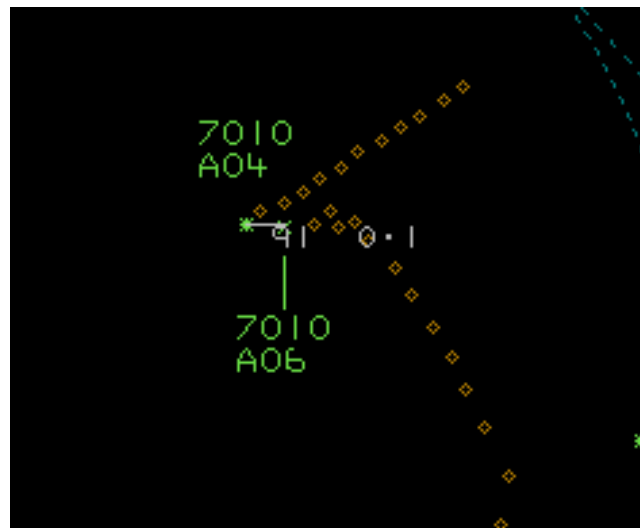
Figure 5: CPA 1329:44

The pilot of R100 lost situational awareness and turned base leg and then final without having the aircraft ahead (PA28(1) C/S) in sight.

The Safety Action Group agreed with the above Root Cause Analysis; however, it recommended that a slight change in phraseology used by the FISO could help to reinforce the UK-AIP entry which states 'Straight-in', 'downwind' and 'base' joins are strongly discouraged when the circuit is active.
