AIRPROX REPORT No 2021092

Date: 23 Jun 2021 Time: 0914Z Position: 5305N 00239W Location: 16NM SE Liverpool

PART A: SUMMARY OF INFORMATION REPORTED TO UKAB

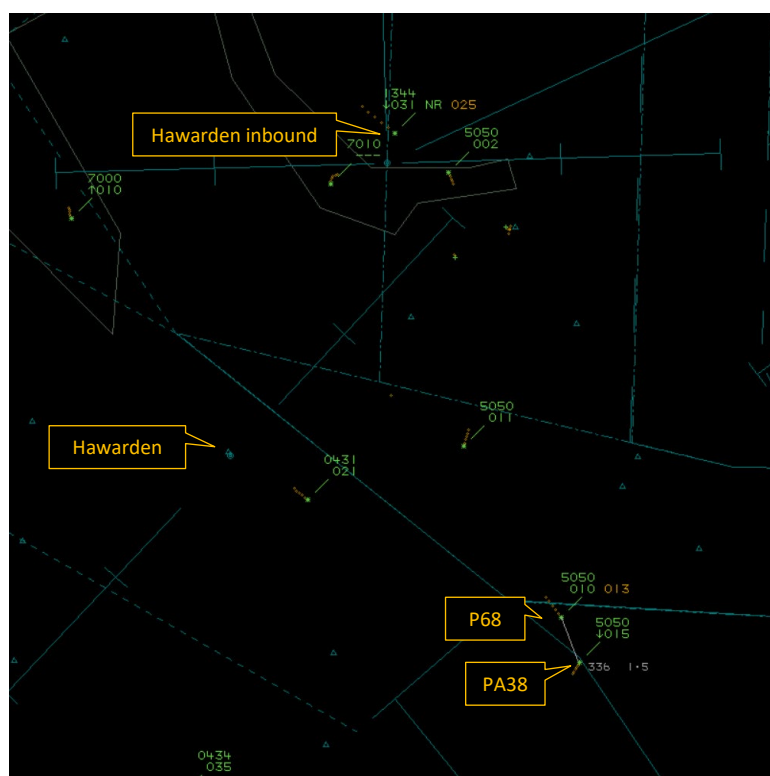
Figure 1: 0914:00

At 0914:00 the Hawarden aircraft was given a turn towards the Hawarden ILS localiser and cleared for the ILS approach. (The aircraft was not transferred to Hawarden until 0915:40). (Figures 1 & 2).

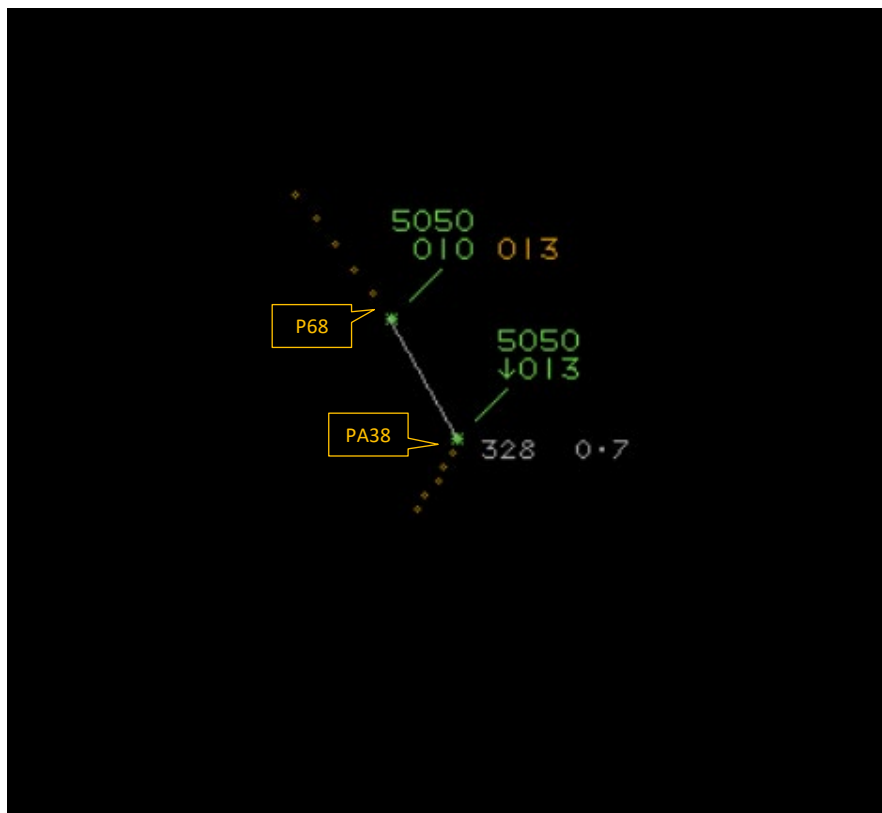
Figure 3: 0914:15

Between 0914:00 and CPA which occurred at 0914:26, there were no other aircraft calls heard on the RTF (Figures 3 & 4).
