## AIRPROX REPORT No 2021103

Date: 05 Jul 2021 Time: 1342Z Position: 5112N 00049E Location: Challock

### PART A: SUMMARY OF INFORMATION REPORTED TO UKAB

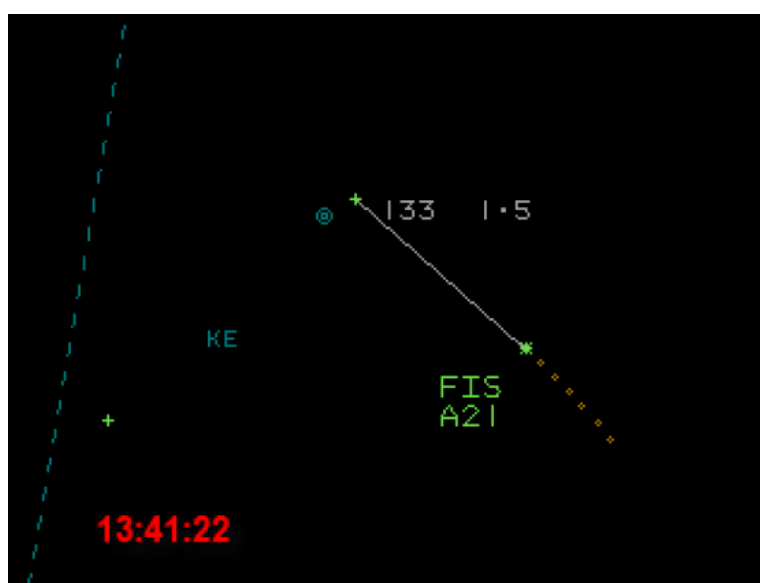
Figure 1

[B407 C/S] tracked from SANDY towards Challock airfield. When 1.5NM from Challock, at 1341:22, a primary radar return appeared in the vicinity of Challock (Figure 1). This primary return was believed to correlate with the positioning of [Discus C/S], a glider operating out of Challock. Challock airfield is located within Class G airspace.

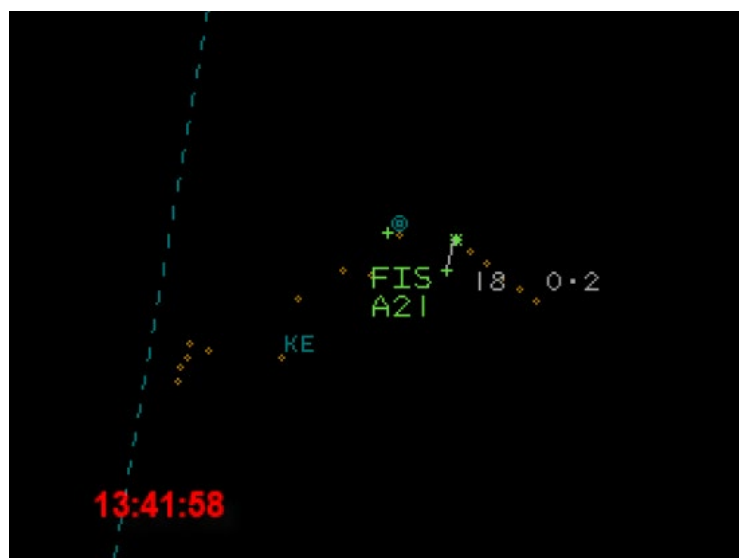
Figure 2

The closest point of approach between [B407 C/S] and the primary radar return occurred at 1341:58, measured on the Multi-Track Radar as 0.2NM (Figure 2). The pilot of [B407 C/S] made no reference to this potential confliction on the R/T.
