**AIRPROX REPORT No 2021123**

Date: 20 Jul 2021 Time: 1335Z Position: 5155N 00209W Location: Gloucestershire ATZ

**PART A: SUMMARY OF INFORMATION REPORTED TO UKAB**

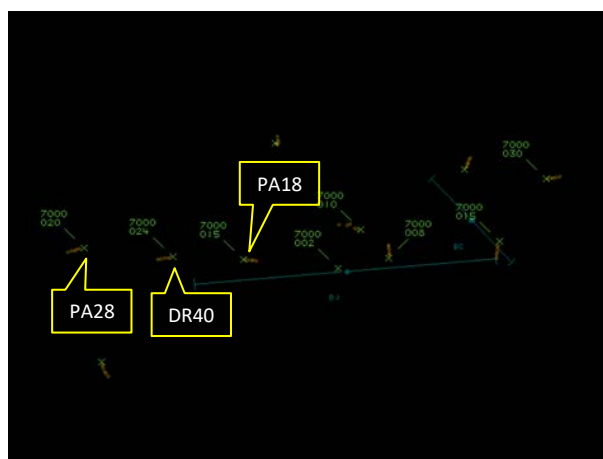
Figure 1 – 1326:20

At **1326:20** the DR40 [pilot] called again, reporting at 5 miles, and advising that they were still waiting for joining instructions. The Approach controller passed the DR40 pilot Traffic Information on the outbound PA18 and then instructed them to join downwind right-hand for RW27. The DR40 pilot requested an overhead join instead, and so was instructed to make a standard overhead join for RW27RH. The DR40 pilot was then transferred to the Tower (Figure 1).

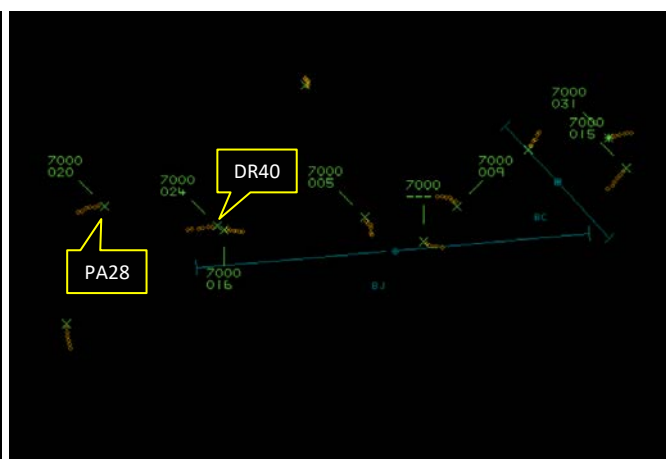
Figure 2 – 1327:06

At **1326:45** the Approach controller passed Traffic Information to the outbound PA18 on the inbound DR40 (but not the following PA28). At **1327:06** the Approach controller instructed the PA28 [pilot] to make a standard overhead join for RW27 and to report with 5 miles to run, advising that they might still be able to clear them for a direct right-hand downwind join. The PA28 pilot replied; *“roger that, standard overhead left, otherwise right. Currently about five miles to the west of you”* (Figure 2).

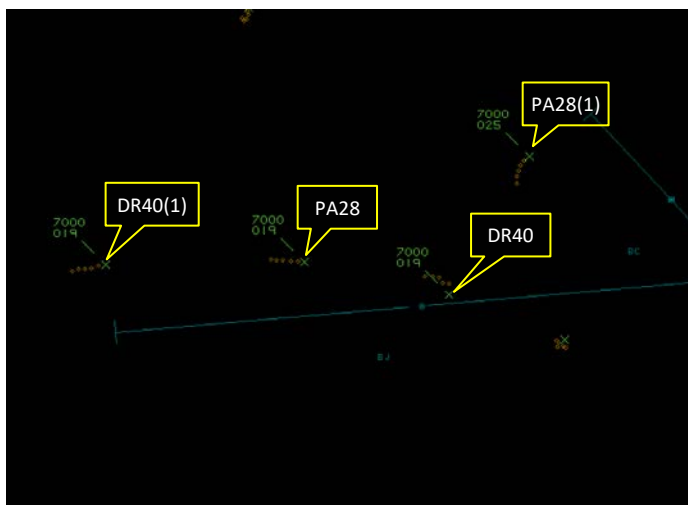
Figure 3 – 1330:25

On the Approach frequency there had been no further calls until **1330:25** when the DR40(1) [pilot] called again, advising they were 4 miles west for an overhead join. The new Approach controller acknowledged this, passed Traffic Information on the PA28 ahead of them and instructed them to route for a standard overhead join for RW27RH. This was read-back by the pilot who reported approaching 3 miles. The controller advised that both the fixed-wing and helicopter circuits were active and transferred them to the Tower (Figure 3).

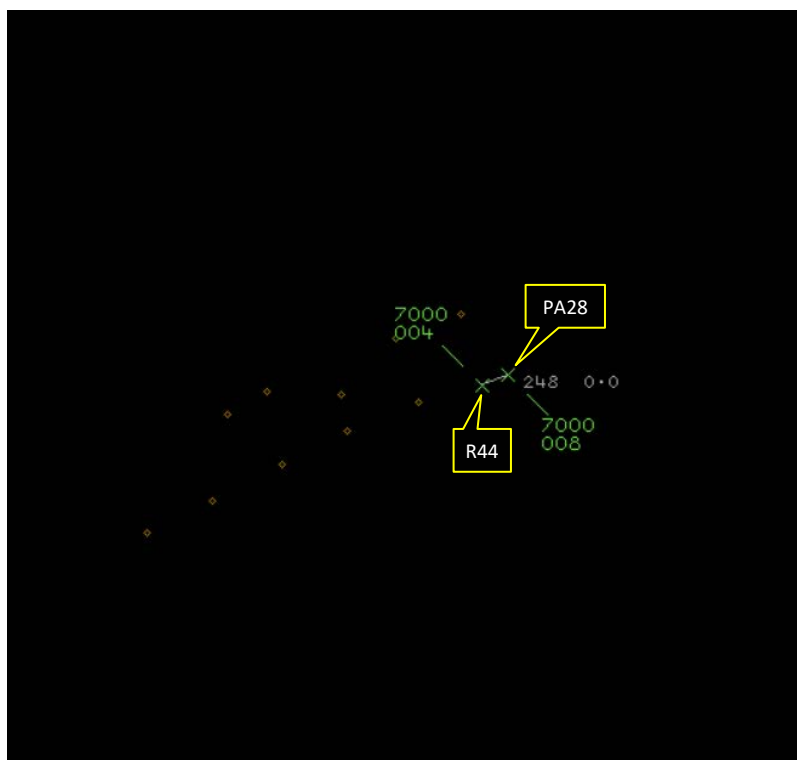
Figure 9 – 1334:38 – Radar CPA

At **1334:37** the pilot of the R44 in the helicopter circuit asked; *“can I take the er height of that one above us in the er circuit?”*. CPA occurred at **1334:38** with the aircraft separated by less than 0.1NM laterally and 400ft vertically (Figure 9). At **1334:54** the Tower controller requested the PA28’s level which was reported as 800ft. The Tower controller reminded them that the fixed-wing circuit level was 1000ft and the helicopter circuit *“not above 750 QFE”*.

Whilst there were a number of issues relating to the integration of the PA28, the Airprox between the R44 and the PA28 appears to have occurred due to the low level of the PA28 in the circuit. Both a readback made by the pilot of the PA28 at **1327:06** in response to the Approach controller’s instruction to route to the overhead to join; *“roger that, standard overhead left, otherwise right, currently about five miles to the west of you”*, and then the initial pattern and descent profile flown by the pilot, appear to suggest that the pilot might have been disorientated, and initially positioning for a different runway, in this instance downwind right-hand for RW09. This thinking was further reinforced by the pilot reporting crosswind after they had just crossed the approach lane for RW27 and were deadside, and again when the aircraft was observed as descending to as low as an indicated height of 600ft when south of the climb-out lane for RW27. It was then observed to have

climbed to 800ft as it flew through the RW27 climb-out lane, possibly as a result of the pilot realising their error.
