## AIRPROX REPORT No 2021143

Date: 03 Aug 2021 Time: 1532Z Position: 5159N 00131W Location: IVO Oxford

### PART A: SUMMARY OF INFORMATION REPORTED TO UKAB

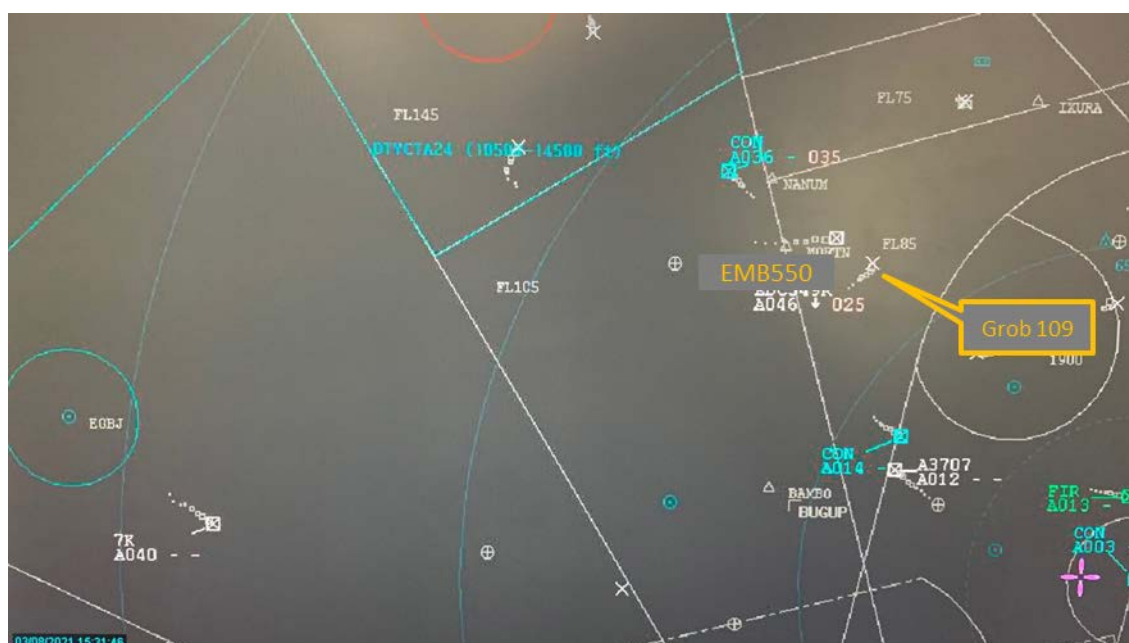
Figure 1: 1531:46

[EMB550 C/S] was inbound to Oxford, IFR. An acceptance level of 6000ft was co-ordinated with London Control prior to the aircraft being transferred to Oxford Radar. The crew first made contact with Oxford Radar at time 1528. At 1531 the controller descended the EMB550 to 2500ft (See Figure 1, screenshot taken from the Oxford radar).

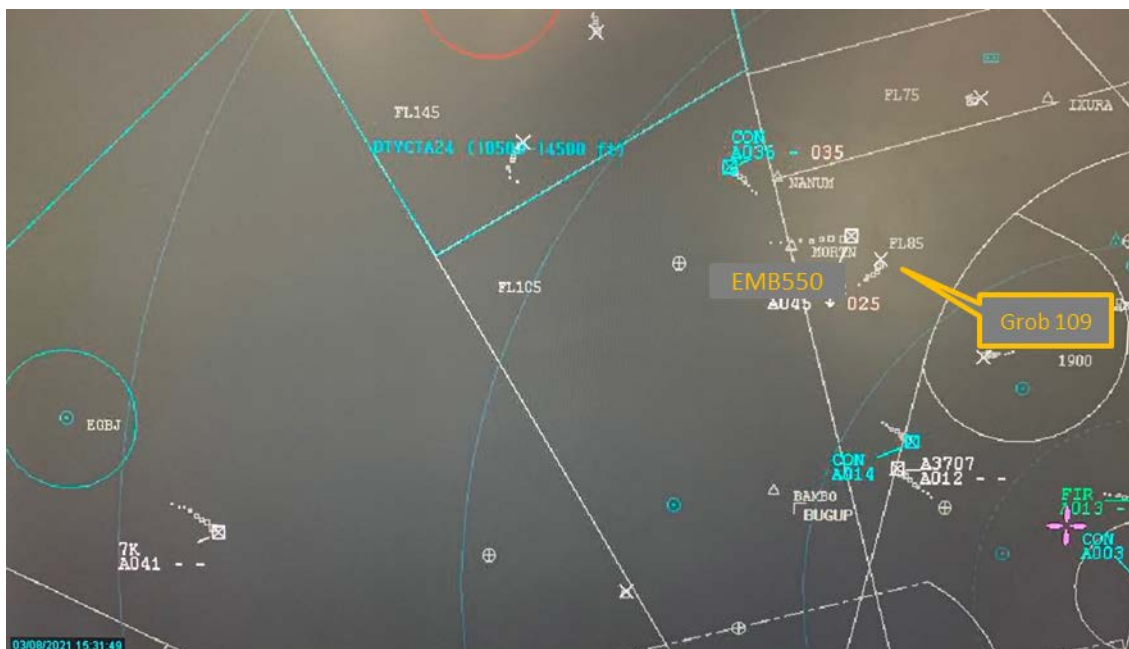
Figure 2

At around 1532 the track of the non-transponding aircraft (believed to be the glider involved in this Airprox<sup>2</sup>), altered track slightly on to a more northerly one and thus into further conflict with [EMB550 C/S], see Figure 2.

<sup>2</sup> The Oxford investigation believed this non-transponding primary contact to be the Airprox glider; in fact the contact was a Grob 109.

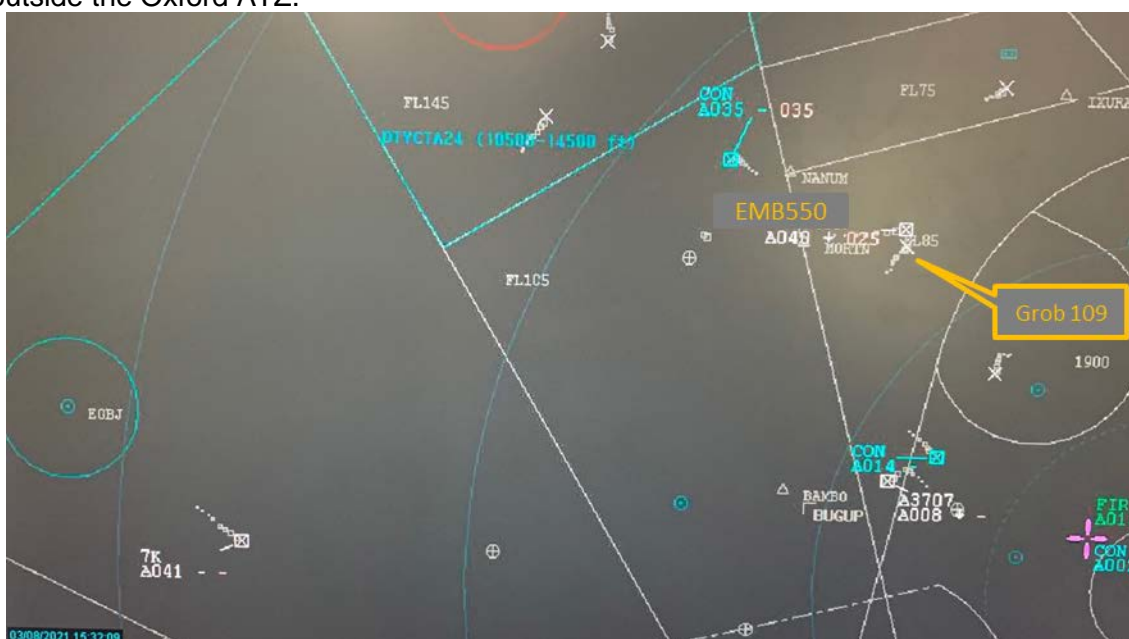
Figure 3: CPA 1532

At the time of the CPA (1532, see Figure 3) the Oxford Radar controller was passing Traffic Information to inbound jet traffic on the ILS on the conflicting traffic crossing the final approach track just outside the Oxford ATZ.

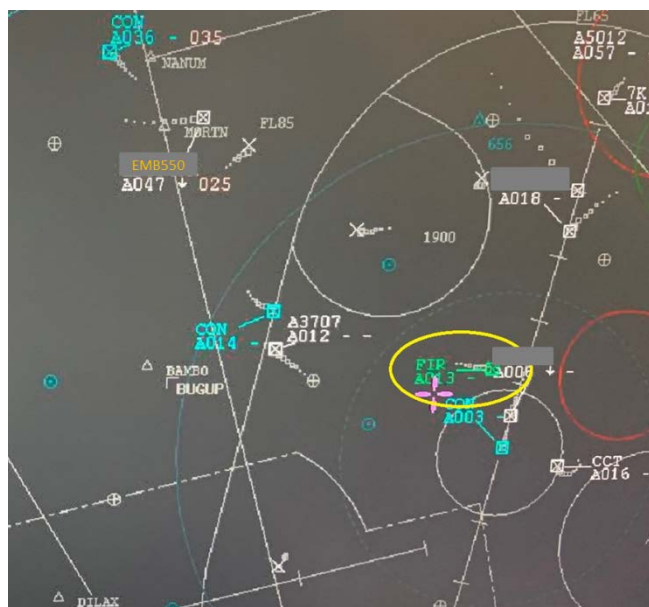
Figure 4: FIR squawk circled in yellow

The aircraft was on a heading that the controller believed would ensure they would pass north of the non-transponder equipped aircraft owing to its faster speed. At time 1532 the unknown aircraft was seen to commence a slight left turn in a more northerly direction thus putting it into further conflict with [EMB550 C/S]. At this time the Oxford Radar controller was engaged with a telephone conversation with the Oxford Tower controller informing them of traffic squawking 1177 north of the Oxford ATZ tracking east, see Figure 4.

The traffic was observed to be indicating 1300ft and as the Oxford circuit altitude is 1500ft (and was active), it became the controller’s priority at the time. The controller then passed this Traffic Information to an inbound jet on the ILS and ascertained the pilot’s intentions, who declared they were happy to continue with the approach. It was evident from the replay that by the time the

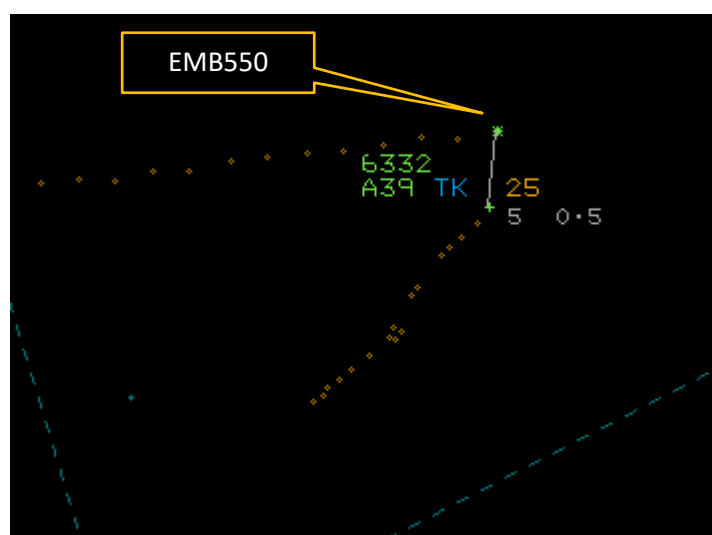
Figure 5: 1532:10 taken from the NATS radar

The Oxford Investigation assumed the glider involved in the Airprox to be the radar contact seen to the south of the EMB550. However, this contact routed from the south and at its closest point was 0.5NM from the EMB550, see Figure 5 taken from the NATS radar, this aircraft has since been identified as a Grob 109.

No other radar contacts can be seen in the vicinity. The K8 pilot provided a GPS file which unfortunately stopped at 1519:46. However, at this time the glider was in the vicinity of Barford St John, having routed south from the Banbury area. Unfortunately, due to the lack of GPS or radar data the separation between the two aircraft cannot be measured.

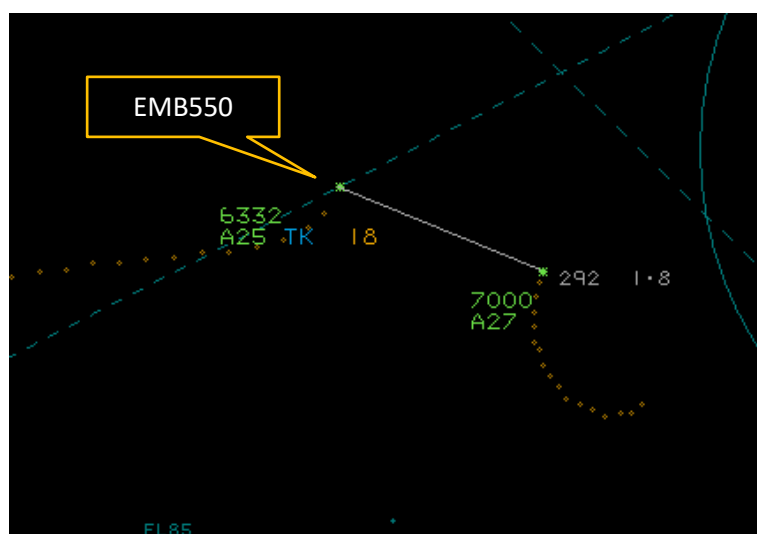
Figure 6: 1534:08

The subsequent incident described by the EMB550 pilot, for which the Oxford controller gave avoiding action, occurred at 1534:08. The EMB550 and a second unknown contact, this time squawking 7000, with Mode C indicating 2700ft, were 1.8NM apart, see Figure 6. This traffic cleared

to the north and the separation increased as the controller turned the EMB550 in a 360° turn onto final approach.
