AIRPROX REPORT No 2021152

Date: 18 Aug 2021 Time: 0930Z Position: 5130N 00048W Location: White Waltham ATZ

PART A: SUMMARY OF INFORMATION REPORTED TO UKAB

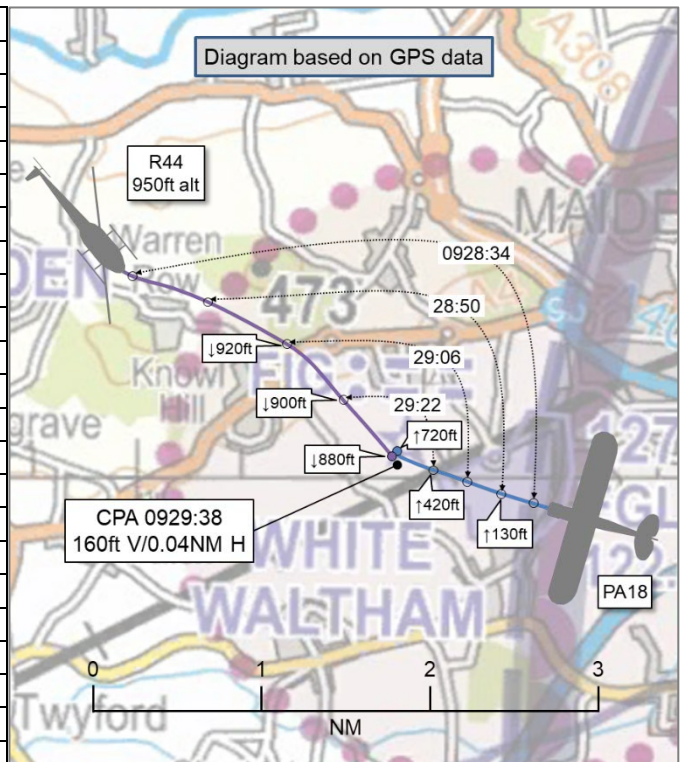
Recorded	Aircraft 1	Aircraft 2
Aircraft	PA18	R44
Operator	Civ FW	Civ Comm
Airspace	White W'tham ATZ	White W'tham ATZ
Class	G	G
Rules	VFR	VFR
Service	AGCS	AGCS
Provider	Waltham Radio	Waltham Radio
Altitude/FL	720ft	880ft
Transponder	Not fitted	A, C, S
Reported		
Colours	White	Blue, white
Lighting	Strobe, nav	HISL, landing light
Conditions	VMC	VMC
Visibility	5-10km	>10km
Altitude/FL	600ft	500ft
Altimeter	QFE (1013hPa)	QNH (NK hPa)
Heading	300°	NK
Speed	65kt	100kt
ACAS/TAS	Not fitted	TAS
Alert	N/A	None
Separation at CPA		
Reported	100ft V/150m H	50-100ft V/100m H
Recorded	160ft V/0.04NM H ¹

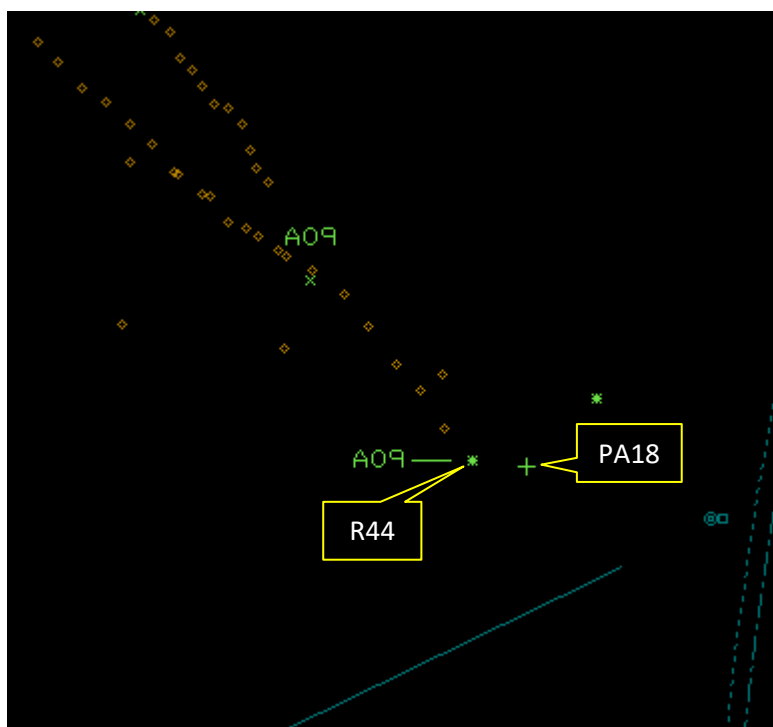
An analysis of the NATS radar replay was undertaken. The PA18 was not equipped with a transponder so it was not possible to identify – by use of the radar alone – the single primary radar return detected shortly before CPA (see Figure 1). However, both pilots provided the UKAB Secretariat with their GPS log files from the flight and the position of the primary radar return correlated with the positional information from the PA18 pilot's GPS log file. The NATS radars held a stable track on the R44 throughout the moments leading up to the Airprox and this track also correlated with the GPS data provided by the R44 pilot. Using the GPS data provided by both pilots, a CPA of 0.04NM horizontal and 160ft vertical separation was measured.

Figure 1 – 0929:35 – single primary radar return
