**AIRPROX REPORT No 2021122**

Date: 18 Jul 2021 Time: 0934Z Position: 5203N 00100W Location: Silverstone

**PART A: SUMMARY OF INFORMATION REPORTED TO UKAB**

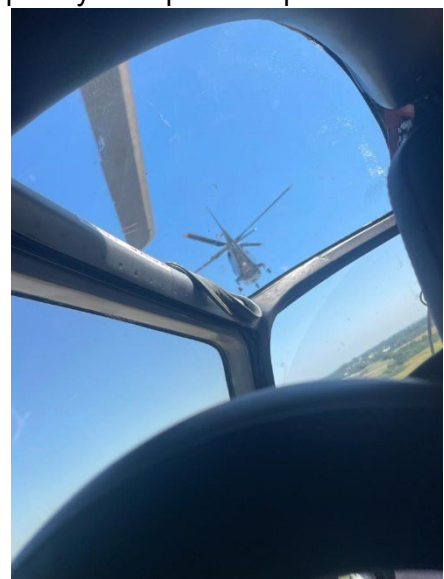
Figure 1

**THE EC155 PILOT** reports that they joined the Silverstone RAT on the Silverstone Tower frequency and was asked to take up the hold at South Point. The pilot identified one aircraft already in the hold, so followed their path in the hold at 80kt. On completion, the pilot reported 'hold complete' and was then given permission to join for finals and change to Silverstone Pad frequency. The pilot completed the hold by turning towards the final point. They then started to descend to 1000ft (requested height at Final point) and changed to Silverstone Pad. There was a small 5-10sec delay in changing frequency due to radio problems. The pilot was not aware of any other aircraft being on final. The pilot reported final on the Pad frequency and was given a gate to route to. At around 20-50m from the start of the FATO<sup>1</sup> the A109 flew straight over the top of the aircraft. At the time it seemed very close, in the range of 40-100ft. The Pad frequency was so busy there was no time to raise the Airprox issue at that time. The passengers were dropped at one of the gates, and then departed. One of the passengers in the EC155 was also the owner of the aircraft. They later spoke to the control tower who were aware of the closeness of the aircraft. The pilot got in touch with the other pilot of the A109 who stated that they were completely unaware that they had flown over the EC155 at such close proximity. Both pilots agreed an Airprox should be filed due to the nature of the situation. One of the passengers took a picture of the A109 several seconds after it flew over (Figure 1).

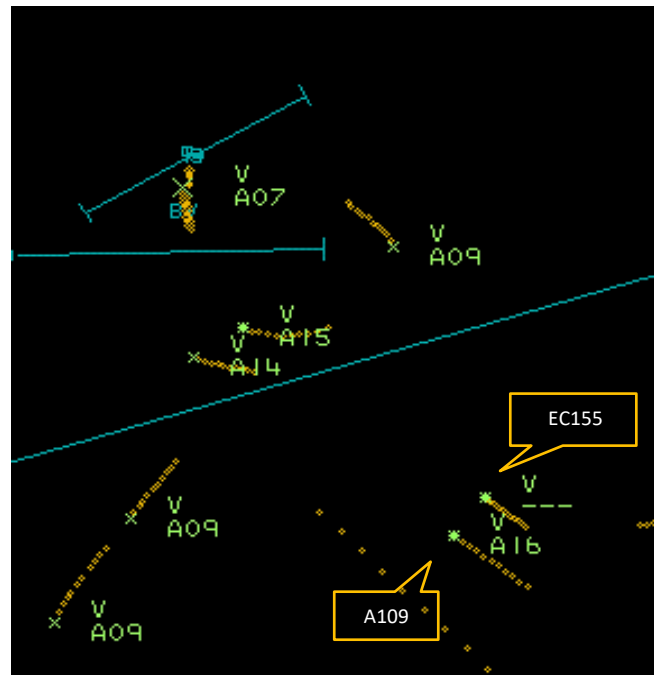
Figure 1 - 0928.40

At 0928.40 the EC155 pilot made initial contact with the Tower controller, using their callsign and registration, followed by a request to join at South Point, the controller responded, *"good morning, enter and take up the hold initially, there are 3 others doing similar, but report approaching South Point and I'll hopefully update you on that with a no delay."* The pilot read back, *"enter and take up the hold, report approaching South Point."* (Figure 1).

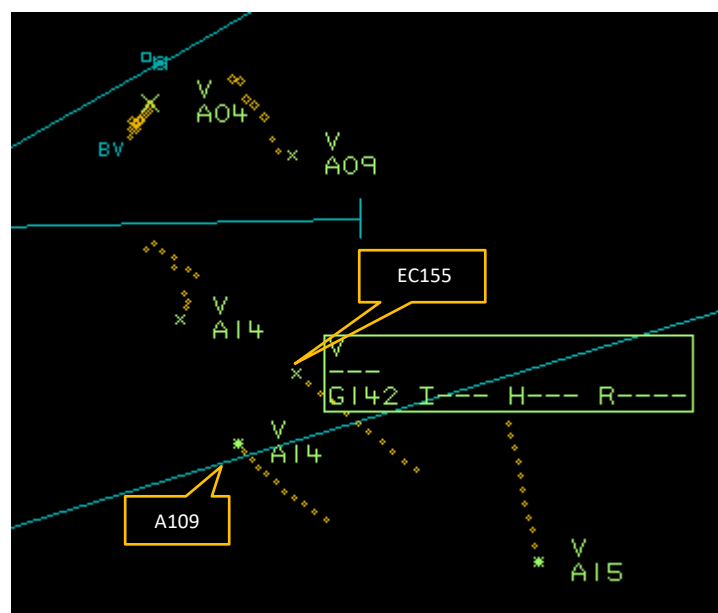
At 0930.40 the EC155 pilot reported, *“joining at South Point.”* The controller responded, *“once round, report approaching South Point.”* The pilot read back, *“once round, report approaching South Point.”* (Figure 2).

Figure 2 - 0930.40 (EC155 indicating a Ground Speed of 142 kts at South Point)

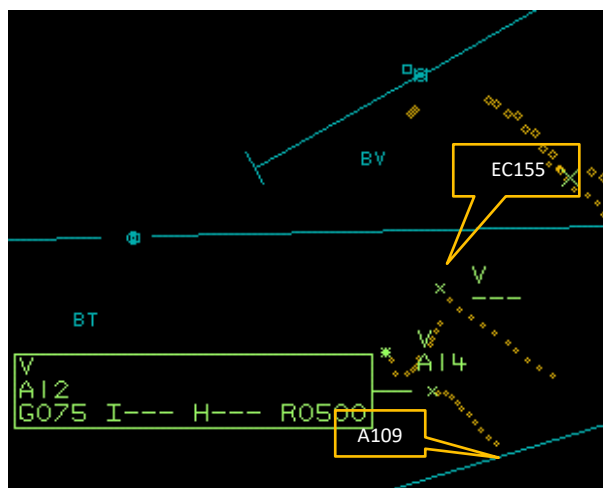
At 0931.20 The A109 pilot reported, *“entering the hold.”* The controller responded, *“once round, after the hold your join is approved, report South Point.”*

Figure 3 - 0931.20 (A109 indicating a Ground Speed of 75kt at the hold datum)

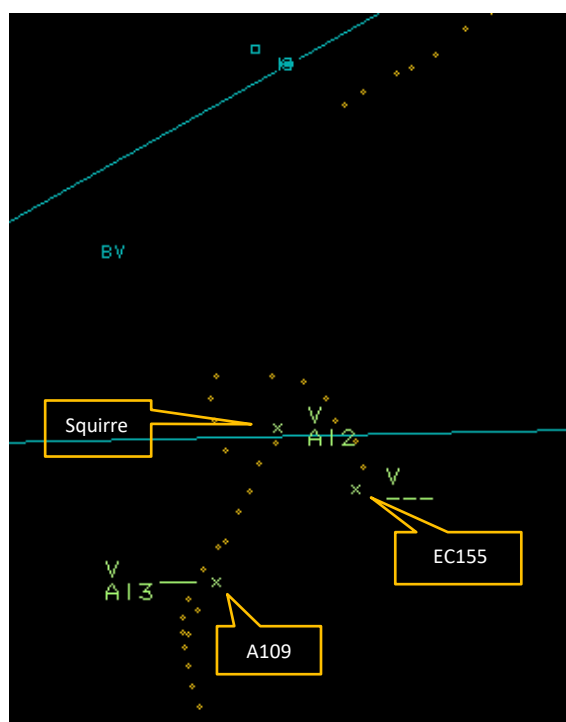
Figure 4 - 0932.20

At 0932.20 the A109 pilot reported, *“South Point behind the Squirrel.”* The controller responded, *“roger, join is now approved and contact Pad 130.280.”* The pilot read back the frequency correctly (Figure 4).

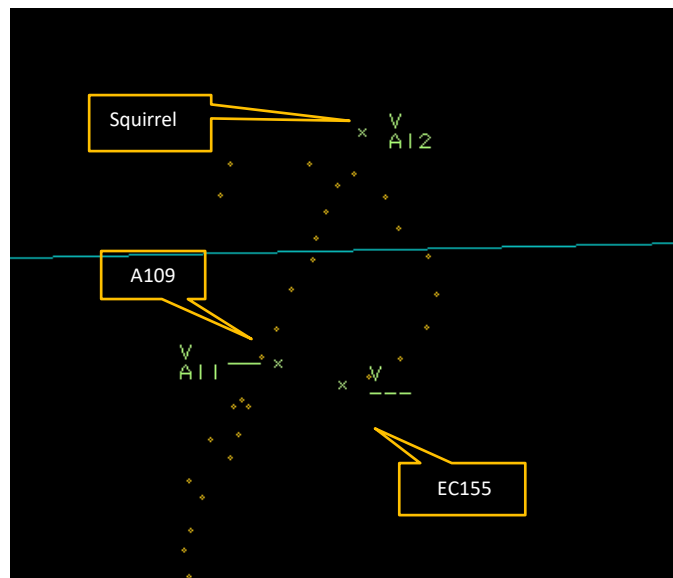
Figure 5 - 0932.30

At 0932.30 the EC155 pilot reported, *“hold complete, now reaching South Point.”* The controller responded with the incorrect callsign but correct two-digit number from the EC155 callsign, *“roger South Point, join approved and report final, contact Pad 130.280.”* The pilot read back, *“contact Pad 132.80”* and finished the transmission with their correct callsign. The controller picked up the incorrect readback and responded, *“130.280.”* There was no response from the pilot (Figure 5).

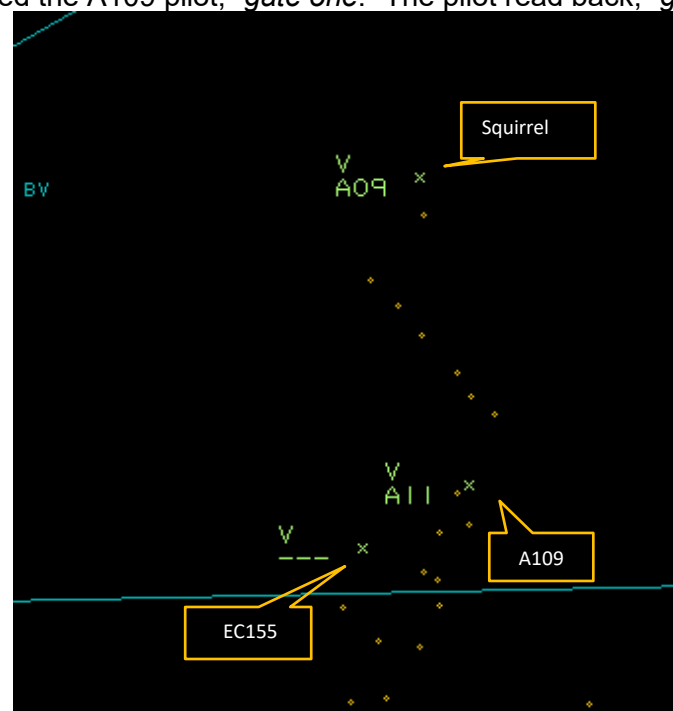
At 0933.00 the A109 pilot reported on the Pad frequency, “(callsign) is at South Point, er is at final.” The controller responded, “report final.” The pilot responded, “approaching final, behind the Squirrel.” There was then a call from an unrelated aircraft and the controller responded to them. The controller then instructed the A109 pilot, “gate one.” The pilot read back, “gate one” (Figure 6).

Figure 6 - 0933.00 (the EC155 pilot completing the final right turn in the hold, not yet on the Pad frequency and now west of the A109)

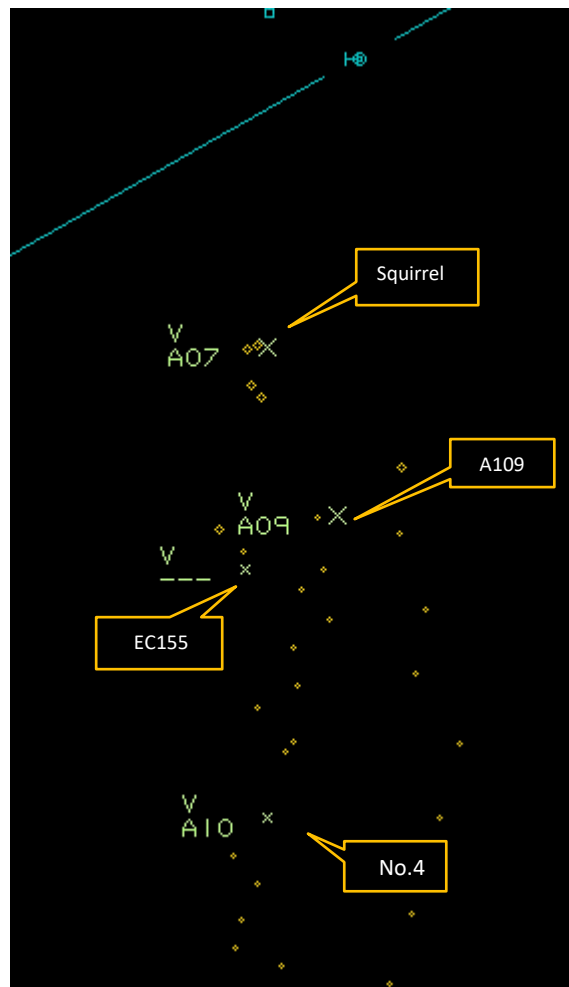
At 0933.30 a fourth helicopter pilot made initial contact with the Pad controller and reported final. The controller responded, “roger, continue, you’re number 4, you’ve got an EC155 ahead of you.” The pilot responded, “affirm (unintelligible word)” (Figure 7).

Figure 7 - 0933.30 (EC155 not yet on the Pad frequency)

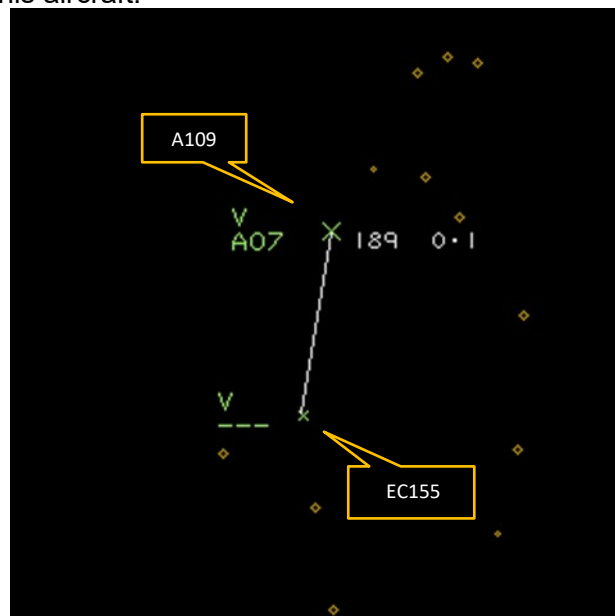
At 0933.40 a joining aircraft incorrectly checked in on the Pad frequency and the Pad controller turned their attention to this aircraft.

Figure 8 - 0933.55 (EC155 not yet on the Pad frequency)

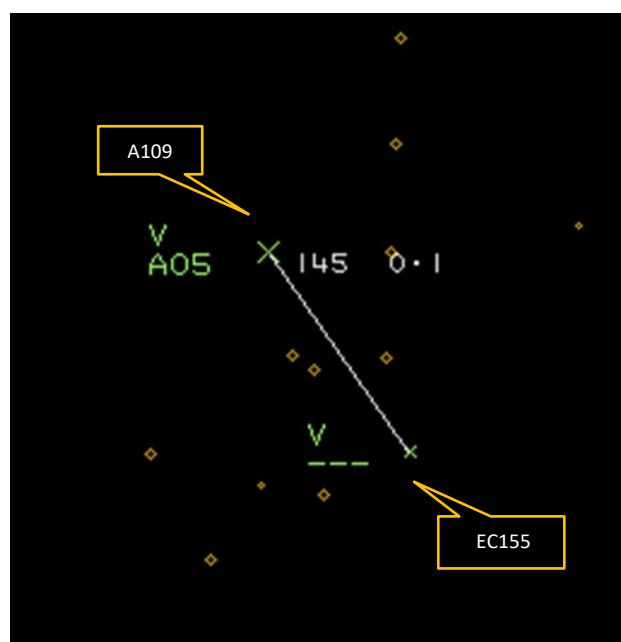
At 09:34.00 the controller instructed the EC155 pilot, "gate two." The pilot did not respond initially and after a few seconds responded, "apologies, we had problems with our radio there." The controller responded, "gate two. which the pilot read back.

Figure 9 - 0934.06 (EC155 now on the Pad frequency)

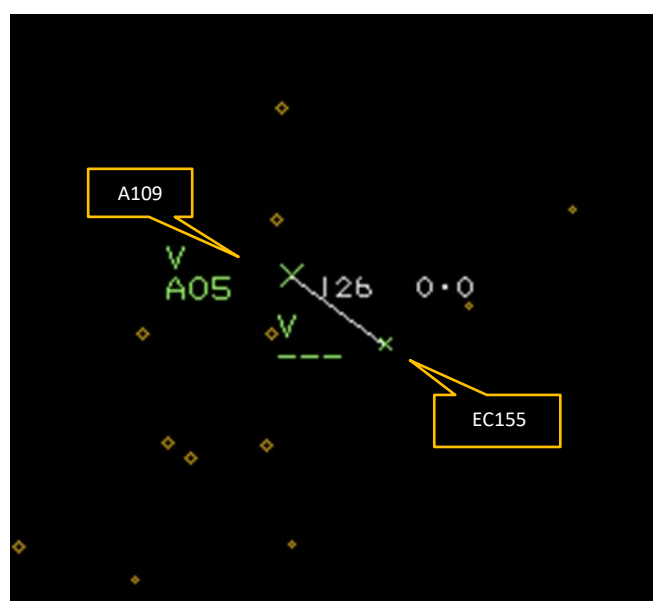
Figure 10 - 09:34.10 Radar CPA

At 09:34.10 radar CPA occurred, with the aircraft separated by an indicated <math><0.1\text{NM}</math>. The EC155 pilot reported that they were at an altitude of between 100-200ft and the A109 indicated an altitude of 500ft. The EC155 pilot believed the vertical separation to be between 40 and 100ft as the A109 flew over the top of them (Figure 10).
