AIRPROX REPORT No 2021185

Date: 16 Sep 2021 Time: 1045Z Position: 5140N 00016W Location: Borehamwood

PART A: SUMMARY OF INFORMATION REPORTED TO UKAB

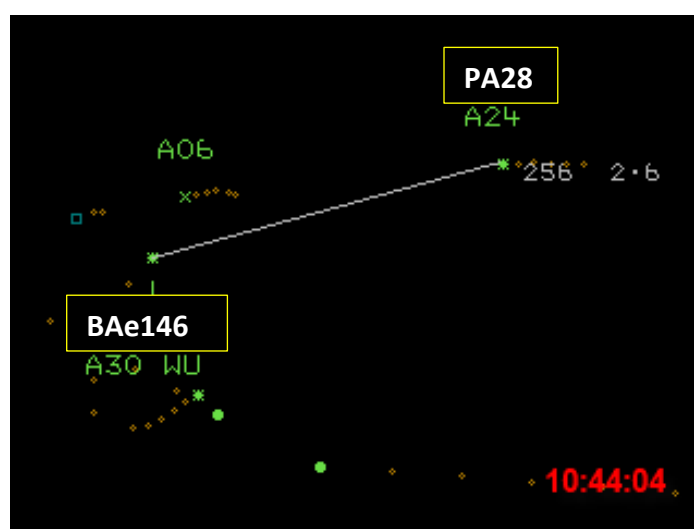
Figure 1

[The PA28] was displaying mode-A 5023 (Farnborough LARS North) and believed to be in receipt of a Basic Service. [The PA28] always remained outside controlled airspace. [The BAe146] was inside CAS and appeared to carrying out radar circuits at Northolt under the control of Northolt Radar, indicating 3000ft mode C.

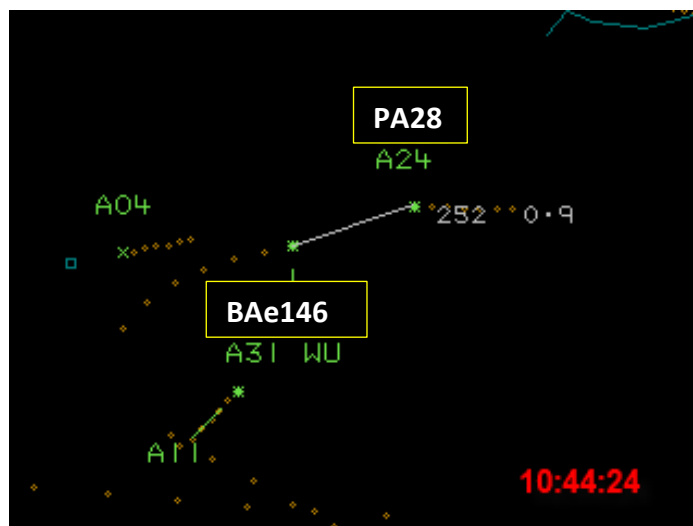
Figure 2

[The BAe146] was initially at 3000ft – the 5023 squawk (Mode S indicated this to be [the PA28]) at 2400ft. The base of the London TMA in this area is 2500ft. [The BAe146] was inside controlled airspace. [The PA28] was outside controlled airspace.

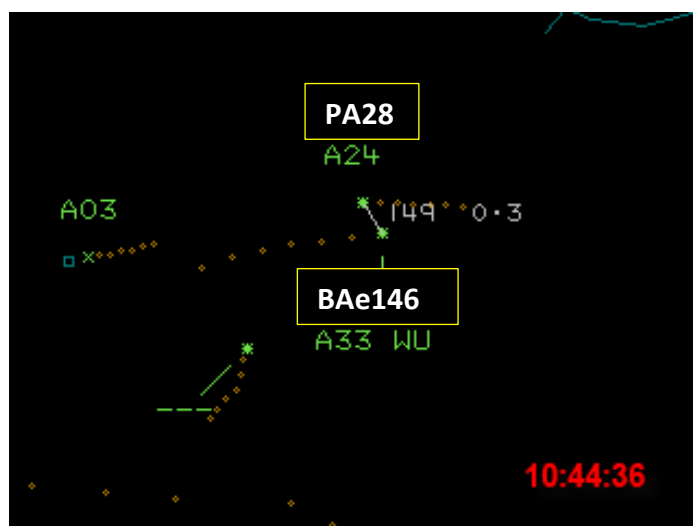
Figure 3

As the aircraft approached, [the BAe146] commenced climb.

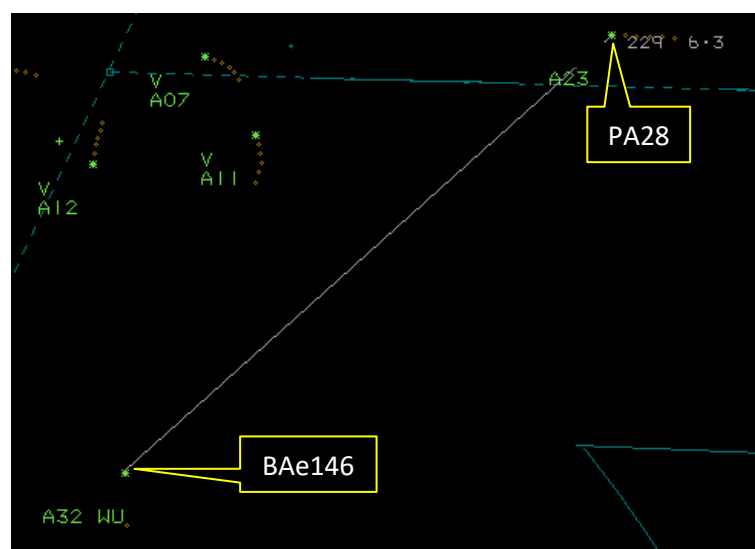
Figure 4

The BAe146 pilot was advised that there was '*traffic north east by six miles, tracking west indicating 2300ft*' and the Northolt Radar controller stipulated that they would be separated by classification of airspace (Figure 4).

Information regarding the PA28 passed to the BAe146 pilot

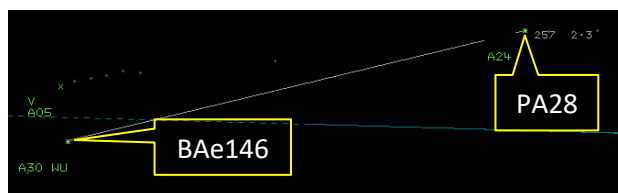
Figure 5

The BAe146 pilot was given a right-hand turn to 090°, 29sec after the initial Traffic Information. 25sec later, the Northolt Radar controller provided an update on the location of the PA28. Separation had decreased to 2.3NM and 600ft (Figure 5). 6sec later, the BAe146 pilot reported responding to a TCAS RA. Separation had decreased to 1.6NM and 600ft (Figure 6).

BAe146 pilot provided with an update on the PA28

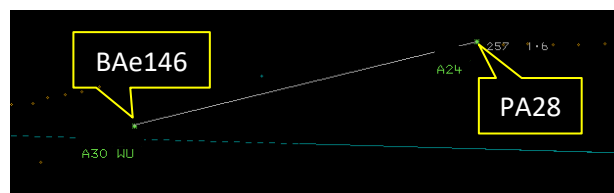
Figure 6

BAe146 pilot reported TCAS RA and climbing

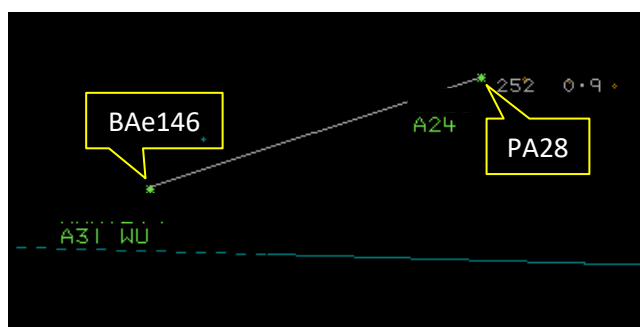
Figure 7

Minimum vertical separation occurred between radar sweeps with separation of approximately 1NM and 600ft before the radar displayed the BAe146 climb in response to the TCAS RA (Figure 7).

Minimum vertical separation

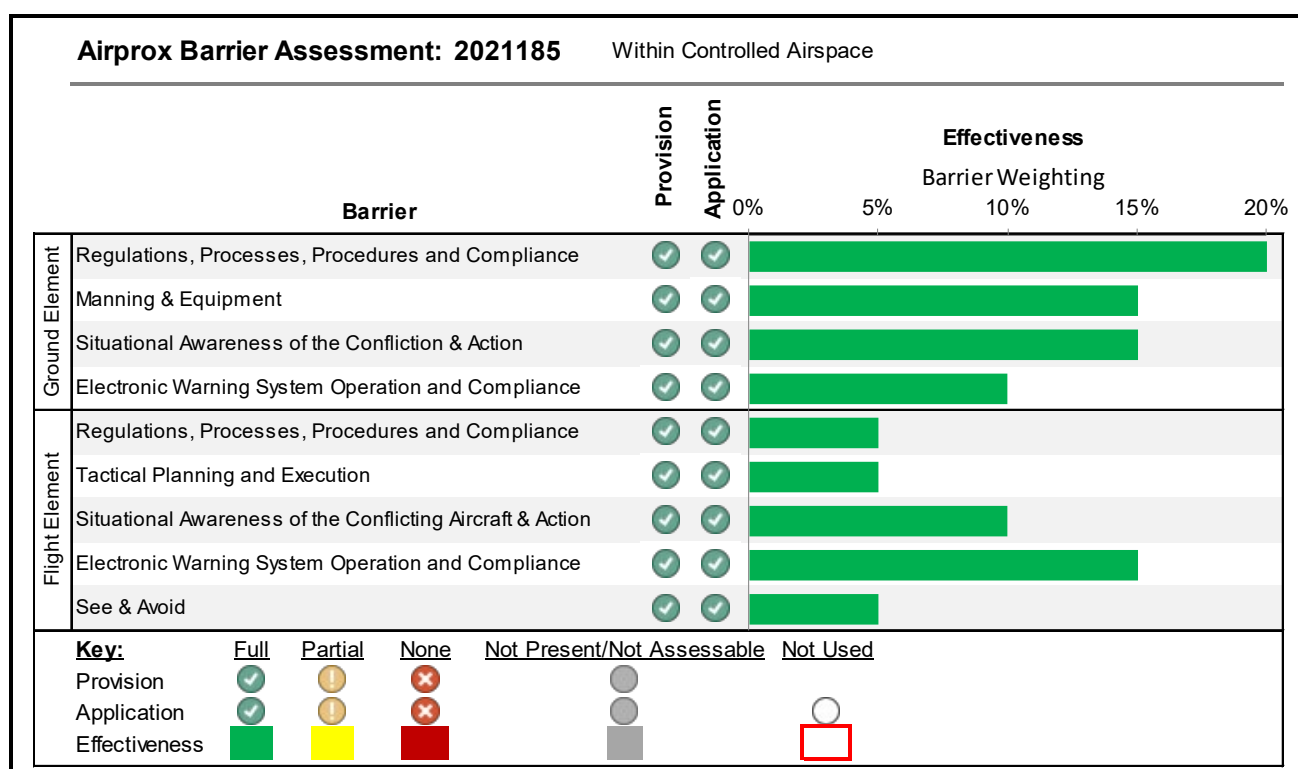
In assessing the effectiveness of the safety barriers associated with this incident, the Board concluded that, in this case, all the barriers to mid-air collision had performed as intended.
