AIRPROX REPORT No 2021228

Date: 09 Nov 2021 Time: 1446Z Position: 5145N 00135W Location: Brize Norton overhead

PART A: SUMMARY OF INFORMATION REPORTED TO UKAB

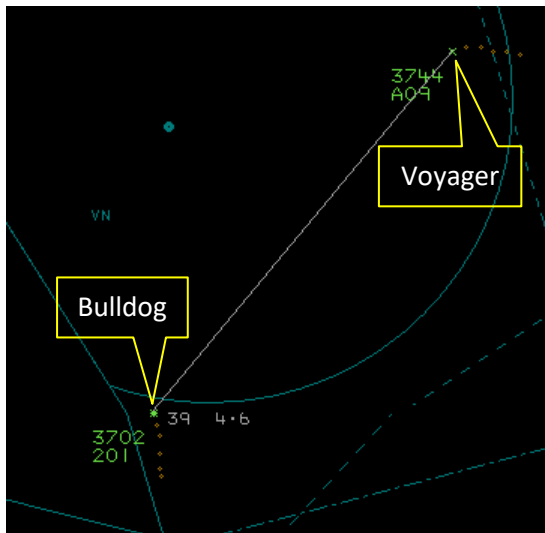
Figure 1 was the first available screenshot taken at 1445:00. The Bulldog pilot had been given a CTR crossing clearance and the Approach controller had approved a SID B departure for the Voyager to join the RTC which had been relayed to the Voyager pilot by the Aerodrome controller. Traffic Information had been passed to the Bulldog pilot 52sec previously as "*traffic north east 7 miles, er tracking north west is an A330 in the visual circuit at Brize, conducting a low approach, then climbing out er runway track 2800ft, report when you're visual*". The Bulldog's Mode C was displaying incorrectly at this point. Between the Traffic Information being passed to the Bulldog pilot and Figure 1, the Approach controller was handling 2 other aircraft.

Figure 1
1st available screenshot

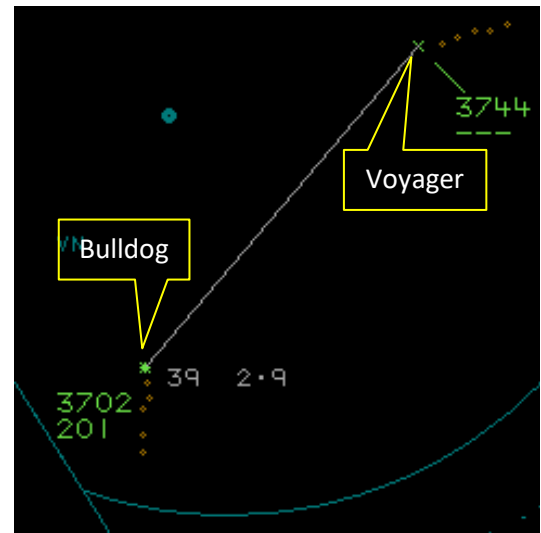
Figure 2
Bulldog pilot asked to turn off Mode C

Thirty-seven seconds later, observing the Bulldog's incorrect Mode C, the Approach controller requested the pilot to turn off the Mode C (Figure 2). This was not acknowledged by the Bulldog pilot. Separation decreased to 2.9NM horizontally with an unknown vertical separation.

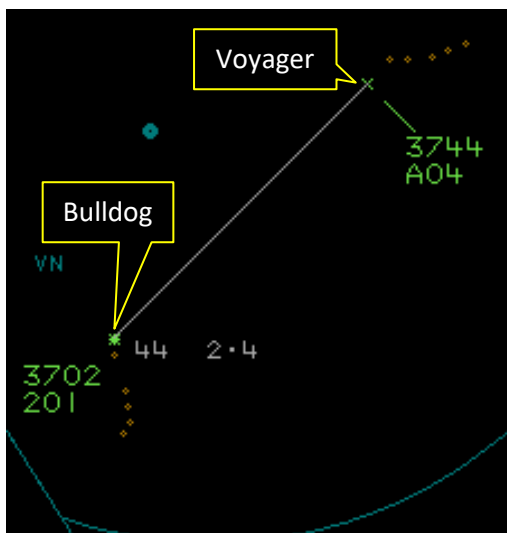
Six seconds later the Bulldog pilot reported visual with the Voyager. Separation had decreased to 2.4NM (Figure 3). On completion of their approach in the visual circuit, the Voyager pilot was instructed to switch to Brize Director (Figure 4). Three seconds prior to this, the Mode C on the Bulldog was seen to be turned off. The Approach controller, 11sec earlier, had provided another aircraft with a squawk and QNH and agreed a Basic Service. Separation decreased to 1.6NM horizontally with an unknown vertical separation.

Figure 3
Bulldog pilot reported visual

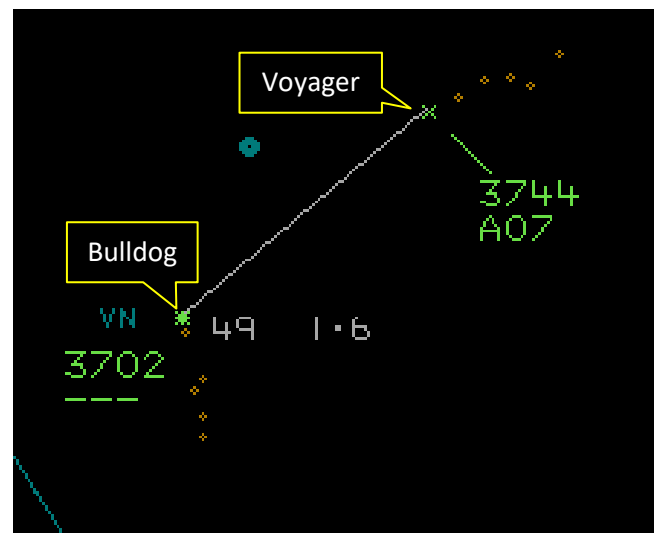
Figure 4
Voyager pilot transferred to Director

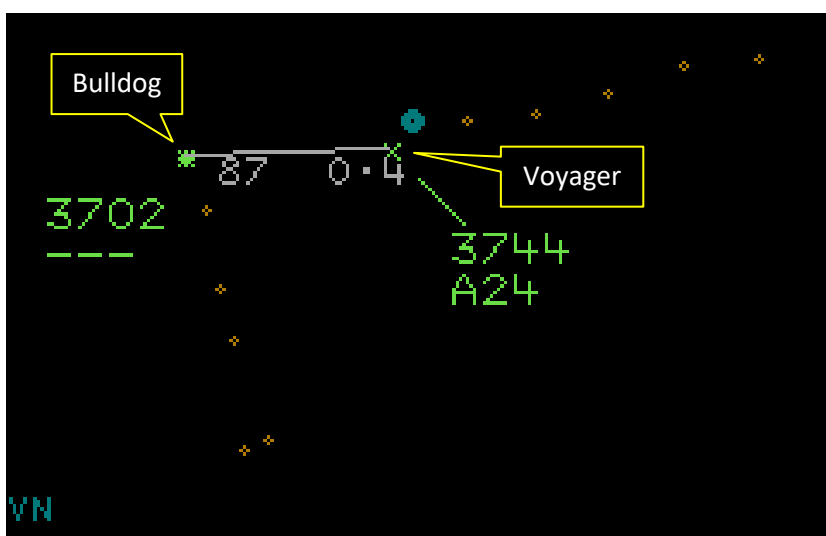
Twenty-two seconds later CPA occurred (Figure 5). Separation was measured at 0.4NM horizontally; the vertical separation could not be measured on radar.

Figure 5
CPA
