**AIRPROX REPORT No 2021234**

Date: 13 Nov 2021 Time: 1223Z Position: 5139N 00012E Location: Stapleford visual circuit

**PART A: SUMMARY OF INFORMATION REPORTED TO UKAB**

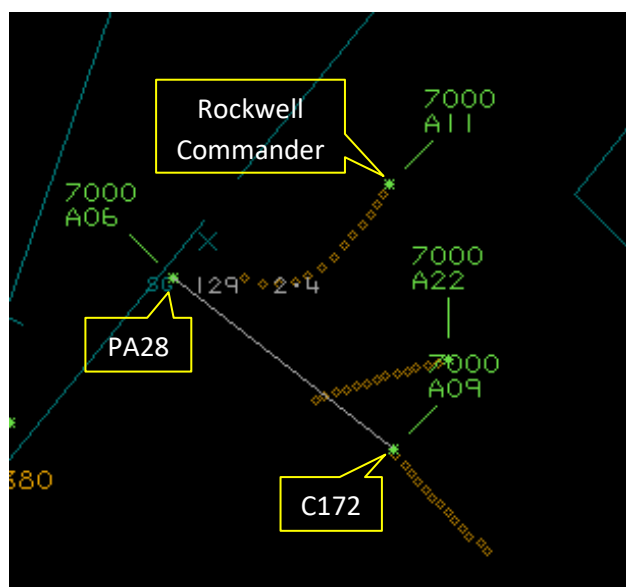
Figure 1 – 1221:12

Analysis of the NATS radar replay showed that both aircraft were detected by the NATS radars throughout the period of the Airprox. The PA28 first appeared on radar at 1221:12, on climb-out from the previous circuit; the C172 was seen to be tracking north-west at an altitude of 900ft and the aircraft were separated by 2.4NM at this time (see Figure 1). The PA28 continued to climb on the crosswind leg and the C172 passed in front of the PA28 at 1221:38 at a range of 1.4NM and co-altitude (see Figure 2).

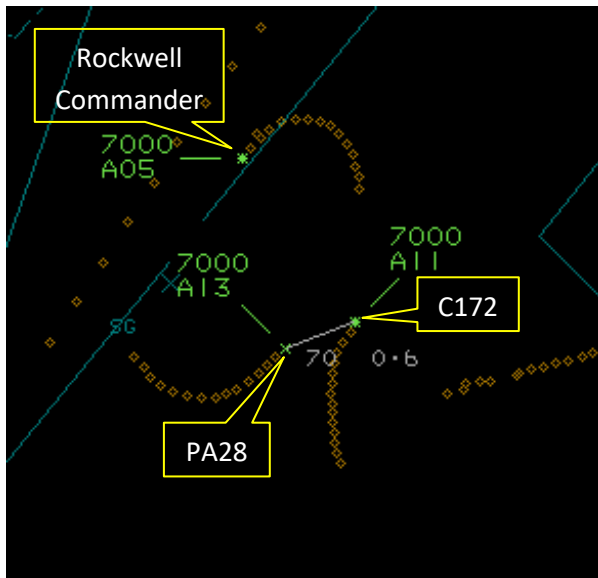
Figure 3 – 1222:18

At 1222:18, both aircraft were established on parallel downwind tracks approximately 0.3NM (~500m) apart. The separation between the 2 aircraft at this point was 0.6NM and 200ft, the higher aircraft being the PA28 (see Figure 3). At 1222:50 the C172 pilot, flying a wider downwind leg than the PA28 pilot, commenced their turn onto base leg (see Figure 4). CPA occurred at 1222:10; radar separation was measured at <0.1NM horizontally and 300ft vertically (see Figure 5).
