AIRPROX REPORT No 2021244

Date: 14 Dec 2021 Time: 1046Z Position: 5627N 00301W Location: Dundee

PART A: SUMMARY OF INFORMATION REPORTED TO UKAB

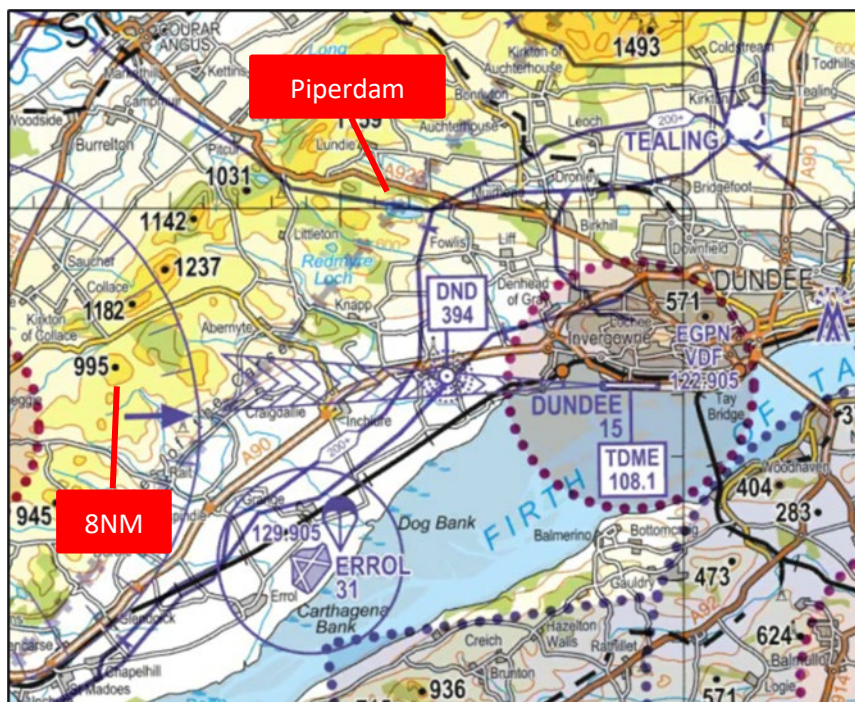
Figure 1

The ATR42 was inbound to Dundee, completing an ILS approach to RW09, converting to a visual circling approach to the RW27 which was the runway in use. The PA28 was returning from the north, approaching Piperdam Loch, an unpublished visual reference point 4.5NM to the northwest of the airfield (Figure 1). Only the ATR42 was initially visible on the area radar replay as it approached Dundee from the southeast. However, the radar contact was lost when the aircraft descended below 3000ft. The PA28 was never seen.

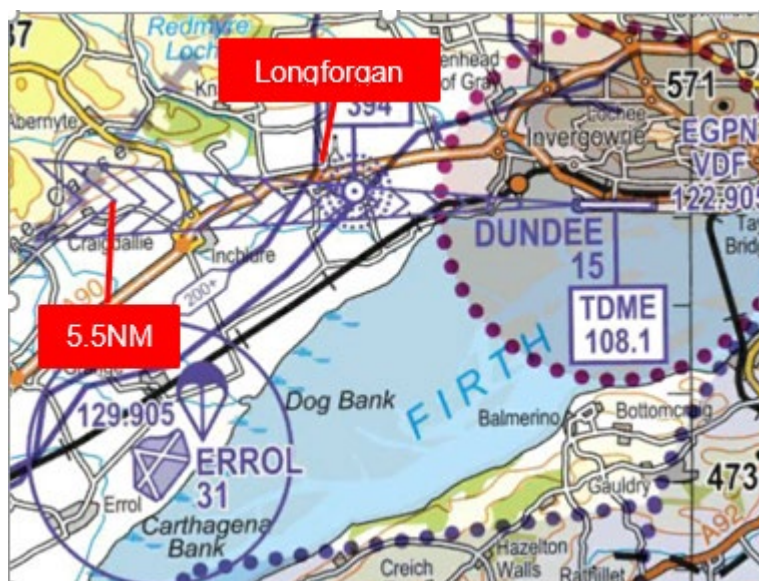
Figure 2

At 1046:25 the ATR42 pilot reported “*I have an aircraft in my 12 o’clock at the same level at two miles, joining downwind and I am heading 150 for the circling procedure for 27 at Dundee. We called beacon outbound about five minutes ago*”.
