## AIRPROX REPORT No 2021065

Date: 26 May 2021 Time: 1345Z Position: 5318N 00058W Location: Retford/Gamston circuit

### PART A: SUMMARY OF INFORMATION REPORTED TO UKAB

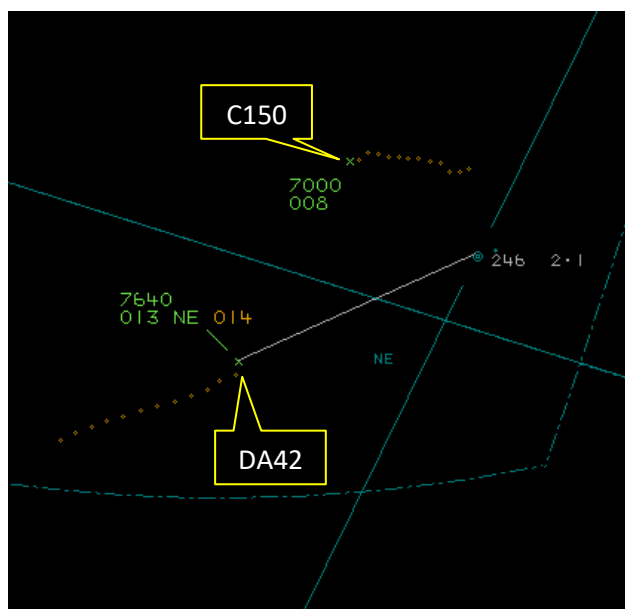
Figure 1 – 1343:19

At 1343:19 the DA42 pilot took up a northerly heading as the C150 pilot turned onto the downwind leg. The DA42 was 2.1NM from the airfield at this point (see Figure 1). The DA42 pilot continued on a northerly heading at approximately 2NM from the airfield and passed 0.7NM abeam and 700ft above the C150 at 1343:47 (see Figure 2).

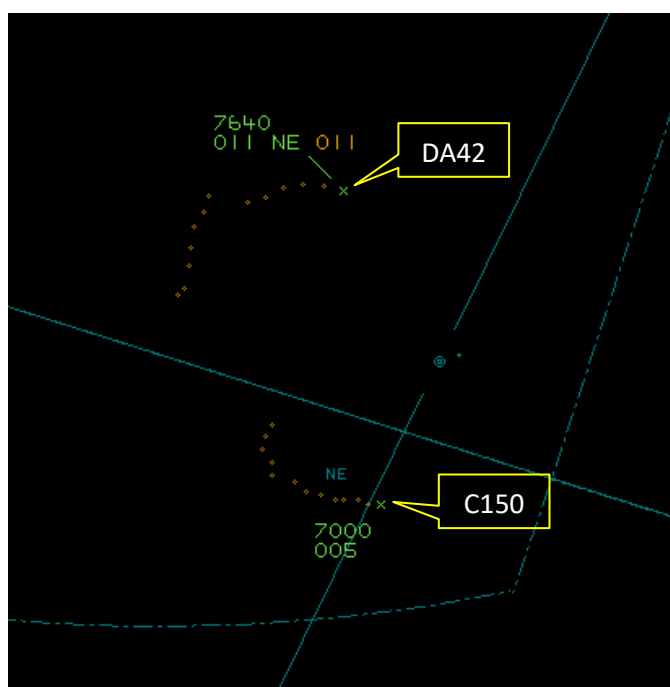
Figure 3 – 1344:51 – estimated CPA

The DA42 pilot then continued northbound and descended to an altitude of 1200ft before turning right to establish downwind for RW03LH at 1344:30. It is assessed that CPA occurred approximately 20sec after this turn, as the DA42 pilot reached an altitude of 1100ft and was approximately 90° off the RW heading (see Figure 3).
