AIRPROX REPORT No 2020037

Date: 14 May 2020 Time: 0859Z Position: 5316N 00422W Location: RAF Mona

PART A: SUMMARY OF INFORMATION REPORTED TO UKAB

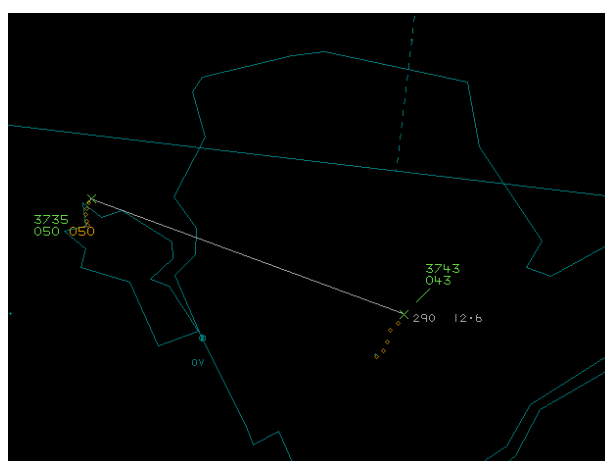
Figure 1: Both aircraft on radar

Having completed one approach, the Hawk pilot climbed out of Mona with the intention of completing another PFL. The Texan had departed Valley and was level at FL50. This was the first time that both aircraft were displayed on the radar replay and separation between the aircraft was 12.5NM at this point.

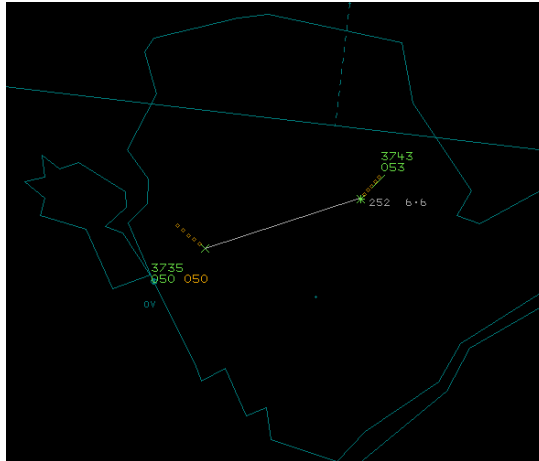
Figure 2: Hawk transferred to Mona

As part of the Radar PFL profile, the Hawk had been cleared to descend to 3000ft and had begun a turn inbound to Mona whilst there was still 12NM separation between the aircraft. At this point, the Valley Approach controller began liaising with the Mona Tower Controller to agree a joining level and also coincided with a call from another aircraft. The liaison with Mona Tower was protracted

due to a comms issue and by the fact that a working party had been given permission to enter the Mona runway. At the end of this landline call the Hawk was transferred to Mona Tower. Separation had decreased to 6.5NM and 300ft by this point.

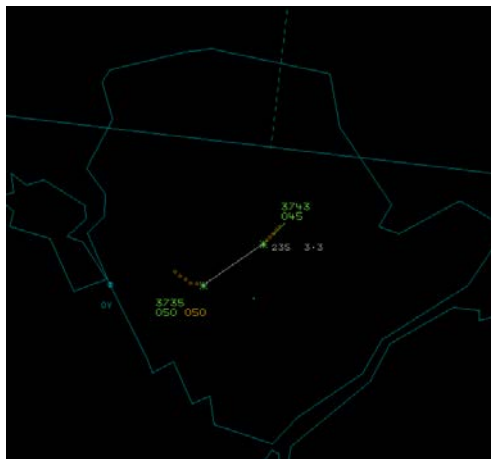
Figure 3: Separation decreased below 5NM.

Immediately following the transfer of the Hawk, the Valley Approach controller received another call pre-noting another departure from Valley as well as a call from another aircraft. At the end of this sequence of events, separation between the aircraft had decreased to 3.3NM and 500ft.

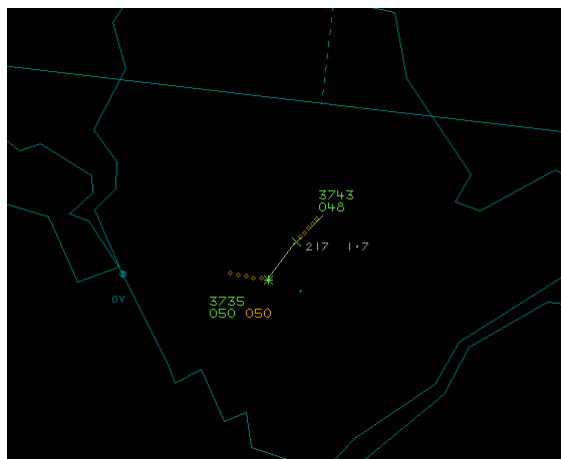
Figure 4: Vertical CPA

The Hawk instructor reported that the aircraft was too high to complete the PFL approach and instructed the student to re-set for an additional PFL. Because of this, the Hawk pilot did not actually call Mona Tower and was thus not receiving an ATS at the time of the incident. The radar replay shows the Hawk beginning a climb at a rate of approximately 500ft per minute. At 1.7NM this rate of climb is reversed and is likely coincident with the Hawk instructor receiving a TCAS TA and instructing the student to descend. The Valley Approach controller passed Traffic Information to the Texan for the first time approx. 10sec after the Hawk began the descent noted above. The Texan pilot reported having seen the conflicting traffic on TCAS. At this point separation was 1.7NM and 200ft and was the closest point vertically that the aircraft came to each other.

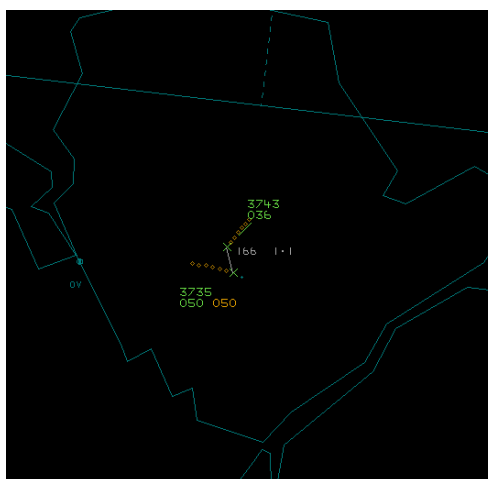
Figure 5: Lateral CPA

Allowing the radar replay to continue showed that lateral separation decreased to a minimum of 1.1NM but by this time, horizontal separation had increased to 1400ft.
