AIRPROX REPORT No 2020042

Date: 20 May 2020 Time: 1105Z Position: 5439N 00131W Location: Newton Aycliffe

PART A: SUMMARY OF INFORMATION REPORTED TO UKAB

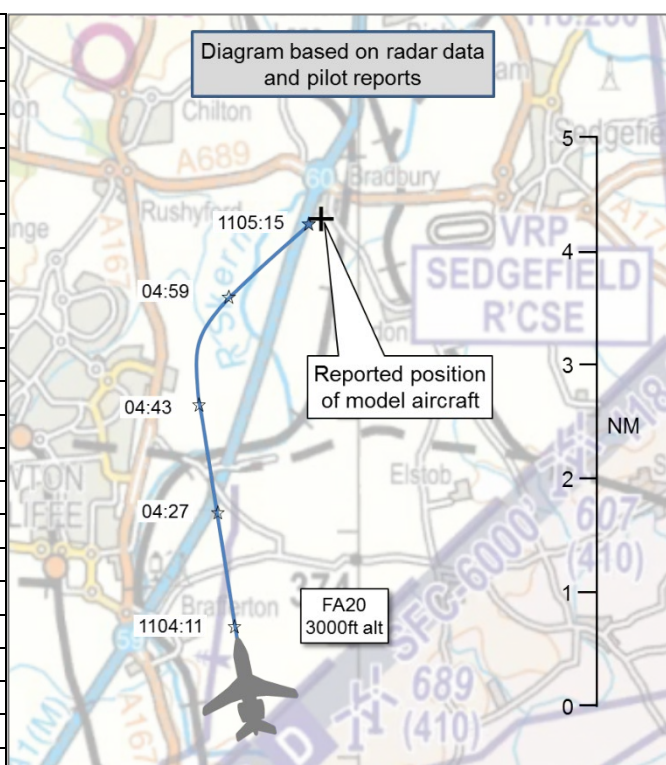
On reviewing the radar recordings around the time of the event, the FA20 was 2.5NM NW of Teesside Airport, routing northbound maintaining a distance of approximately 4.5NM to the west of the Redmarshall model flying club site. Due to the distance of the aircraft from the Redmarshall site at the time of the event, the FA20 pilot was contacted to ensure that the report was accurate. It was noted that the FA20 made an approximate 20° left turn at the time of the event. The turn took the aircraft to the west of a known permanent echo (a windfarm located 5NM NNW of the airport) but there were no other discernible contacts displayed. Unfortunately, ATC was not advised of the event at the time and, due to the FA20 operating VFR and only making a relatively small adjustment of 20° to avoid the craft, it was not noticed or questioned by the Radar controller. Had ATC been notified, and because the weather conditions were favourable, the Aerodrome controller may have been able to visually acquire and maybe track the craft.
