AIRPROX REPORT No 2020044

Date: 27 May 2020 Time: 1415Z Position: 5046N 00211W Location: 13NM W Bournemouth

PART A: SUMMARY OF INFORMATION REPORTED TO UKAB

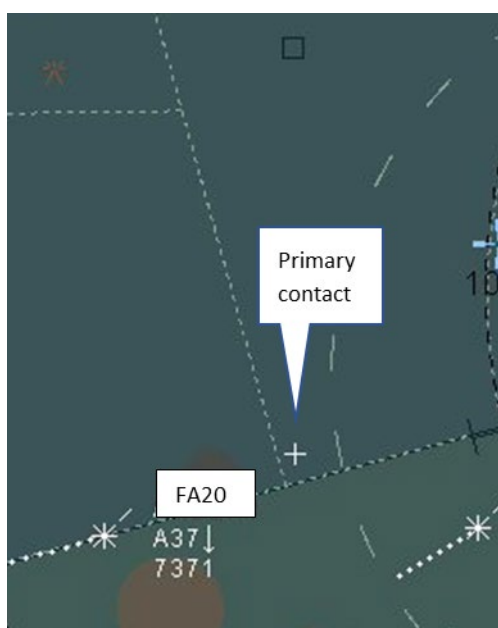
Figure 1

The controller passed Traffic Information to the FA20 pilot on another FA20 joining VFR ahead at 1413:21. The controller then co-ordinated with the ADI controller during which the radar controller advised of the two joining FA20s and two CTR transits. Clearance was then given to a pilot to transit the north eastern edge of the CTR not above 2000ft VFR, at 1414:21, whilst that pilot read back the transit clearance, a PSR contact briefly reappeared ahead of the FA20 approximately 0.5NM north of the final approach track 4NM east of the aircraft. A screen capture taken at this time is depicted below with FA20 descending through 3700ft (Figure 1).

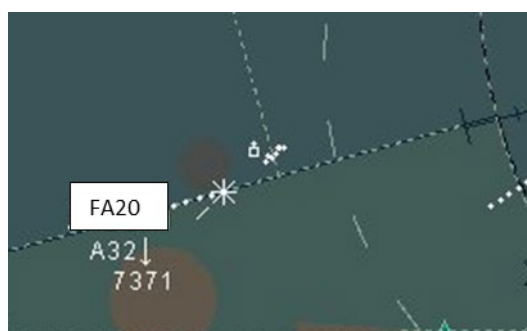
Figure 2: 1414:59

A continuous primary contact remained on the radar display making subtle movements until the contact began to coast at 1414:55 for several seconds (Figure 2). At 1415:07 the contact reappeared more solidly, approximately 0.75NM due north of the FA20 tracking slowly westbound, Figure 3.

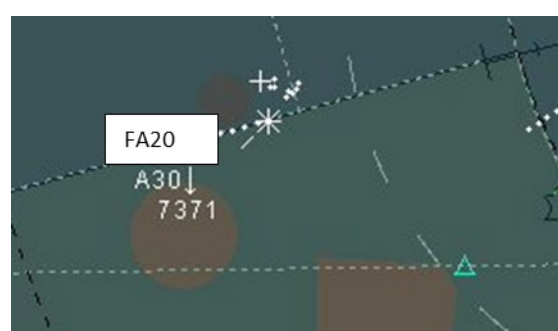
Figure 3: 1415:07

At 1415:17 the FA20 pilot reported visual with the field and was told to contact Bournemouth Tower, just before leaving the frequency the pilot reported that he had flown within 400ft of a glider, which was not showing on TCAS. This was acknowledged by the controller. The controller could not recall whether they saw the primary contact or not, but Traffic Information was not passed.
