## AIRPROX REPORT No 2020047

Date: 27 May 2020 Time: 1424Z Position: 5046N 00412W Location: Halwill, Devon

### PART A: SUMMARY OF INFORMATION REPORTED TO UKAB

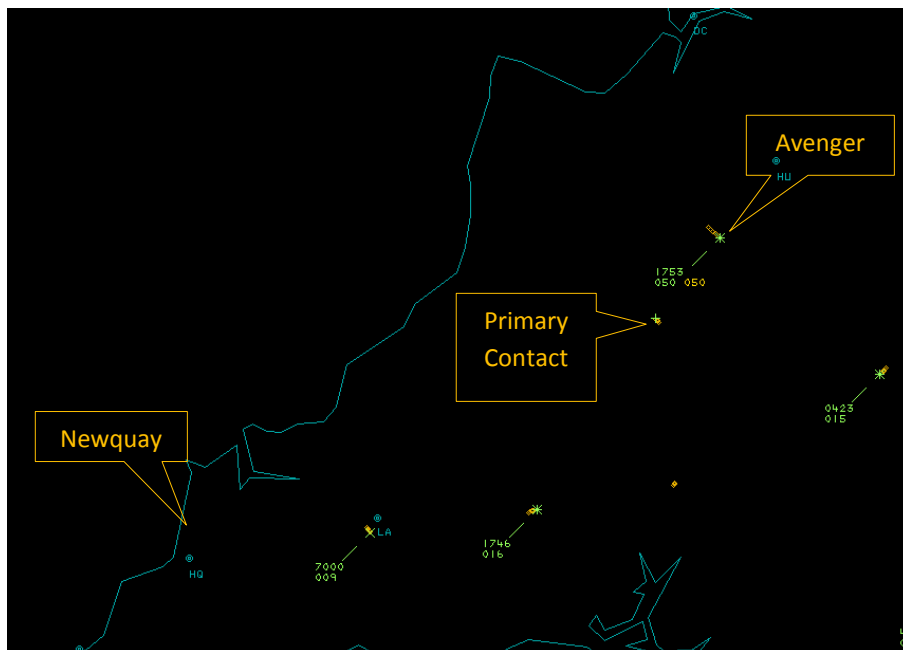
Figure 1: 1421:15 – Avenger 42NM NE of Newquay

An Airprox was reported by the pilot of the Avenger with the Discus, whilst the Avenger was receiving a Traffic Service from Newquay ATC. The Discus had been airborne for some time and was returning to its landing site. The Avenger had been tracking east and had been receiving a service from Newquay for approximately 15 minutes prior to the Airprox. At 1421:15Z they reported turning right onto a south-westerly heading and commencing descent to 4000ft (Figures 1 & 2).

On the area radar replay a primary-only contact, which could have been the Discus, had been visible since 1418:28, but this is not the surveillance source utilised by Newquay ATC. The primary contact subsequently disappeared from the area radar replay at 1421:26. Newquay ATC provided some snapshots of their radar display but none which showed the area being flown-in by the glider during this period. The Newquay controller reported that they did not see the primary contact associated with the Discus and so no Traffic Information was passed at any time.

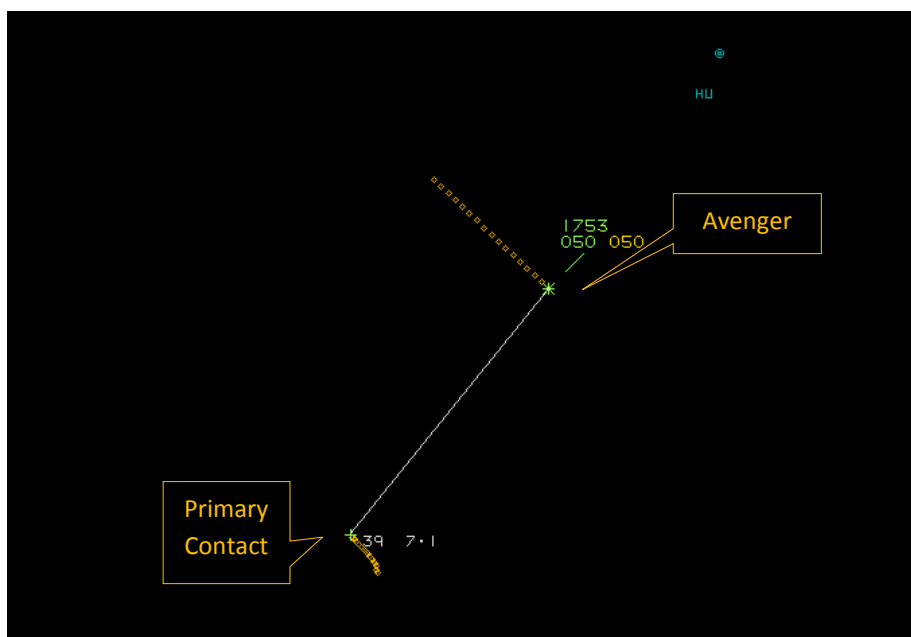
Figure 2 – 1421:15

Whilst the area radar appeared to show a sustained period where the primary contact was visible, this was not the picture that was being presented to the Newquay controller because they were using a different local source. The controller was handling a couple of other aircraft and a departure during this period. These aircraft were at or in the vicinity of Newquay, whilst the Avenger was operating at a range of between 38-42NM at the time. Newquay ATC is authorised to use their surveillance radar equipment to provide a surveillance service to 62NM.

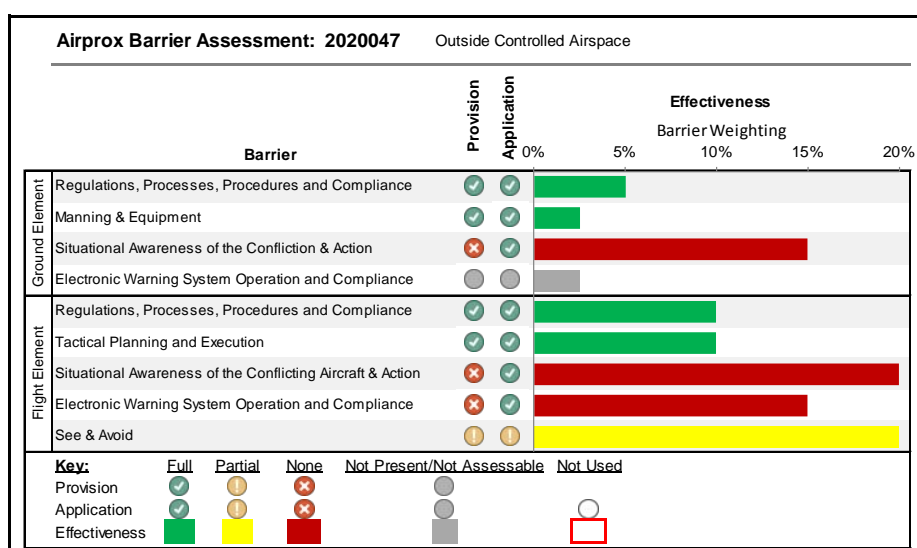
**Situational Awareness of the Confliction and Action** were assessed as **ineffective** because the Newquay controller did not know the glider was in the vicinity because it could not be seen on the radar.

**Situational Awareness of the Conflicting Aircraft and Action** were assessed as **ineffective** because neither pilot knew the other aircraft was in the vicinity prior to seeing it.

**Electronic Warning System Operation and Compliance** were assessed as **ineffective** because the FLARM on the glider and the TCAS on the Avenger were incompatible.

**See and Avoid** were assessed as **ineffective** because neither pilot saw the other in time to take avoiding action that could materially affect the separation.
