**AIRPROX REPORT No 2020084**

Date: 31 Jul 2020 Time: 1124Z Position: 5136N 00022W Location: 3NM N Northolt

**PART A: SUMMARY OF INFORMATION REPORTED TO UKAB**

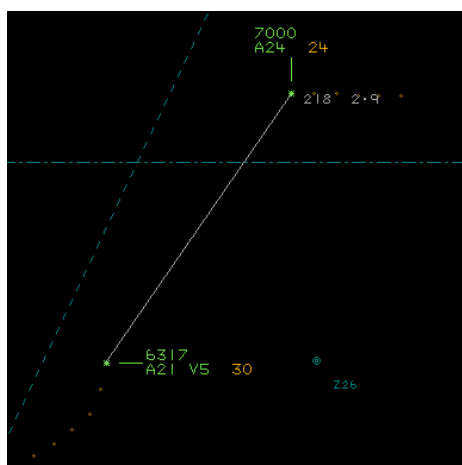
The C680 had departed Northolt on a CPT 5X departure profile inside controlled airspace. The PA46 was transiting E to W outside controlled airspace. The C680 was identified and placed under a Radar Control Service, separation at this point was 2.9NM and 300ft.

Figure 1:  
C680 identified and placed under an RCS by Northolt Departures.

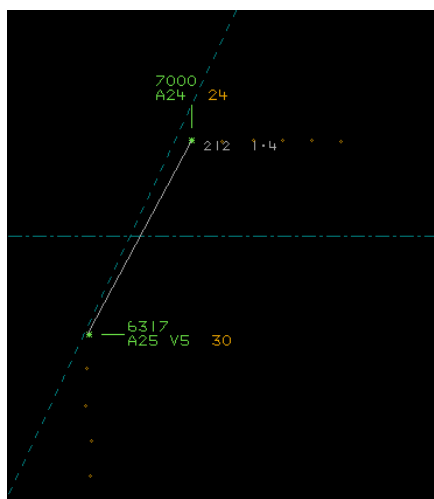
Twenty-two seconds later the controller gave the C680 pilot Traffic Information on the PA46, highlighting that they were outside controlled airspace. The C680 pilot reported visual with the PA46. Separation at this point had decreased to 1.4NM and 100ft.

Figure 2:  
Traffic Information is passed to the C680.

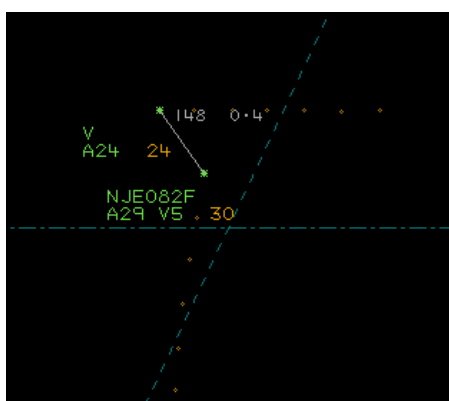
Thirteen seconds later CPA was measured at 0.4NM and 500ft.

Figure 3: CPA.

The Northolt controller was band boxing multiple control positions, however, the traffic levels were extremely light with only a single aircraft departing. The controller could have passed Traffic Information earlier due to the proximity of the PA46 and the perceived slower climb rate of the C680, which may have prompted the pilot to increase their rate of climb. Operating from RW07 gave less track distance for pilots to achieve the required altitude prior to crossing the CTR boundary. This, combined with the PA46 operating at the upper limits of Class G airspace in close proximity to the CTR boundary, led to the incident. Had the C680 pilot followed the SID and achieved the required 3000ft by the CTA boundary, separation would have been greater.

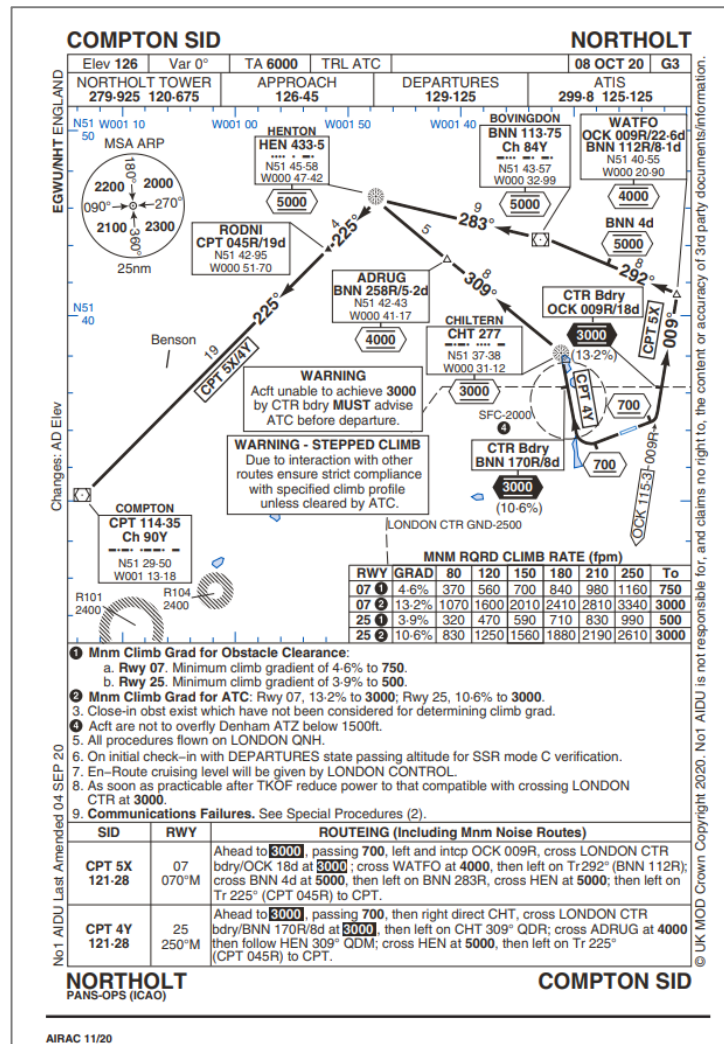
Figure 4

The Northolt Compton SID is reproduced below:

The Board first looked at the actions of the C680 pilot. They were flying the Compton SID from RAF Northolt, which stipulated that they were to be at the CTR boundary at 3000ft. However, in the event, their climb was such that they were passing 2700ft at the boundary (**CF1, CF2**). Whilst this level kept them within controlled airspace, it did not give a 500ft buffer between the C680 and the PA46 outside controlled airspace. Although the pilot was passed Traffic Information on the PA46 operating outside controlled airspace, members thought that they probably hadn't assimilated that the traffic was within the parameters of that likely to alert the TCAS (**CF3**), so as the C680 came into proximity with the PA46, although separated procedurally, the TCAS alerted with an RA (**CF4**). Although the C680 pilot perceived that the PA46 'crossed through their flightpath' in fact it was below the C680 as they approached the CTR boundary (**CF6**).

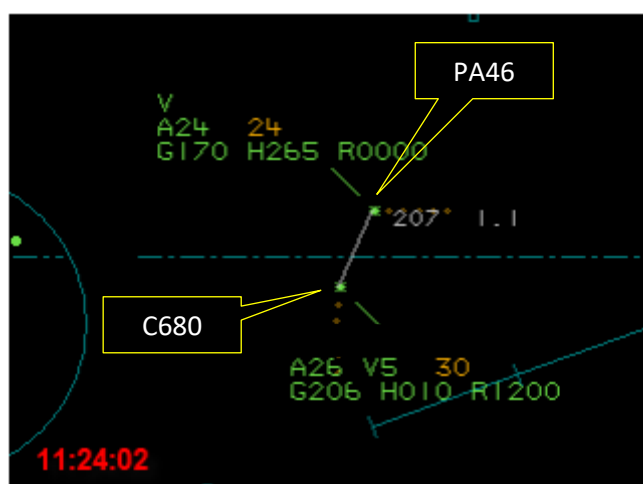
Figure 5

A C680 departed from Northolt under a radar service from Northolt Approach. The aircraft climbed within the London CTR and into the London TMA. However, the aircraft was positioned in proximity to the PA46 (Figure 5).

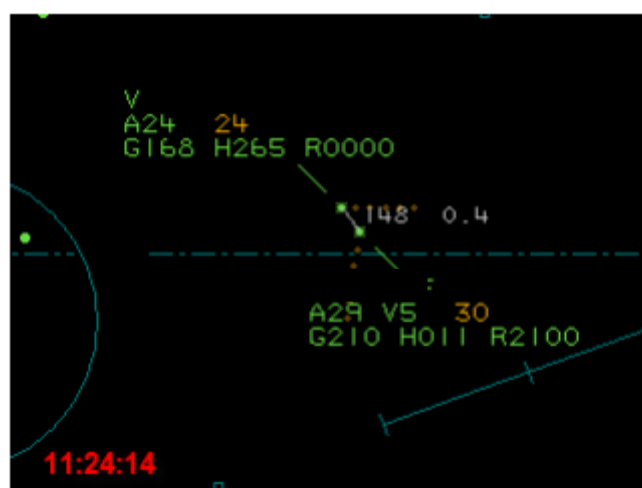
Figure 6

At the point of minimum lateral separation, there was 500ft vertical separation between the aircraft (Figure 6).

With one aircraft inside controlled airspace and one aircraft outside controlled airspace there were no separation requirements between the two aircraft. There was a noticeable increase in the rate of climb of the C680 between 11:24:02 and 11:24:14, although prior to this increased rate of climb it was already above the PA46, and therefore it was deemed that there was no critical manoeuvre made to avoid a collision.
