## AIRPROX REPORT No 2020085

Date: 02 Aug 2020 Time: 1315Z Position: 5153N 00210W Location: Gloucestershire ATZ

### PART A: SUMMARY OF INFORMATION REPORTED TO UKAB

An Airprox was reported when two C42s flew into proximity at Gloucestershire Airport at 1315Z on Sunday 2<sup>nd</sup> August 2020. Both pilots were operating under VFR in VMC, both pilots in receipt of an Aerodrome Control Service from Gloster Tower.

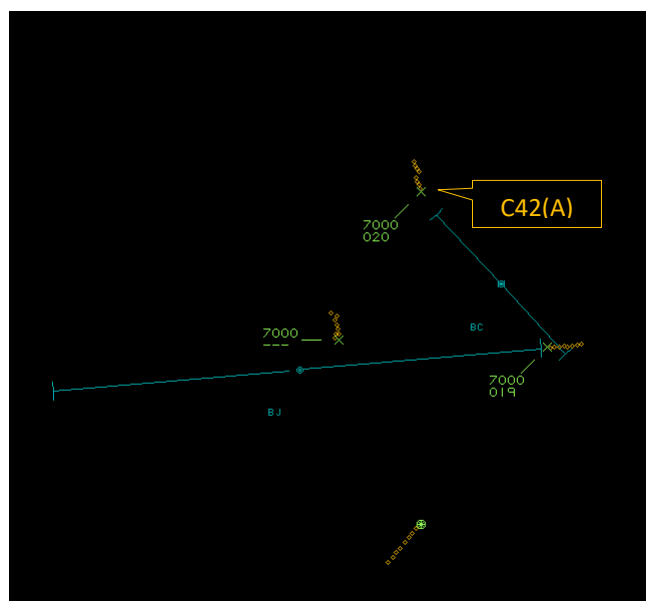
At 1254:08 the C42(A) pilot called the Gloucestershire approach controller advising that they were inbound. The controller agreed a Basic Service with the pilot and advised them it would be a “*standard overhead join Runway 27 right-hand*”, passed them the QFE and requested a call at 3 miles. At 1309:10, the pilot reported at 3 miles. The approach controller advised them that the helicopter circuit was active and instructed them to contact the Tower, which was all read back correctly (Figure 1).

Figure 1 – 1309:10 – C42(A) reports at 3 miles (aircraft is 4.5NM north).  
 Note – area radar displaying aircraft levels as Flight Levels, add 80ft for altitude.

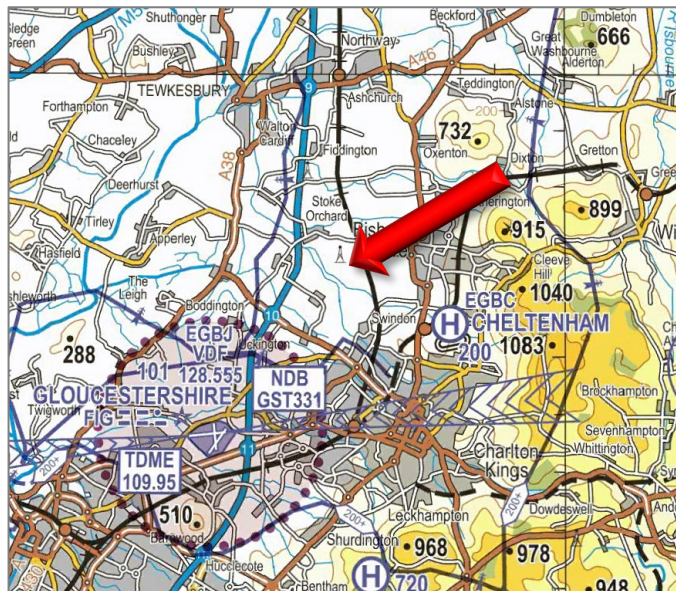
At 1309:40 the C42(A) pilot reported on the Tower frequency. The Tower controller instructed them to report in the overhead, advising that there was a Eurocopter to make a go around. The pilot went on to say, at 1310:00, that they were overhead Tewkesbury and believed that they were approaching the deadside. The Tower controller repeated the instruction to report the overhead. (Note, the aircraft was just approaching the outskirts of Cheltenham some 5NM to the south-east of Tewksbury – Figure 2).

Figure 2 – C42(A)'s position at 1310:00 (arrowed)

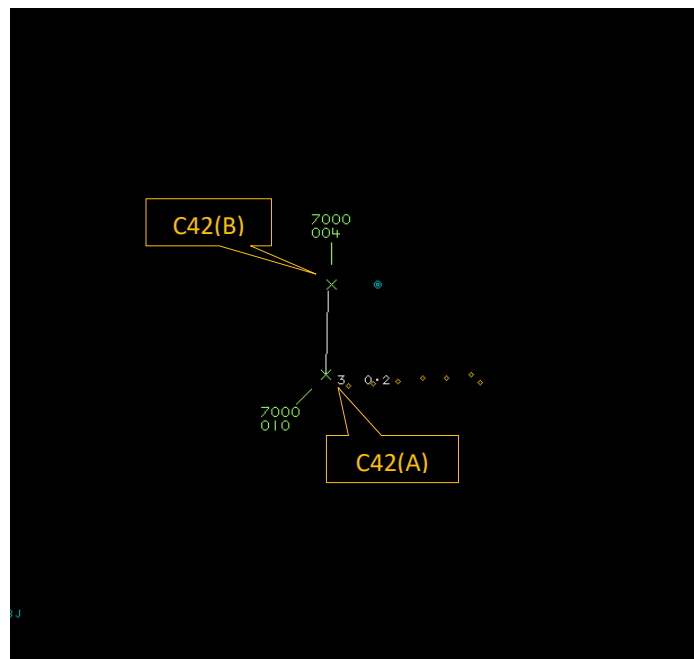
Figure 3 – 1314:39

At 1314:39 the C42(B) became visible on the area radar replay (Figure 3).

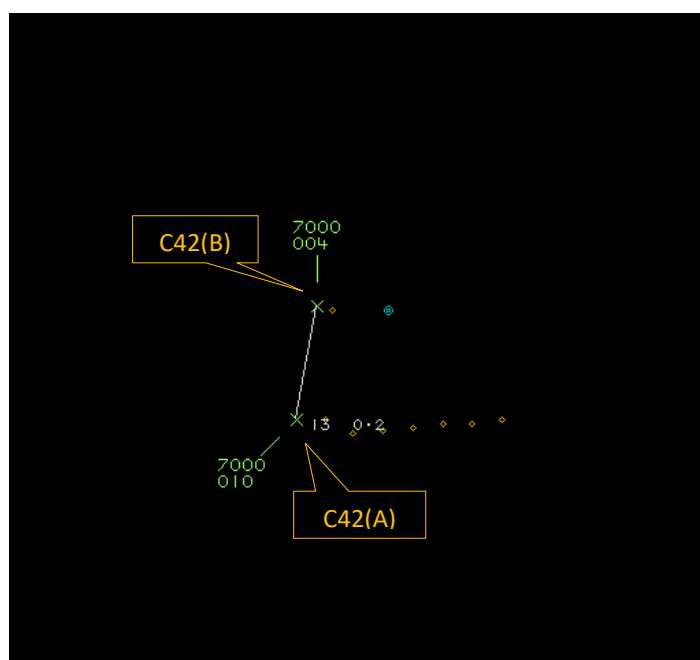
Figure 4 – 1314:44

At 1314:44 the Tower controller advised the C42(A) pilot *“just to caution, the Ikarus on the climb out ahead I think you will go behind but he is for a left turn”*. The C42(B) pilot responded, *“looking out for traffic”* (Figure 4).

Although the Tower controller passed Traffic Information to the C42(A) pilot on the departing C42(B), it was passed once that aircraft was airborne, and no reciprocal Traffic Information was passed to the C42(B). Also, the Traffic Information was passed without being prefixed “*Traffic Information*” and was not delivered in a clear and unambiguous manner.

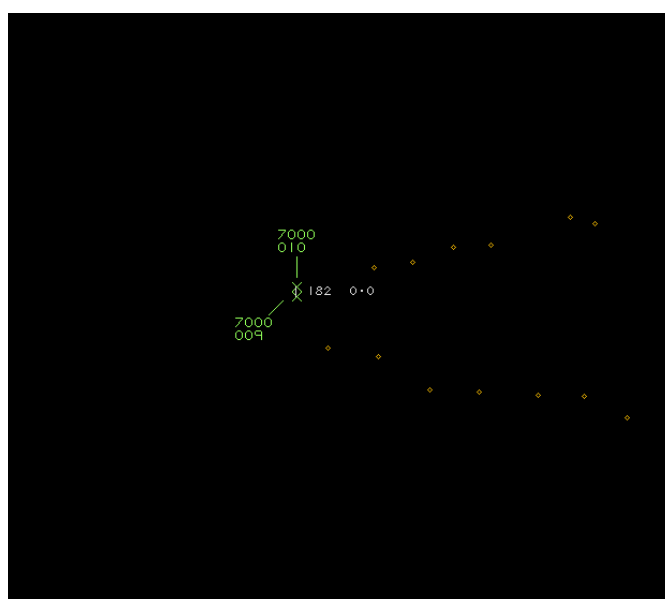
Figure 5 – 1315:02

CPA occurred at 1315:02 (Figure 5).

The pilot of the C42(A) reported seeing the departing C42(B) climbing out ahead of them after having turned crosswind, forcing them to take avoiding action. In their report they stated that they thought the controller had said that the C42B would pass behind them, which was not the case. The pilot of the C42(B) reported being unaware of any other traffic at the time.

Finally, the Board turned to the risk. The C42(A) pilot had not seen the C42(B) until late and the C42(B) pilot did not see the C42(A) at any time. Members agreed that because of this the safety of the aircraft was not assured (**CF8**), a Risk Category B.

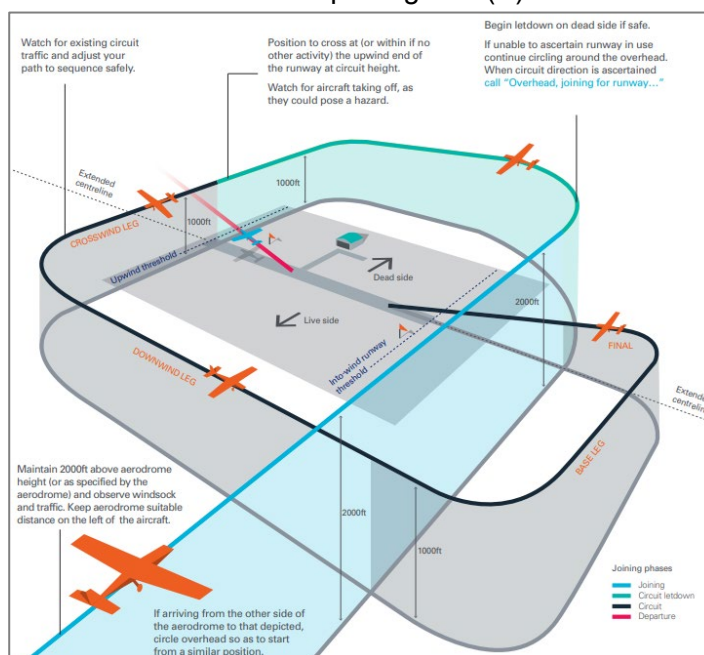
The Board then looked at the actions of the C42(A) pilot who was executing an overhead join. When they turned crosswind, they received Traffic Information about the departing C42(B). Unfortunately, probably due to the verbose phraseology from the Tower controller, the C42(A) pilot did not fully assimilate the Traffic Information that the C42(B) would pass either in front or behind them (**CF6**) and believed the C42(B) would pass behind them. Because of this the C42(A) pilot's situational awareness was flawed, and they did not adequately integrate with the departing C42(B) (**CF7**). The C42(A) pilot was not actively looking for the C42(B), only seeing it as it was climbing and passing in front of them, (**CF10**) resulting in them taking emergency avoiding action. Members agreed that the C42(A) pilot should still have been looking out, (regardless of their interpretation of the Traffic Information) when they were preparing to turn crosswind to cross the upwind end of the runway, the Skyway Code specifically warns pilots joining overhead to *'Watch for aircraft taking off, as they could pose a hazard'*<sup>3</sup>.

Figure 6: CAA CAP 1535, Skyway Code Overhead Joins
