AIRPROX REPORT No 2020086

Date: 18 Jul 2020 Time: 1349Z Position: 5137N 00026E Location: Billericay

PART A: SUMMARY OF INFORMATION REPORTED TO UKAB

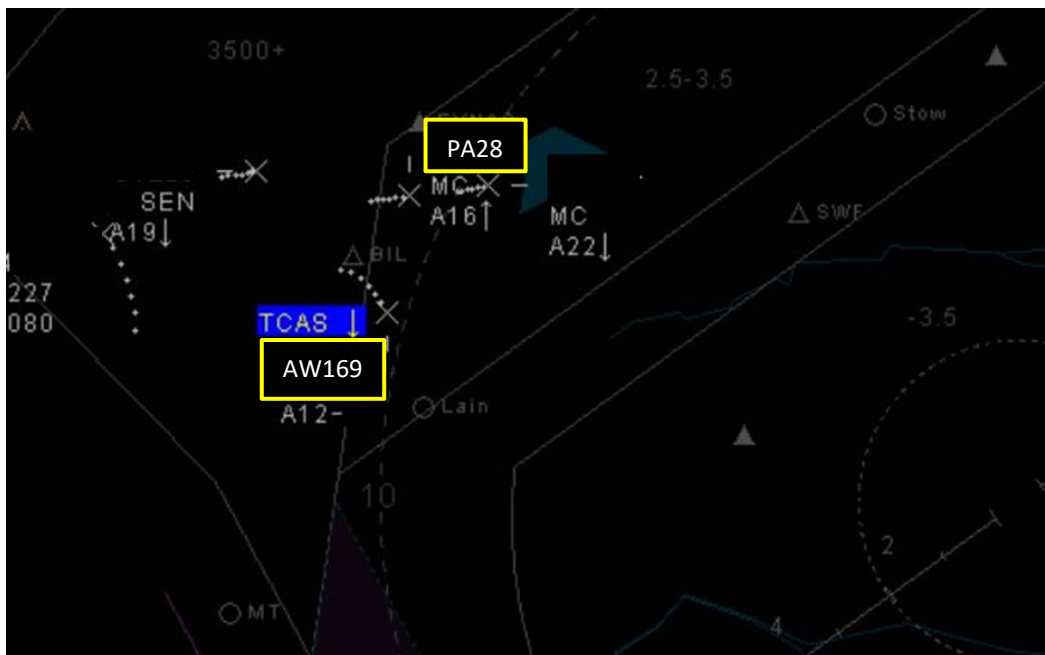
Figure 1 – Southend Radar display at CPA.

1349:15 – The radar indicated [the AW169] TCAS warning with a descent instruction (Figure 1). There were no apparent contacts in the vicinity to account for the warning. [The AW169] was 1NM SE BIL at 1200ft indicated. [The PA28] was 2NM N of [the AW169] at 1600ft indicated.

Southend ATC cannot confirm the level, position or track of [the DR107] at the time of the Airprox/TCAS event. For reasons which only became apparent during this investigation, their transponder had at no stage been recognised or processed by Southend radar systems. This is not an unknown phenomenon, although the precise nature of the problem was generally unknown to controllers. At the time of this incident, Southend was also operating SSR only, due long-term primary radar failure. Hence, in the unusual event that a transponder was not recognised, there is the potential for an aircraft to be rendered invisible to the controller(s). Both [the PA28] and [the AW169] were identified throughout using Mode S/A/C indications.

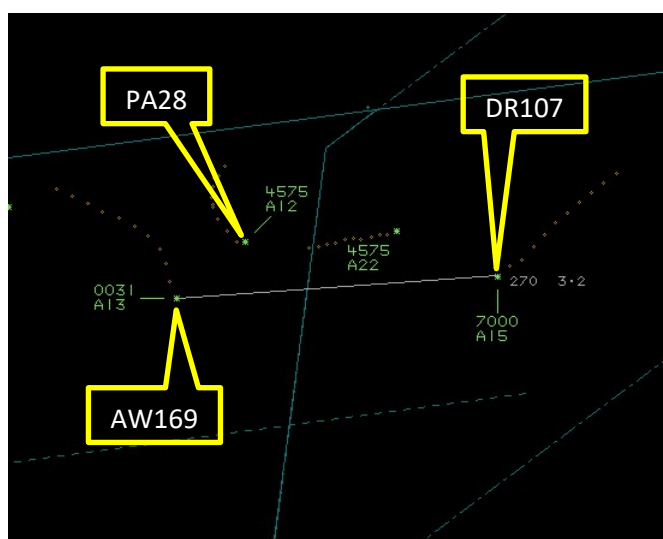
Figure 2

Analysis of the NATS radar replay was undertaken. The phenomenon of a transponder-equipped aircraft not being displayed on the radar screen, such as that which occurred on the Southend radar, was not apparent on the NATS radar. A radar screenshot is provided below (Figure 2) clearly showing the presence of the AW169, the DR107 and the PA28 that is referred to in the Southend ATC investigation. Figure 3 is the radar CPA at 1349:14.
