AIRPROX REPORT No 2020092

Date: 03 Aug 2020 Time: 1349Z Position: 5146N 00100W Location: Thame

PART A: SUMMARY OF INFORMATION REPORTED TO UKAB

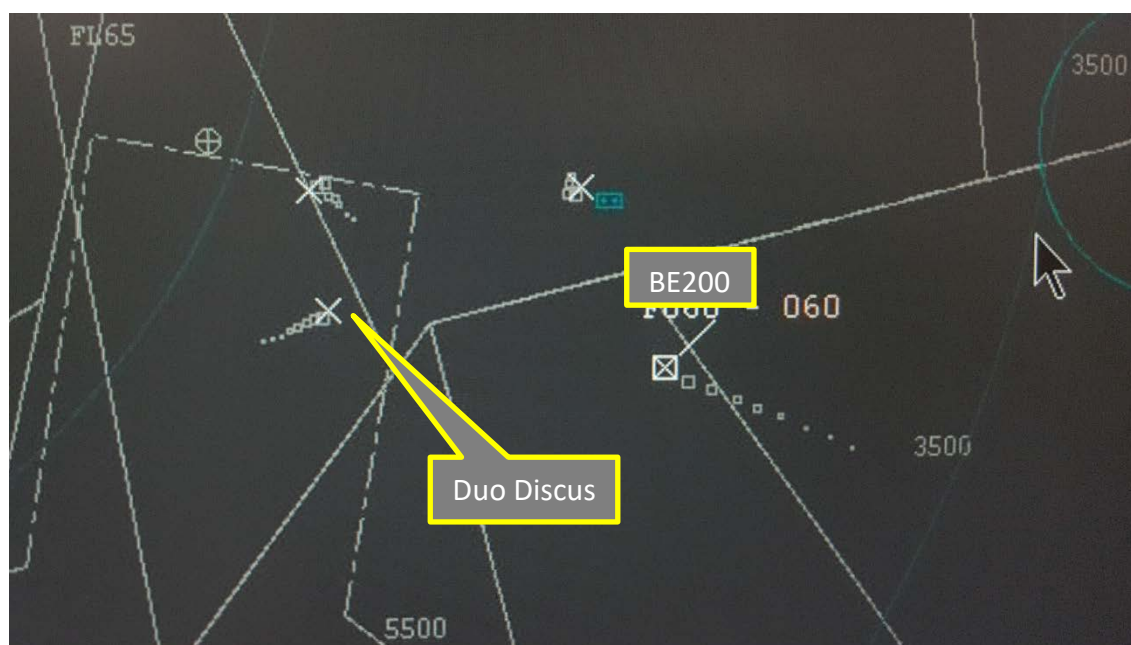
Figure 1 – BE200 pilot reports visual and is cleared for a visual approach and descent.

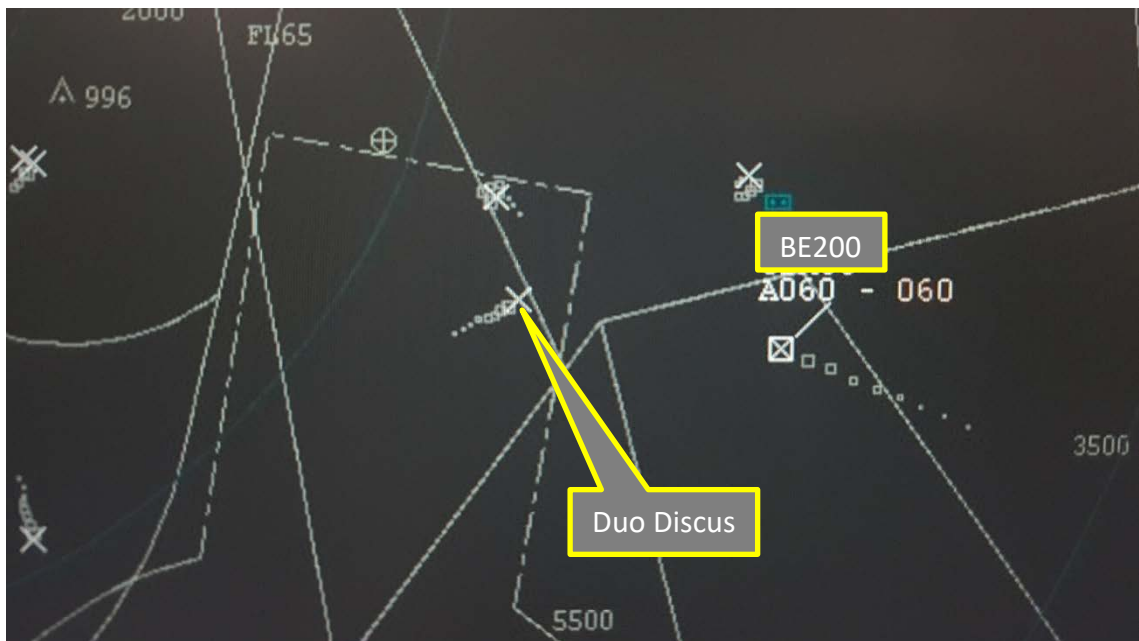
Figure 2 – Traffic Information passed on 2 x Gliders.

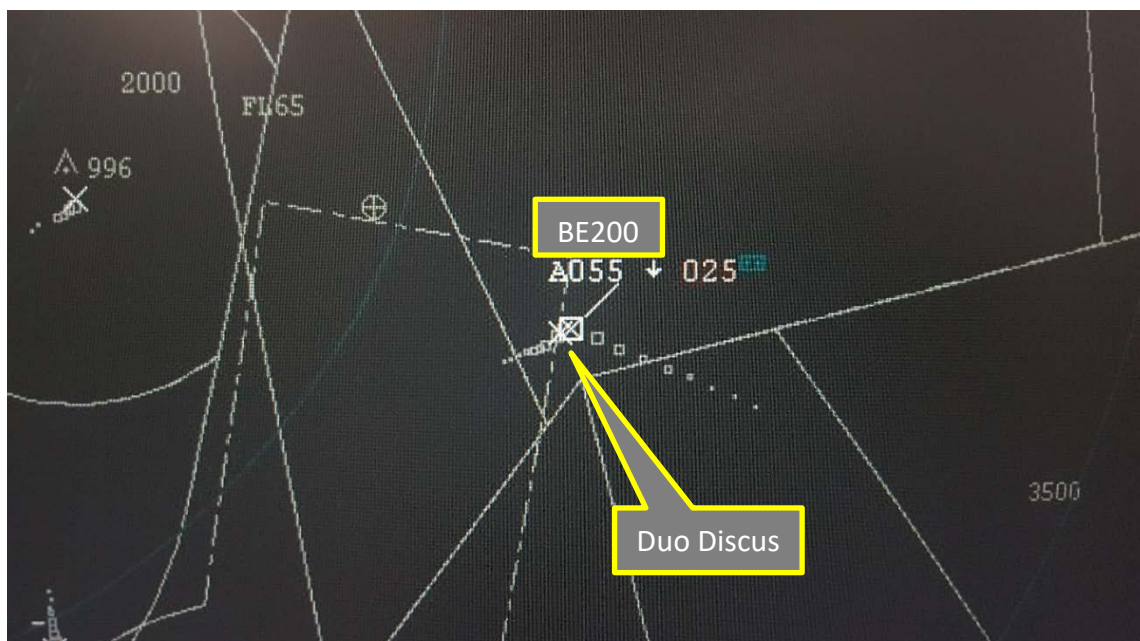
Figure 3 – CPA. Base of controlled airspace FL55
