**AIRPROX REPORT No 2020094**

Date: 08 Aug 2020 Time: 1012Z Position: 5222N 00128W Location: Coventry

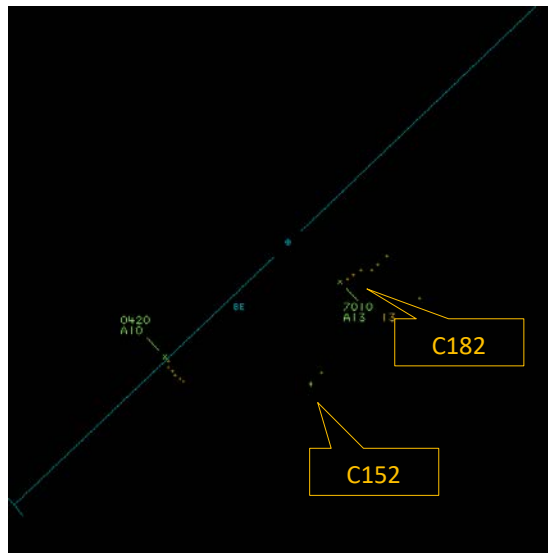
Figure 1 – 1010:37

At 1010:37 the C152 pilot reported downwind for a touch-and-go (Figure 1).

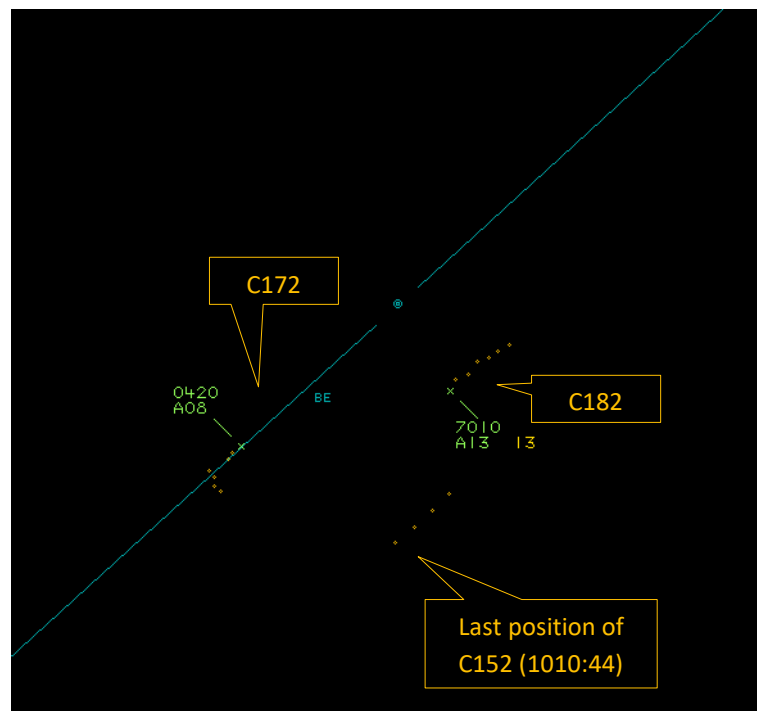
Figure 2 – 1010:48

The AFISO dealt with another aircraft on the ground before replying at 1010:48 “(c/s) roger, report turning right base, traffic ahead is a C172 last reported on right-base” which was acknowledged by the pilot of the C152. (The C172 had rejoined from the north-east and had been requested to report at the Southam VRP to the south-east of the airfield). The C182 was also at the beginning of the downwind leg but flying a pattern inside the C152. Note - the radar return for the C152 had started to become intermittent on the radar replay (Figure 2).

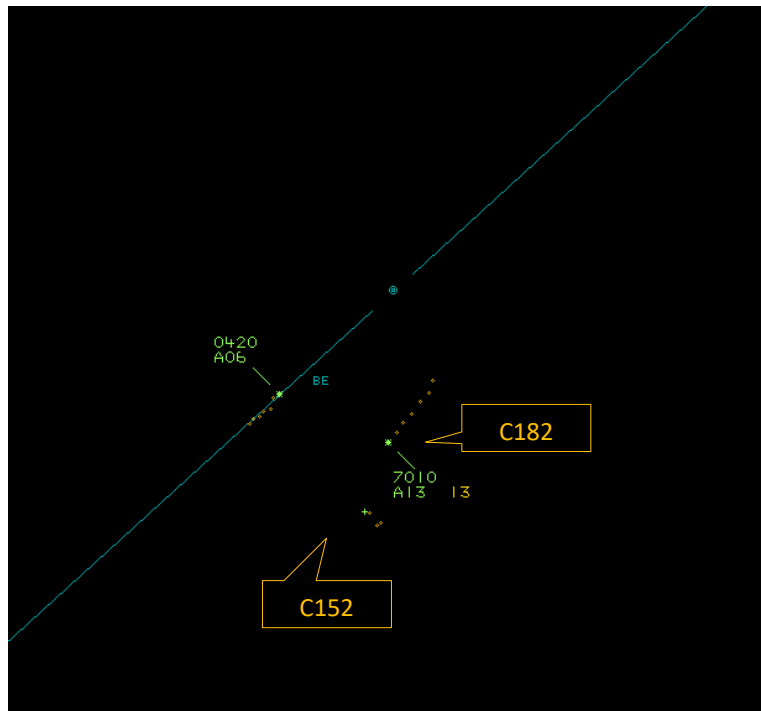
Figure 3 – 1011:15 (C152 subject to radar jitter)

At 1011:15 the C182 pilot reported “late downwind”. The AFISO requested them to “report final, you have one ahead” which was acknowledged (Figure 3).

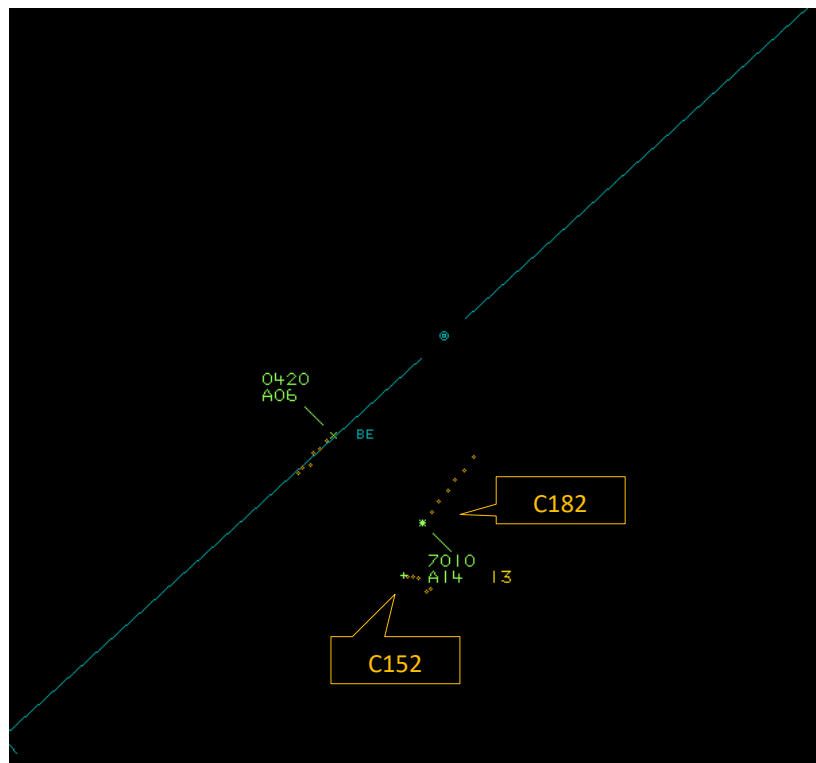
Figure 4 – 1011:25

The C152 reported turning onto base leg at 1011:25 and was requested to report final which was acknowledged by the pilot (Figure 4).

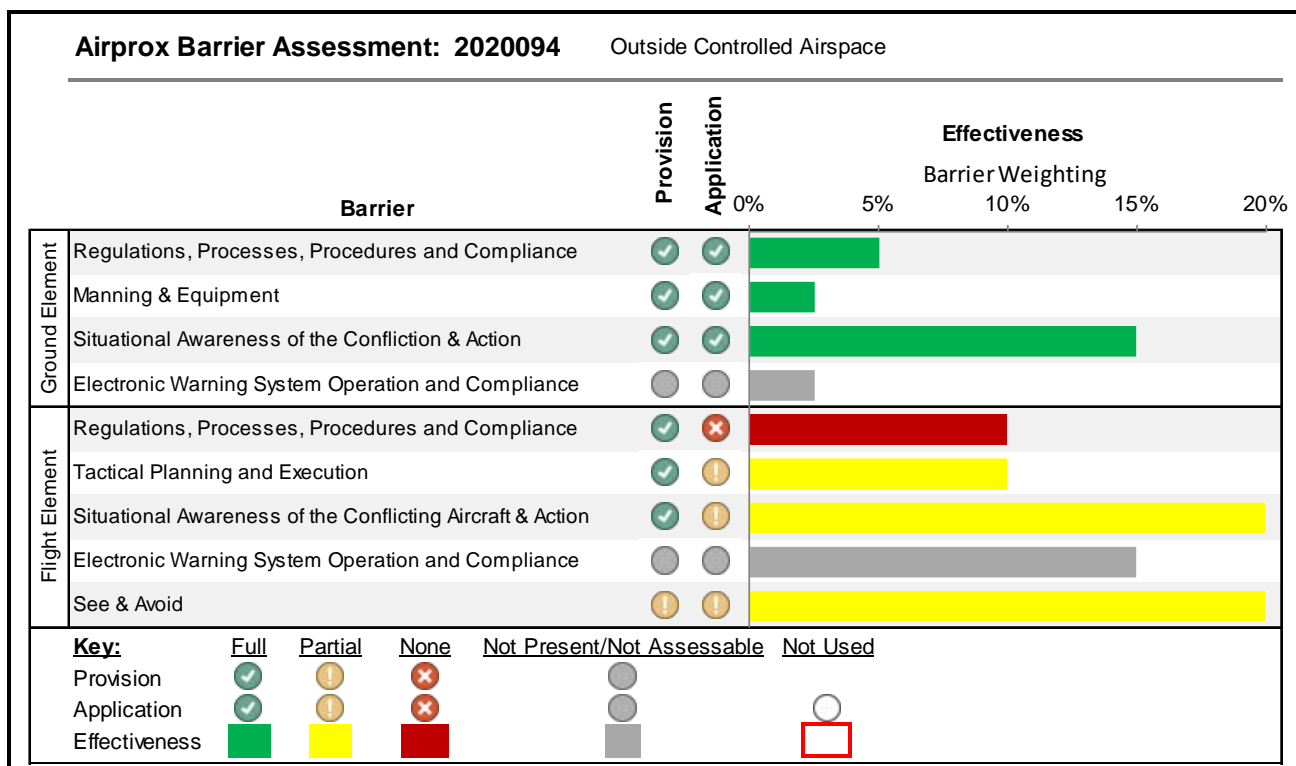
**Regulations, Processes, Procedures and Compliance** were assessed as **ineffective** because the C182 pilot did not conform with the pattern of traffic formed by the C152.

**Tactical Planning and Execution** was assessed as **partially effective** because the C182 pilot did not adapt the plan once it became apparent they were not visual with the traffic ahead.

**Situational Awareness of the Conflicting Aircraft and Action** were assessed as **partially effective** because the C182 pilot could have taken action to address the fact that they weren't visual with the C152 prior to overflying it.

**See and Avoid** were assessed as **partially effective** because it was a late sighting by the C152 pilot and a non-sighting by the C182 pilot.
