## **AIRPROX REPORT No 2020106**

Date: 26 Aug 2020 Time: 1127Z Position: 5156N 00125W Location: Enstone

### **PART A: SUMMARY OF INFORMATION REPORTED TO UKAB**

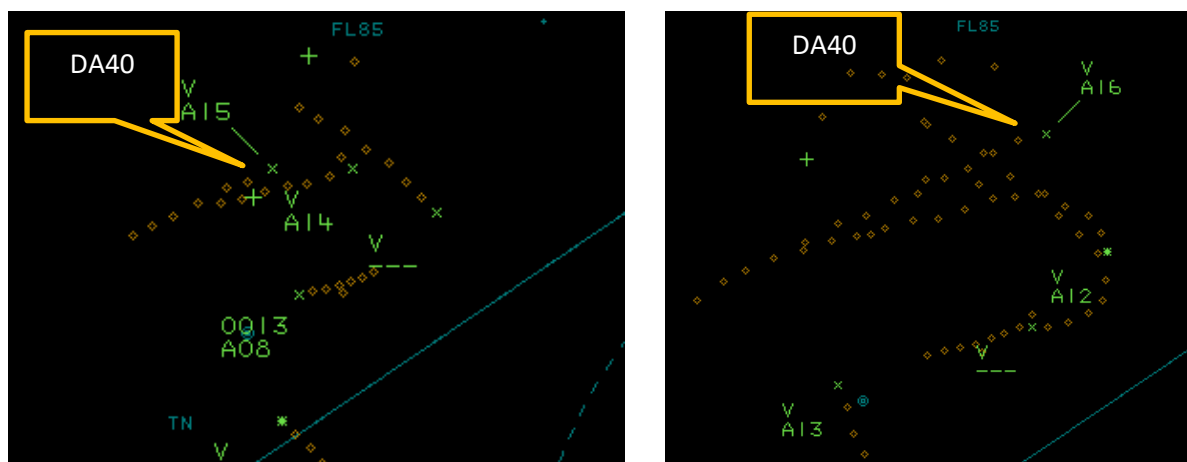
Figure 1: 1125:04 Figure 2: 1125:53

Whilst Enstone is not radar equipped, the Enstone circuit can be seen on the NATS radars. At Figure 1, the DA40 (identified by Mode S) can be seen downwind in the visual circuit, which was busy with other aircraft ahead and joining behind. The Pitts is not transponder equipped and so can not be identified, although a PSR contact can be seen to the north-east of the airfield. At Figure 2 and 3 the DA40 can be seen turning base leg, at 2.6NM measured from the airfield datum.

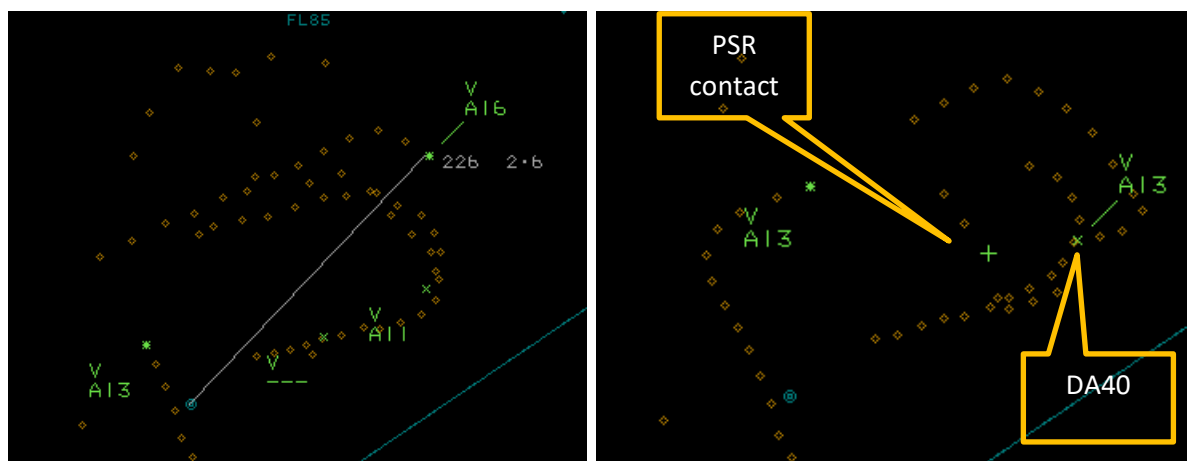
Figure 3: 1126:14 Figure 4: 1127:11

At 1127:11, Figure 4, a PSR track can be seen on a base-leg, similar to that described by the Pitts pilot, although without SSR the height is not known. However, the PSR then disappears from the radar and is subject to radar jitter for the next few sweeps, reappearing at Figure 5 to the east of the DA40. Consequently, the exact separation at CPA is not known.
