AIRPROX REPORT No 2020121

Date: 14 Sep 2020 Time: 1411Z Position: 5728N 00147W Location: 2NM SSE of Peterhead

PART A: SUMMARY OF INFORMATION REPORTED TO UKAB

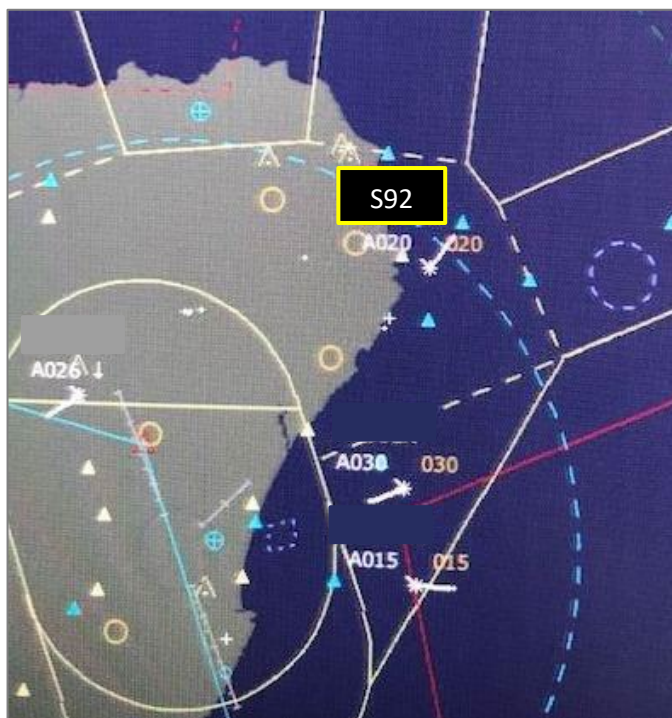
Figure 1

At **1409:33** an intermittent PSR contact first appeared on the Allanshill radar about 4NM ahead of [the S92 C/S] (Figure 1). This was not visible on the Perwinnes radar, which is the source the HELS controller was primarily using at this time. Approximately 10sec later this contact had faded and was no longer visible on the Allanshill display either.

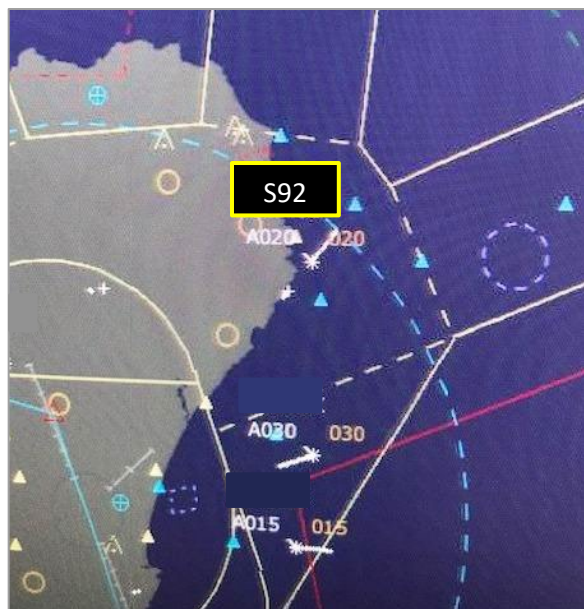
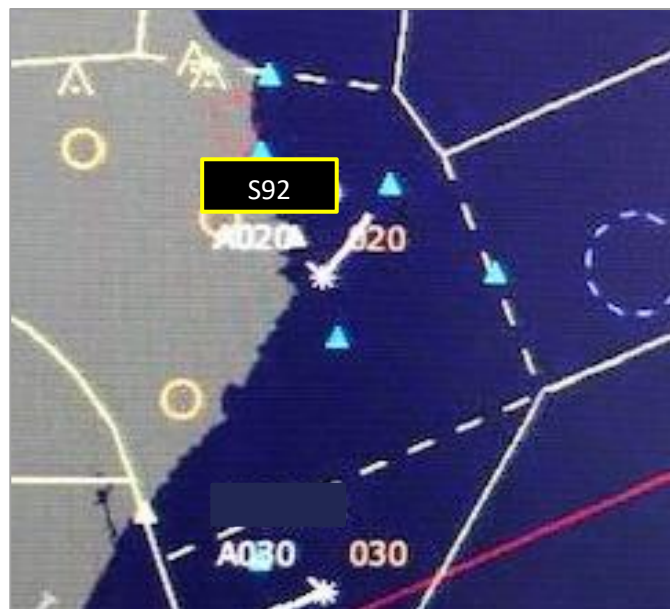
At **1409:59** the PSR return re-appeared on the Allanshill display, as shown in Figure 2. Again, nothing was seen on the Perwinnes radar display, as shown in Figure 3; both screenshots were taken at the same time.

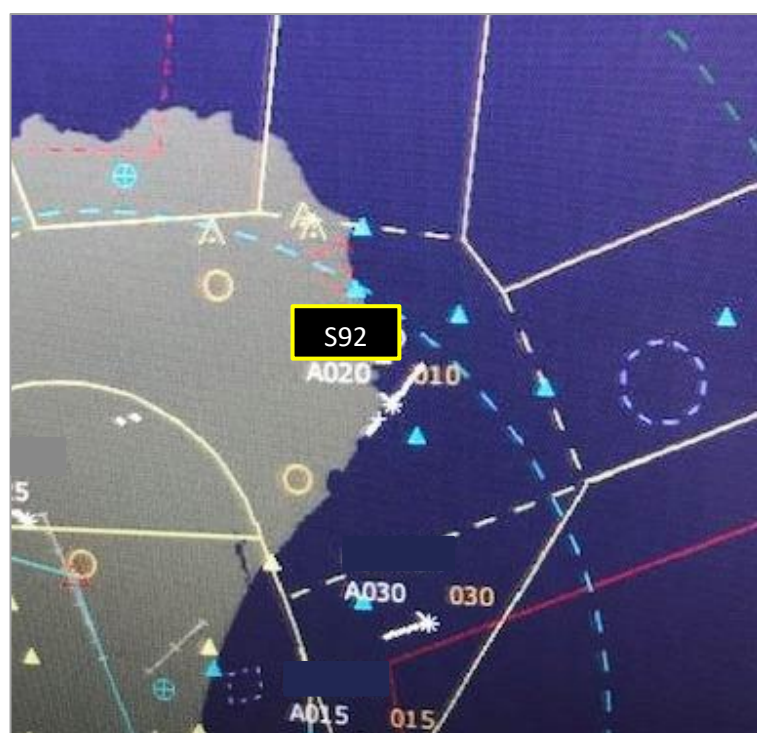
Figure 4

At **1410:17** the Allanshill radar showed the PSR return about to merge with the combined PSR/SSR return of [the S92] (Figure 4). There was still nothing seen on the Perwinnes radar and, on the next sweep of the Allanshill radar, the PSR return faded again. It could be seen for one more sweep as the aircraft passed each other and was then not seen again.

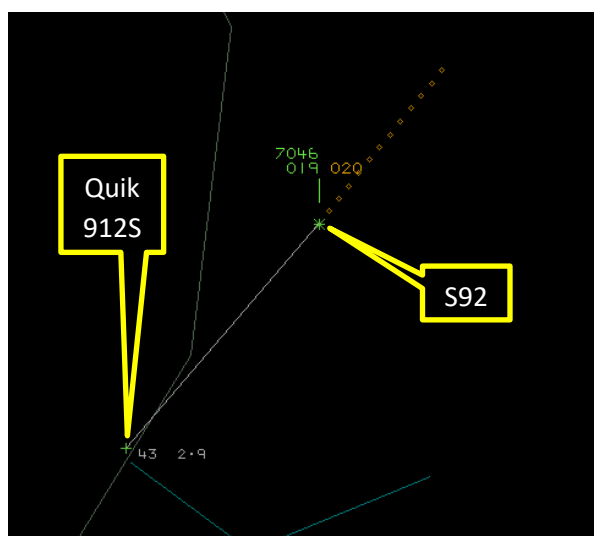
Figure 5 – 1409:49

Analysis of the NATS radar replay showed the S92 tracking southwest in accordance with the pilot's report. At 1409:49, a primary radar return appeared 2.9NM SW of the S92, in a position that was commensurate with both pilots' reports (Figure 5). The primary return tracked northeast, on a reciprocal track to that of the S92, for another 40sec until radar track was lost at 1410:29 (Figure 6). Separation at this time was 0.6NM horizontally; the altitude of the Quik 912S was not recorded so it was not possible to assess the vertical separation.

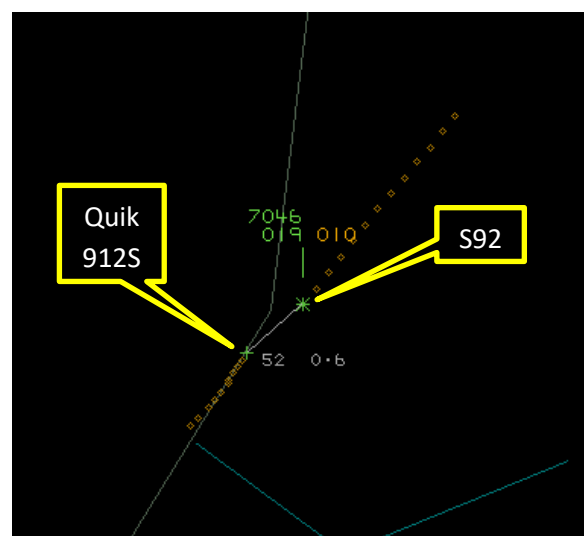
Figure 6 – 1410:29

There was no perceptible deviation of track from the S92 until the 2 aircraft are assumed to have passed. It is estimated that CPA occurred at approximately 1410:37 but, due to the radar return from the Quik 912S fading some 8-10sec prior to the aircraft passing each other, it has not been possible to measure CPA.
