AIRPROX REPORT No 2020141

Date: 13 Sep 2020 Time: 1044Z Position: 5328N 00226W Location: Manchester/Barton circuit

PART A: SUMMARY OF INFORMATION REPORTED TO UKAB

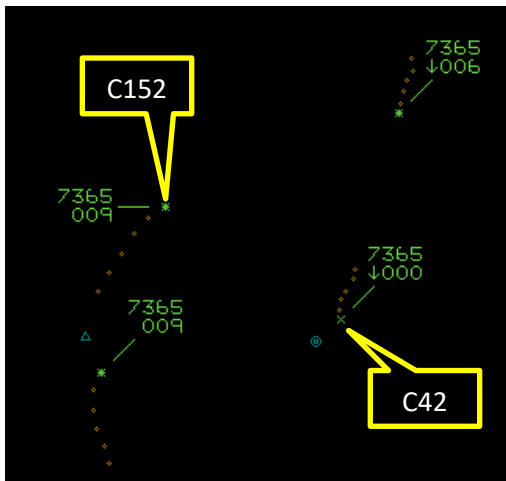
Figure 1 – 1041:50

At **1041:30** the C42 pilot reported final for a touch-and-go and the AFISO responded, “*callsign, runway two zero surface wind two two zero degrees at one five knots, touch-and-go at your discretion*”. The pilot acknowledged with their callsign. At **1041.50** the C152 pilot reported downwind. The AFISO responded, “*callsign, two ahead report final*”. The pilot acknowledged with their callsign (Figure 1). Note: there were 3 aircraft ahead of the C152 at this point. The 3rd aircraft was a Jodel which was not transponding and, as such, was not displayed on the radar replay. The pilot of the Jodel had reported downwind at time **1040:10**. If the Jodel pilot was following the pattern of traffic, they would have been number 3, and would be following the aircraft in the northeast corner of the screenshot below, which was number 2. The position of the Jodel aircraft in Figures 1 and 2 below are therefore approximate positions only.

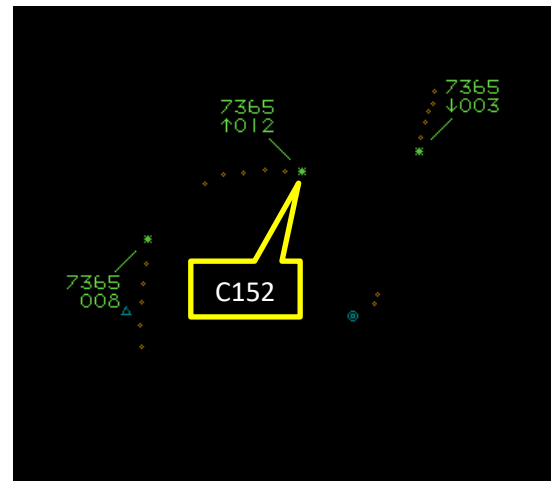
Figure 2 – 1042:10

At **1042:10** the C152 pilot advised the AFISO, “*callsign, we’re gonna climb to the overhead, er I think one aircraft is outside the ATZ*”. The AFISO responded, “*callsign, roger no problem, report descending deadside*”. The pilot acknowledged with wilco and their callsign (Figure 2). Note: the pilot of the aircraft in the 12 o’clock of the C152 in Figure 2 below had previously requested to extend downwind, and the aircraft was observed to have continued downwind to the 2NM ATZ boundary before turning onto a long final. The pilot of the non-transponding Jodel aircraft would have been following this aircraft, and is likely to have also extended downwind to the ATZ boundary.

The C152 pilot would not have been permitted to carry out a delaying orbit when they were ready to turn base leg and had realised that there was already an aircraft on long final that had extended downwind ahead of them (Figure 2). To resolve the situation, the pilot chose to climb into the overhead and descend on the deadside.

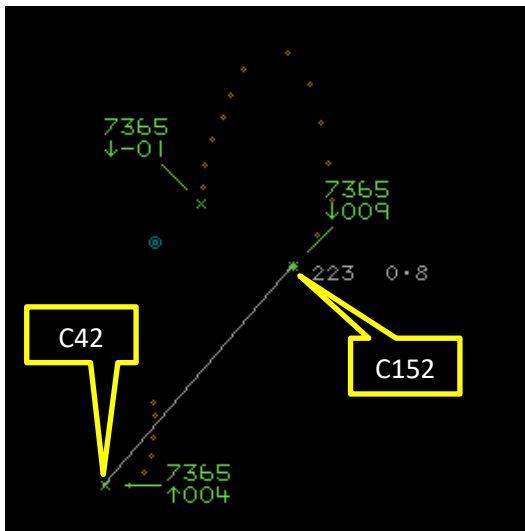
Figure 3 – 1043:00

At **1043:00** the C152 pilot reported. “*callsign, overhead the field, deadside descending*”. The AFISO responded, “*callsign, four in the circuit, report downwind*”. The pilot responded with their callsign and wilco (Figure 3). Figure 4 below displays the positions of the aircraft at **1043:35** (both aircraft are crosswind, with the C152 positioned inside of the C42).

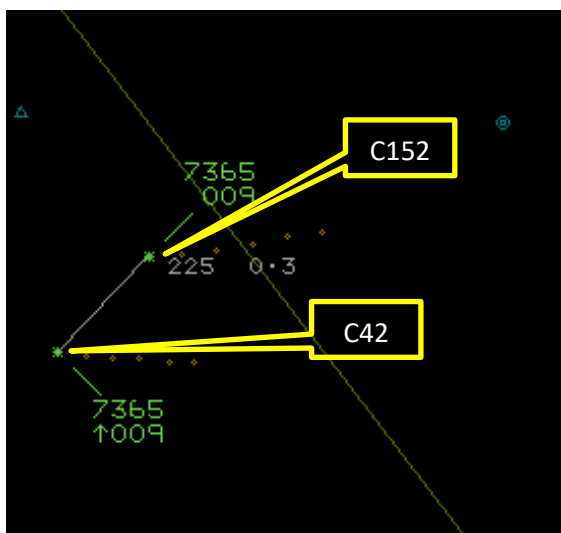
Figure 5 – 1044:00

Figure 5 below displays the positions of the aircraft at **1044:00** (both still on the crosswind leg and gently converging). At **1044:20** CPA occurred, with the aircraft separated by less than 0.1NM laterally and 100ft vertically (Figure 6). The C42 pilot had initiated their turn downwind immediately prior to the C152 pilot initiating their turn downwind.
