AIRPROX REPORT No 2020145

Date: 06 Oct 2020 Time: 0835Z Position: 5046N 00152W Location: Bournemouth Airport

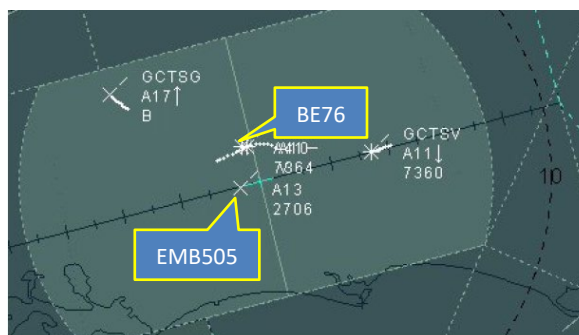
Figure 2: EMB505 shortly after departure

The EMB505 pilot, departing Bournemouth, was given a clearance of right turn after noise abatement towards GWC climbing to altitude 3000ft which was correctly read back. Once released by radar the aircraft was lined up on RW26 and issued clearance to take off. At the time of the release the BE76 pilot had just established in the hold above the airfield at 4000ft. The EMB505 was seen to be climbing relatively quickly and the Bournemouth Tower controller reminded the pilot to maintain 3000ft on reaching and to contact Bournemouth Radar, again the 3000ft was acknowledged by the pilot. Shortly after the Mode C of the EMB505 was seen to pass through 3300ft and came into conflict with the BE76 in the hold. The Bournemouth Radar controller spotted the level bust very quickly and immediately issued avoiding action instructions to the BE76 pilot to climb to 5000ft and turn right onto 360°. The EMB505 was then seen to descend to 3000ft and calls Bournemouth Radar. The separation between the EMB505 and the BE76 was reduced to 1NM and 700ft at the closest point.³

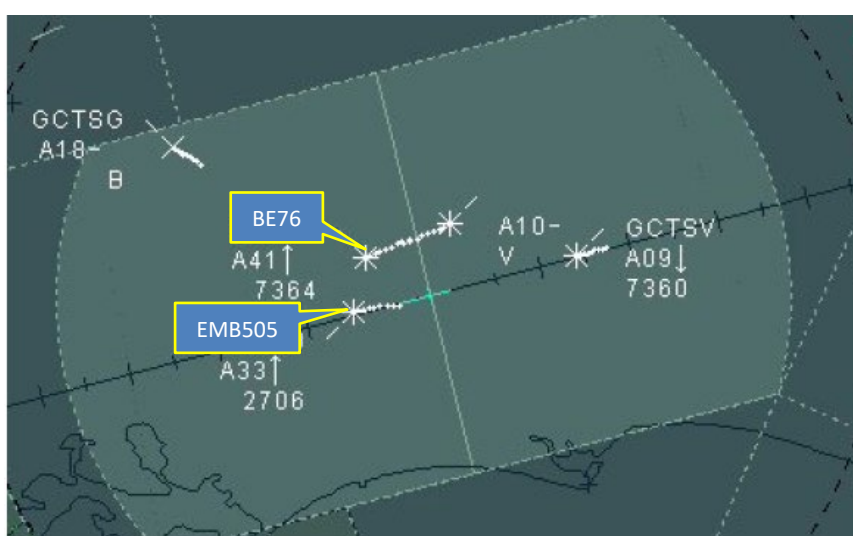
Figure 3: EMB505 Prior to Contacting Bournemouth Radar

Prior to contacting Bournemouth Radar, the Mode C of the EMB505 is seen to be passing 3300ft with the BE76 just to the north of them at about 1NM at 4000ft in the hold. The Bournemouth Radar controller having noticed the Mode C gives immediate avoiding action to the BE76 pilot to climb to altitude 5000ft and turn right heading 360° (Figure 3).
