AIRPROX REPORT No 2020160

Date: 04 Nov 2020 Time: 1232Z Position: 5119N 00102W Location: 6NM W Odiham

PART A: SUMMARY OF INFORMATION REPORTED TO UKAB

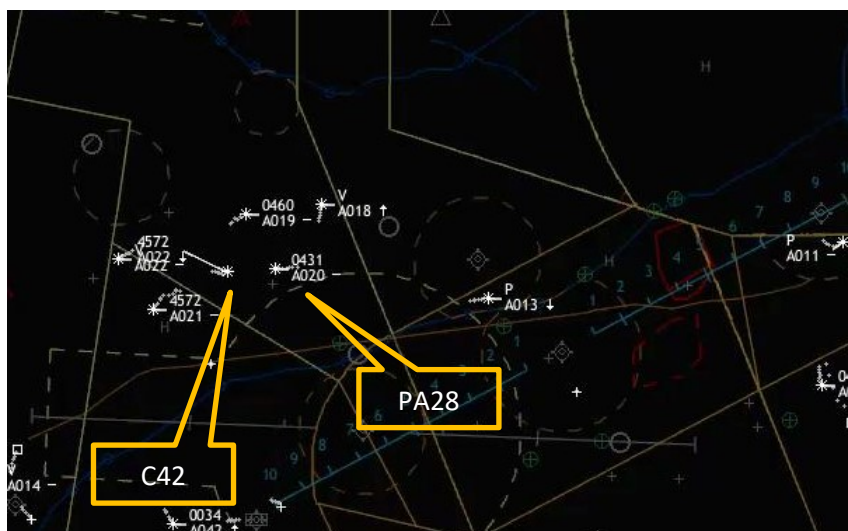
Figure 1

This event occurred with one pilot choosing not to receive a service from Farnborough (C42 on a 4572 SSR code) and the PA28 pilot had requested and been given a Basic Service at 1228Z. [PA28 C/S] had been identified, as is custom and practice for LARS West, but was not provided with Traffic Information on the 4572 code [the C42], which was carrying out various manoeuvres NW of Odiham. The PA28 tracked WSW towards the C42 as shown by the screen capture taken from the operational Radar (Figure 1).

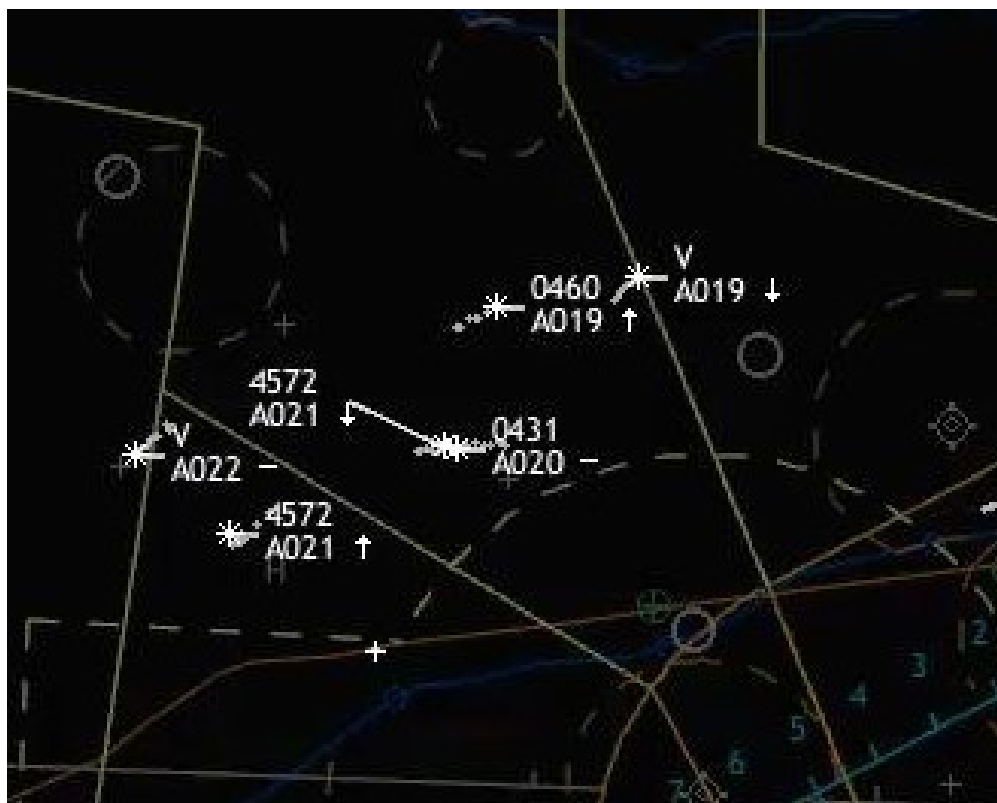
Figure 2 - CPA

The closest point of approach was at 1232Z where the lateral distance between the aircraft was 0.07NM with no vertical separation.
