AIRPROX REPORT No 2020166

Date: 02 Dec 2020 Time: 1442Z Position: 5153N 00214W Location: IVO Gloucestershire Airport

PART A: SUMMARY OF INFORMATION REPORTED TO UKAB

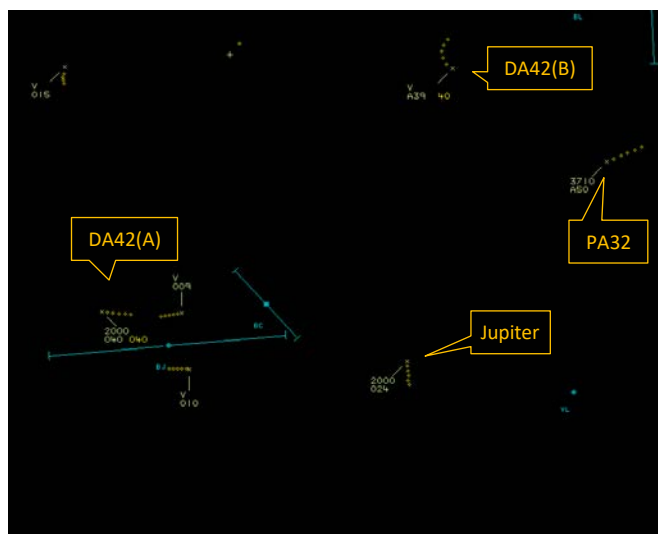
Figure 2 - 1431:23 – radar replay displaying as FL in vicinity of airfield (+54ft for alt)

Then at 1431:23 a PA32 pilot called inbound from the east requesting an RNP approach via LAPKU at FL50. The Approach controller advised them that they would be No4 and cleared them to join the GST Hold at that level. The pilot acknowledged this and said that they would complete an ILS approach instead (Figure 2). The Jupiter, both DA42s and the PA32 were all receiving a Procedural Service from the Gloucestershire Approach controller.

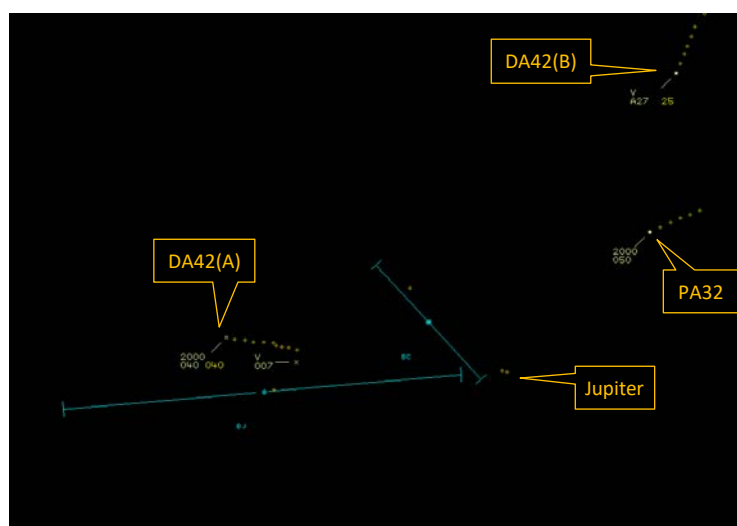
Figure 3 – 1435:45 (Jupiter disappears from area radar replay momentarily)

On the Tower frequency during this period was, along with other traffic, an A109 taxiing for an IFR departure to the southwest and a DR40 waiting to depart VFR to the southeast. At 1435:25 the Tower controller instructed the DR40 to line-up and wait which was readback by the pilot. The A109 reported ready for departure at 1435:40 but was advised that there would be a short delay due to traffic (the Jupiter) on final approach. At 1435:45 the Approach controller passed Traffic Information to the Jupiter pilot on the helicopter circuit and transferred them to the Tower frequency (Figure 3).

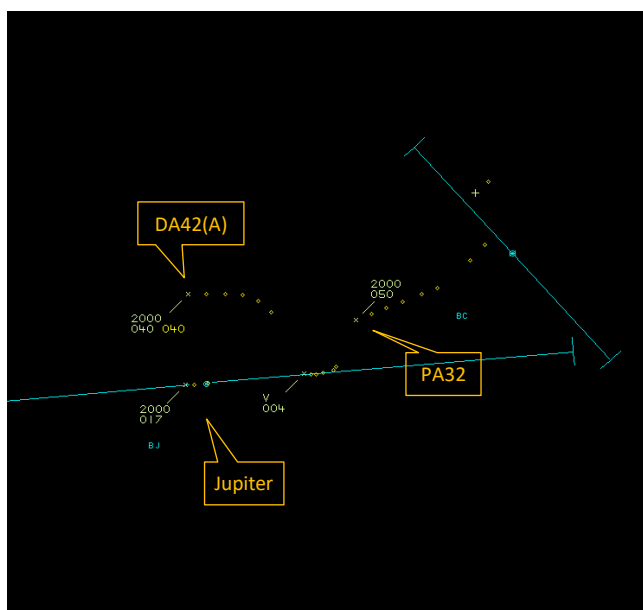
Figure 4 – 1440:10

The Jupiter pilot reported back on the Approach frequency at 1440:10, advising that they were carrying out the missed approach. The controller replied “*Procedural Service, climb to altitude 4000ft, report passing altitude 3000ft*” which was readback correctly by the pilot (Figure 4).

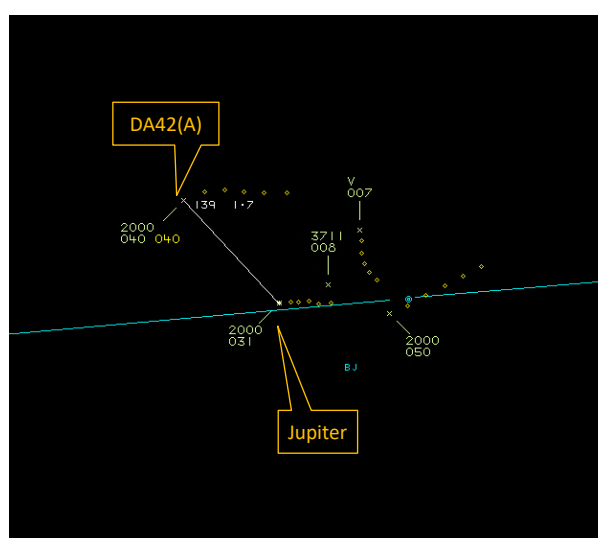
Figure 5 – 1441:30

At 1441:21 the Jupiter pilot reported passing 3000ft, but the Approach controller missed the call sign and the call and asked for the call to be repeated, which the pilot did, but to which the controller then did not reply (1441:30 – Figure 5).

- A further opportunity to spot the confliction between the Jupiter and the DA42 was missed by the Approach controller, when the Jupiter reported passing 3000ft at 1441:21.

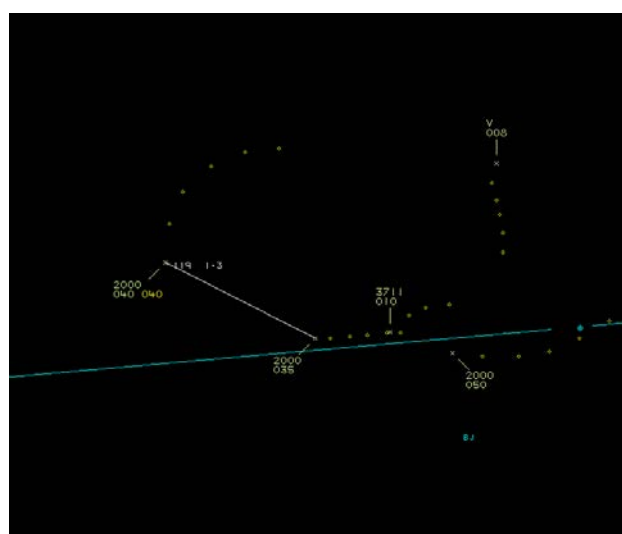
Figure 6 – 1441:38

Then at 1441:38 the PA32 pilot reported taking up the hold at FL50 and requesting descent *“as soon as possible”* as they were picking up ice (Figure 6).

- Finally, the request for descent in the hold due to icing by the PA32, further diverted the Approach controller's attention away from the Jupiter and DA42.

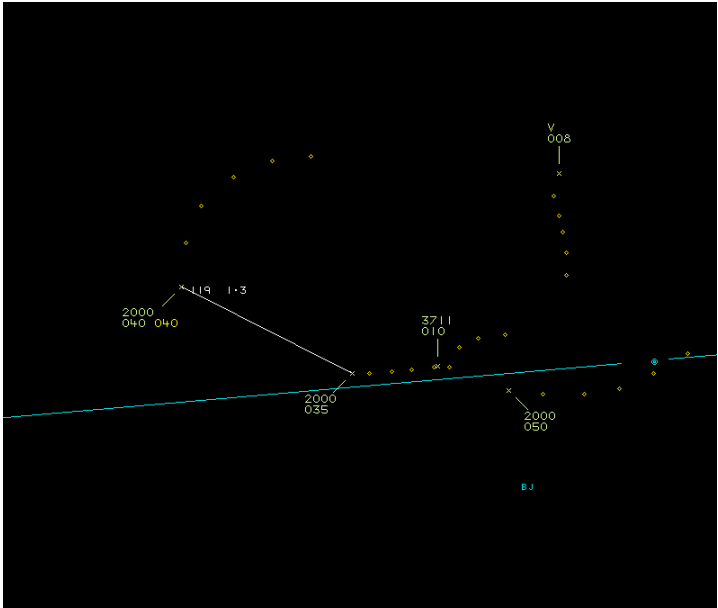
Figure 7 – 1441:50

The Approach controller acknowledged the call and at 1441:50 instructed the DA42(A) to descend to 3000ft, and to report leaving FL40 but received no response (Figure 7).

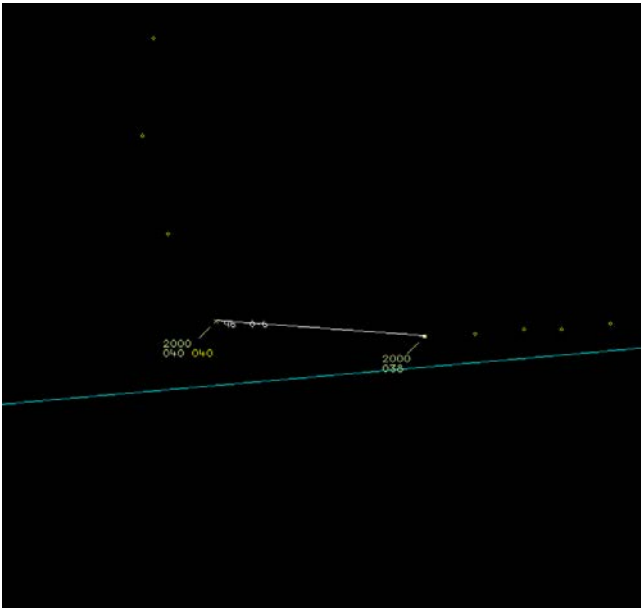
Figure 8 – 1442:10

At 1442:00 the DA42(B) reported at the FAF requesting 3 visual circuits. The controller did not respond to this call and at 1442:10 repeated the descent instruction to the DA42(A) which was readback correctly by the pilot (Figure 8).

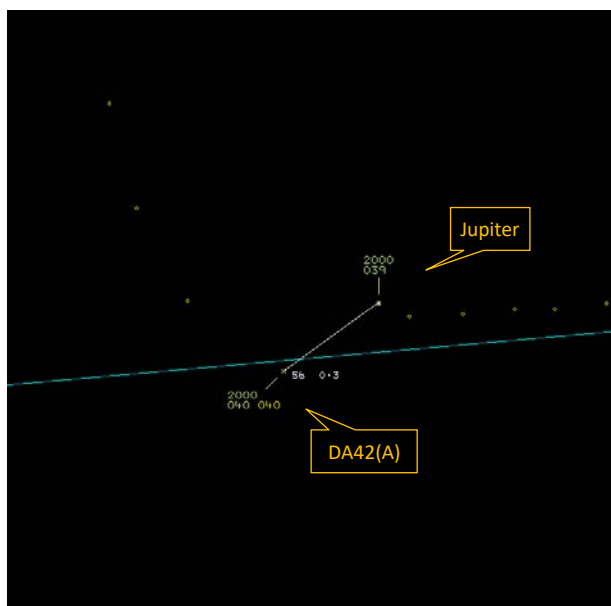
Figure 9 – 1442:14 – CPA

According to the area radar replay, CPA for the Jupiter and DA42(A) occurred at 1442:14, with the aircraft separated by 0.3NM and 100ft. The Jupiter could be seen to be in a right turn as subsequently reported by the pilot in their written Airprox report (Figure 9).

- The Approach controller climbed the Jupiter into confliction with the DA42.

ATSI have made a number of recommendations including a review of the proximity of Tower and Approach controller positions in the VCR, and the quality and content of unit investigation reports. These have already been submitted to the CAA ATS Inspector (Operations) responsible for that unit.
