AIRPROX REPORT No 2019020

Date: 03 Feb 2019 Time: 1121Z Position: 5210N 00007W Location: Gransden Lodge

PART A: SUMMARY OF INFORMATION REPORTED TO UKAB

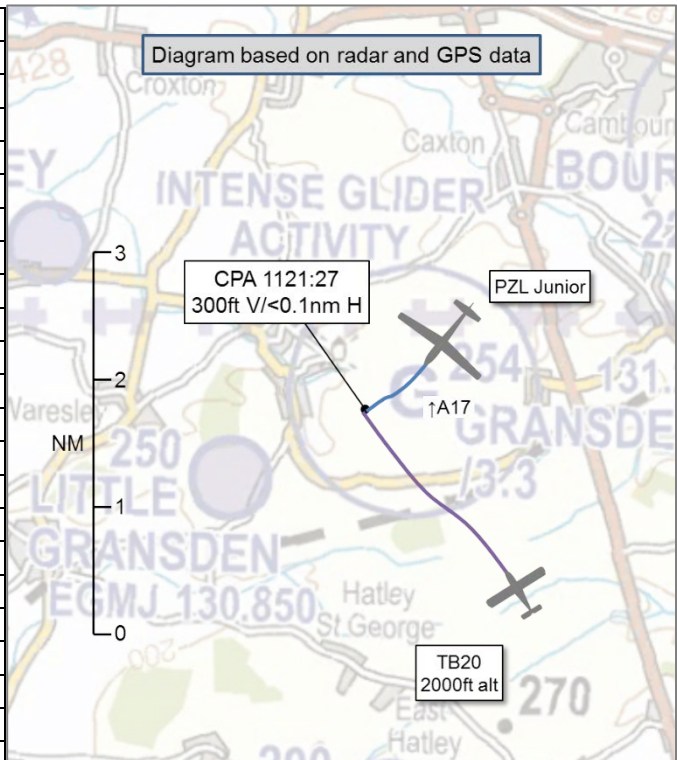
Recorded	Aircraft 1	Aircraft 2
Aircraft	PZL Junior	TB20
Operator	Civ Gld	Civ FW
Airspace	London FIR	London FIR
Class	G	G
Rules	VFR	VFR
Service	Listening Out	AGCS
Provider	Gransden Lodge	Little Gransden
Altitude/FL	1700ft	2000ft
Transponder	Not fitted	A, C, S
Reported		
Colours	White, red	White, blue
Lighting	Not fitted	NK
Conditions	VMC	VMC
Visibility	>10km	>10km
Altitude/FL	1500ft	NK
Altimeter	QNH (NK hPa)	QNH (NK hPa)
Heading	170°	320°
Speed	50kt	115kt
ACAS/TAS	FLARM	Not fitted
Alert	None	N/A
Separation		
Reported	200ft V/0m H	500ft V/0m H
Recorded	300ft V/<0.1nm H

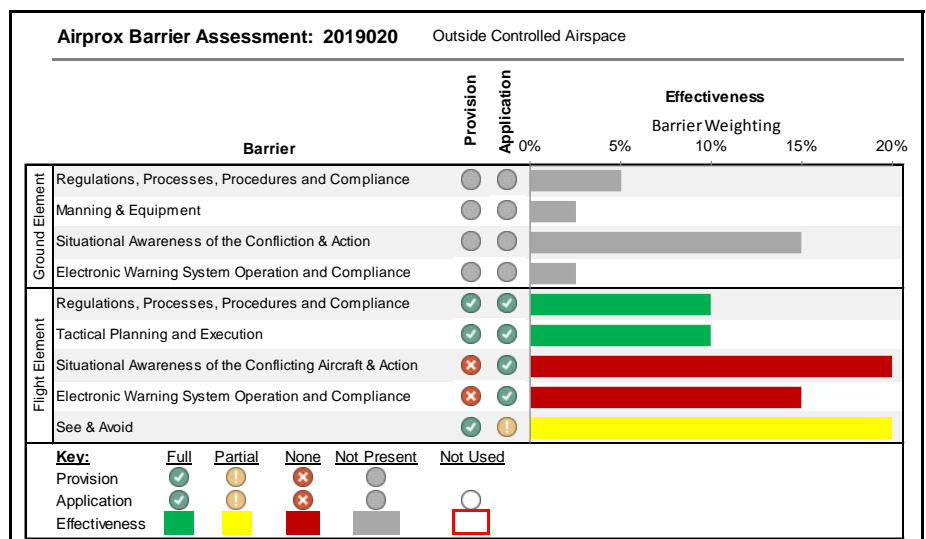
Situational Awareness of the Conflicting Aircraft and Action were assessed as **ineffective** because neither pilot was aware of the other aircraft until visually sighted.

Electronic Warning System Operation and Compliance were assessed as **ineffective** because the PZL Junior FLARM was not compatible with the TB20 transponder.

See and Avoid were assessed as **partially effective** because although the TB20 pilot reported seeing the glider at a range of 1nm he flew over it with a vertical separation of only 300ft at CPA.
