AIRPROX REPORT No 2019022

Date: 06 Feb 2019 Time: 1512Z Position: 5131N 00046W Location: White Waltham – elev 127ft

PART A: SUMMARY OF INFORMATION REPORTED TO UKAB

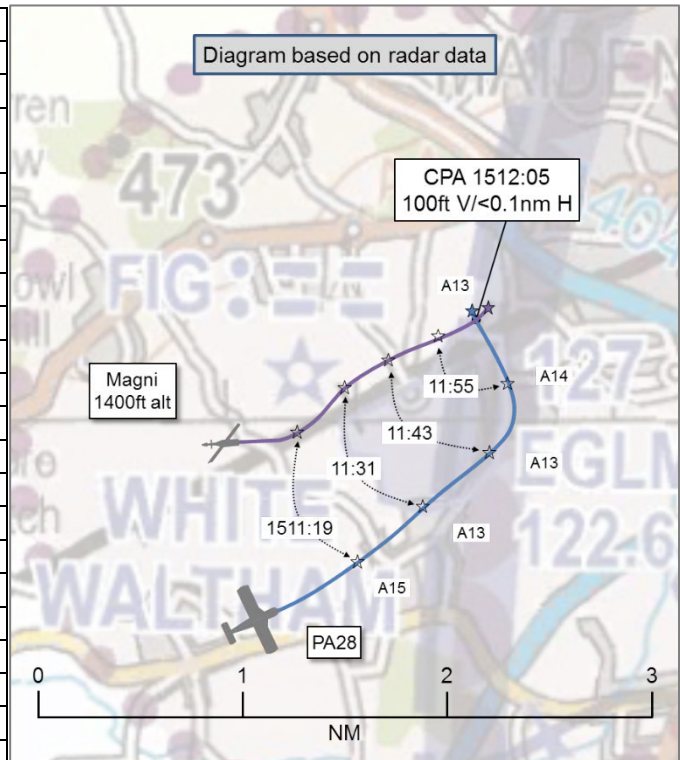
Recorded	Aircraft 1	Aircraft 2
Aircraft	PA28	Magni M24
Operator	Civ FW	Civ Helo
Airspace	White Waltham ATZ	White Waltham ATZ
Class	G	G
Rules	VFR	VFR
Service	AGCS	AGCS
Provider	Waltham Radio	Waltham Radio
Altitude/FL	1300ft	1400ft
Transponder	A, C, S	A, C, S
Reported		
Colours	White, blue	White
Lighting	Strobes, beacon	Strobes, landing
Conditions	VMC	VMC
Visibility	>10km	>10km
Altitude/FL	1000ft	1200ft
Altimeter	QFE (1011hPa)	QFE (1010hPa)
Heading	250°	060°
Speed	85kt	75kt
ACAS/TAS	Not fitted	Not fitted
Separation		
Reported	30ft V/50m H	100ft V/30m H
Recorded	100ft V/<0.1nm H

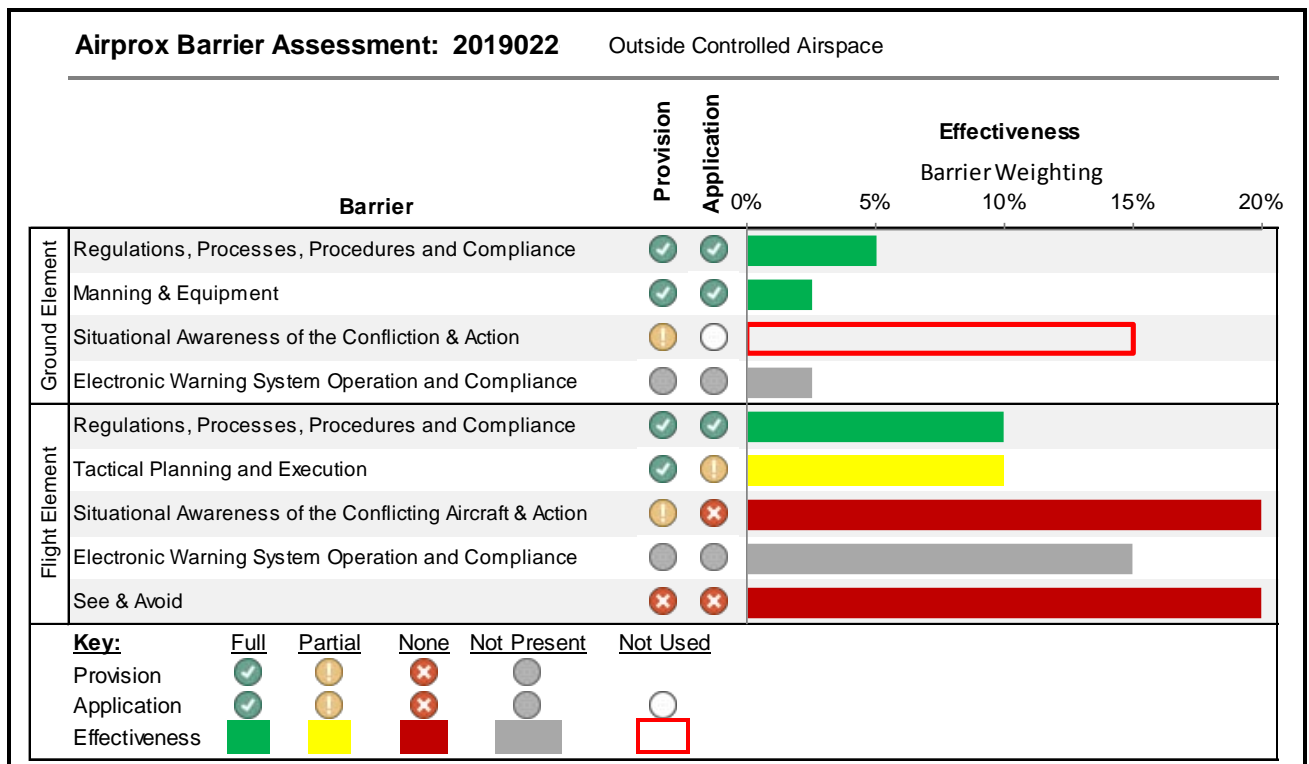
Situational Awareness of the Confliction and Action were assessed as **not used** because an AGCS does not provide SA to pilots, other than relaying other pilots' radio calls.

Tactical Planning and Execution was assessed as **partially effective** because the Magni overhead join was displaced to the north of the airfield, largely due to the confusion of its pilot.

Situational Awareness of the Conflicting Aircraft and Action were assessed as **ineffective** because neither pilot was aware of the other's converging flight path until visually sighted.

See and Avoid were assessed as **ineffective** because neither pilot saw the other in time to materially affect separation at CPA.
