AIRPROX REPORT No 2019051

Date: 03 Apr 2019 Time: 1744Z Position: 5428N 00545W Location: 15nm SE Belfast Aldergrove

PART A: SUMMARY OF INFORMATION REPORTED TO UKAB

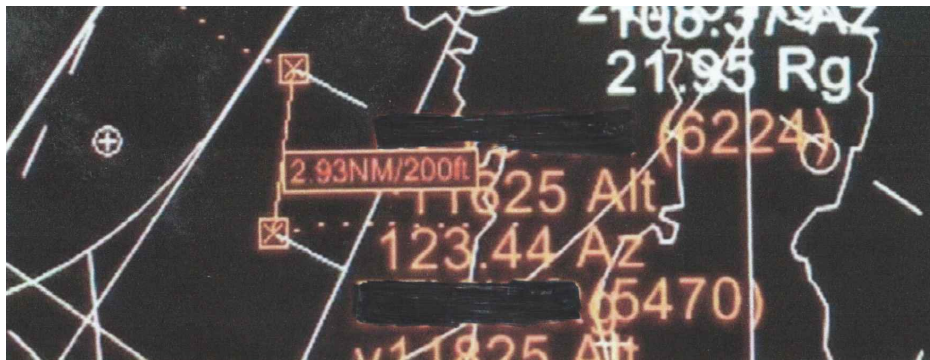
the aircraft was turned onto a heading of 130°. The inbound A319(B) came over from Scottish Control on heading 300°. Climb coordination was requested for A319(B) against A319(A); FL140 was issued. At the same time the Antrim controller offered climb for an aircraft departing from Belfast City airport and FL130 was coordinated for this flight. As the aircraft converged, the Aerodrome controller called to suggest that they may get close. The pilot of A319(B) was instructed to turn left heading 110°, which the pilot queried due to 'a traffic situation'. He asked for confirmation of the heading. He was informed again heading 110°. A319(A)'s pilot was instructed to turn left heading 220°. The pilot of A319(B), before he was transferred, reported that, in his opinion there may have been an Airprox. From ATC's perspective there was a temporary loss of separation for one radar sweep, approximately 2.9nm horizontally and 200ft vertical. (Radar separation required was 3nm.)

Figure 1 Belfast Radar recording. A319(A) (5470); A319(B) (6224).

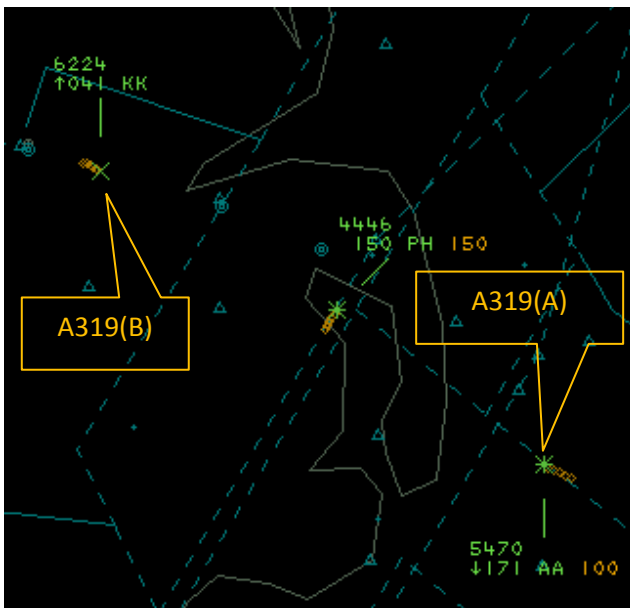
Figure 2 - 1741:20.

At 1741:20 (Figure 2), the pilot of A319(A) made initial R/T contact with the Aldergrove Radar controller, advising that they were inbound for an RNAV approach RW07 via LIRGU and in the descent to FL100, heading 300°. The controller confirmed that they would provide radar vectors for the RNAV approach RW07, advised the pilot that information 'Hotel' was current and that they would be number one for the approach.

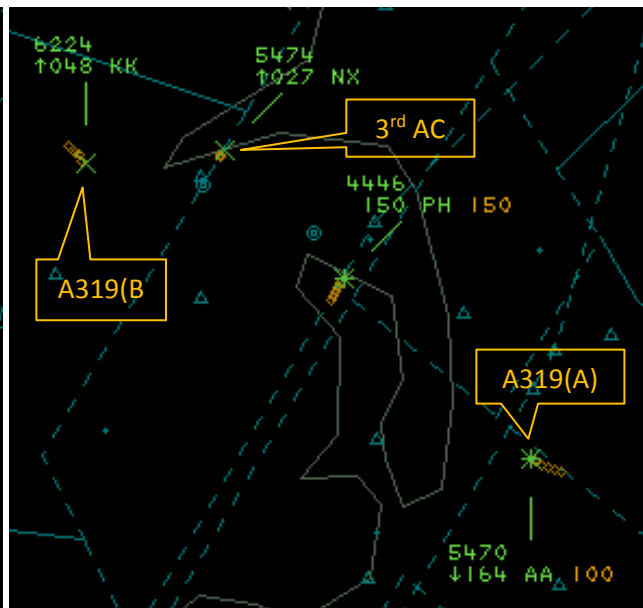
Figure 3 - 1741:40.

At 1741:40 (Figure 3), the pilot of a 3rd aircraft (departing from Belfast City Airport) called the Aldergrove Radar controller, advising that they were airborne and climbing to 3000ft. The controller instructed the pilot to squawk ident.

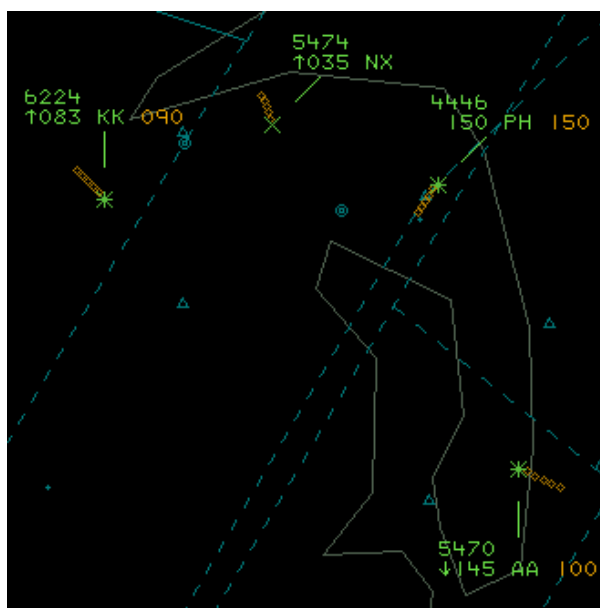
Figure 4 - 1742:40.

At 1742:40 the controller instructed the A319(A) pilot to turn left heading 280° (Figure 4).

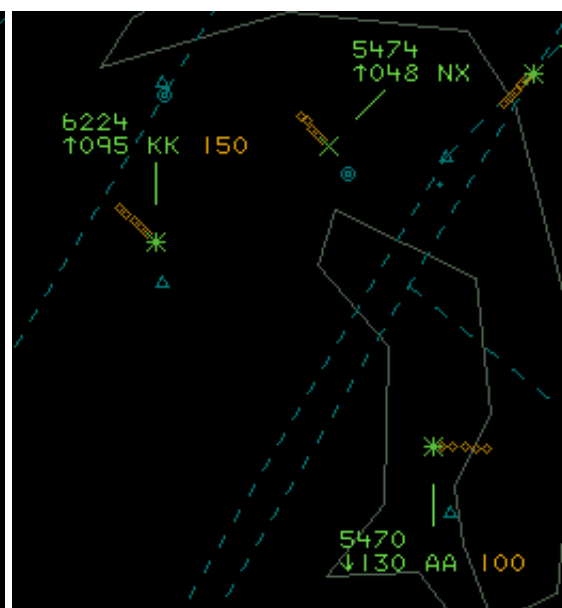
Figure 5 - 1743:30.

At 1743:30 (Figure 5), the controller instructed the 3rd aircraft to climb to FL130.

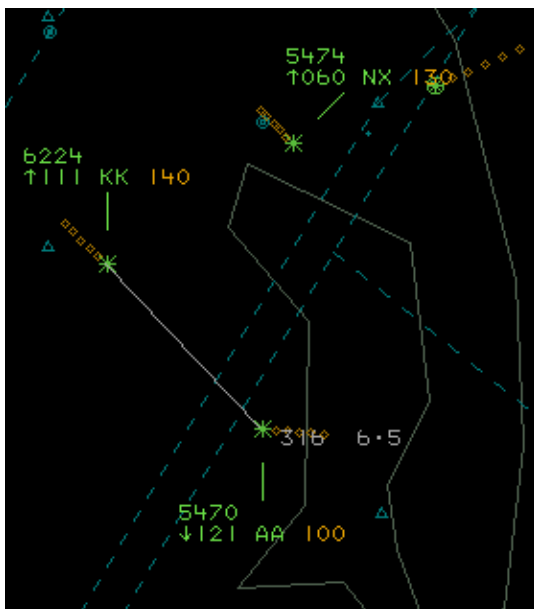
Figure 6 - 1744:00.

At 1744:00 (Figure 6), the controller instructed the A319(B) pilot to turn left heading 110°. The pilot responded that they had a traffic situation and asked the controller to repeat the requested heading. The controller confirmed that the heading was 110°. The controller then turned their attention to A319(A) and instructed the pilot to turn left heading 220°.

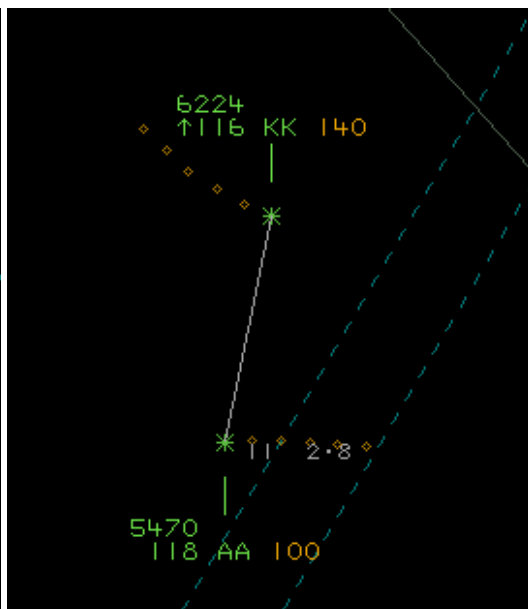
Figure 7 - 1744:31 (CPA).

CPA occurred at 1744:31 (Figure 7), with the aircraft separated laterally by 2.8nm and vertically by 200 feet. The required lateral separation was 3nm.
