AIRPROX REPORT No 2019096

Date: 12 May 2019 Time: 1211Z Position: 5156N 00126W

Location: Enstone Airfield

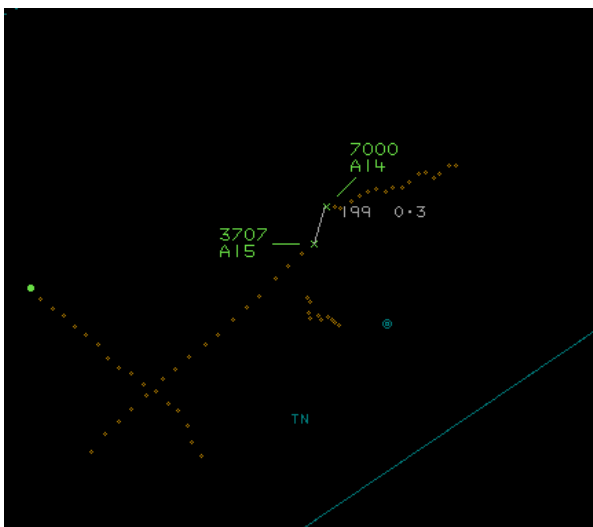
Figure 1: 1411:07

UKAB were able to provide a portion of the radar replay to this HQ but, because no occurrence report was filed by Brize Radar, no RT recording or transcript was available at the time of compiling this report. As a result, full analysis of this incident is not possible and therefore BM staff are not able to provide a perspective on this incident. Figures 1 and 2 show the encounter and indicate that CPA occurred with a separation of 0.2nm and 200ft.

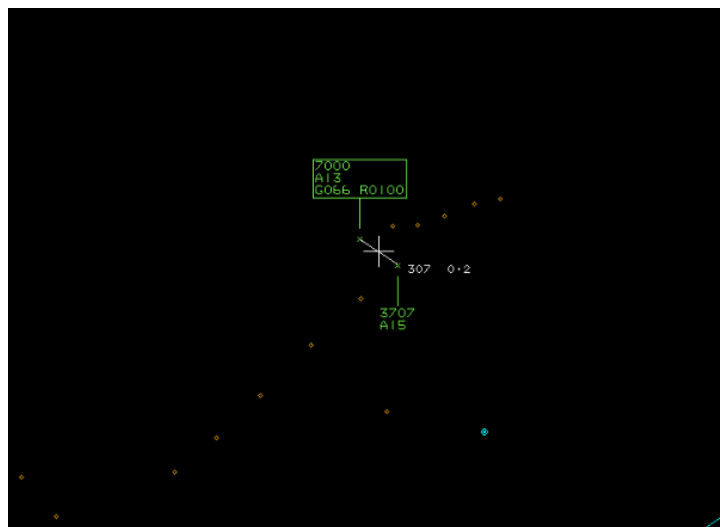
Figure 2 – CPA 1211:11

(SF25 squawk 7000, A109 squawk 3707)

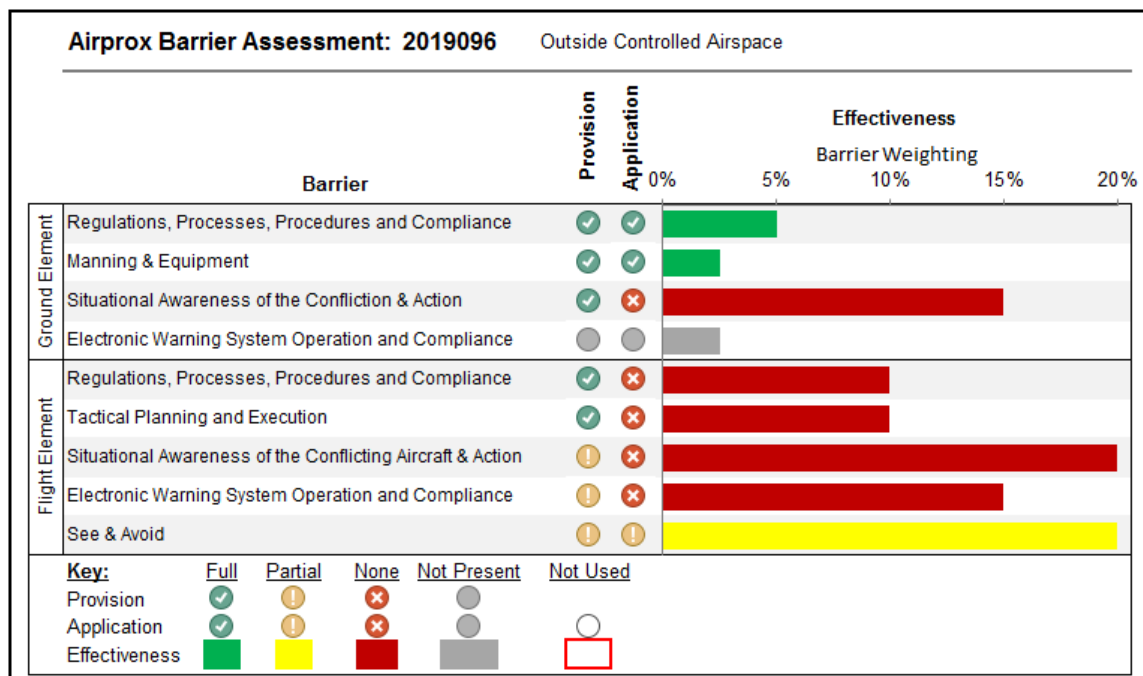
In assessing the effectiveness of the safety barriers associated with this incident, the Board concluded that the key factors had been that:

Situational Awareness of the Confliction and Action were assessed as **ineffective** because the Brize Norton controller did not identify that the A109's track would infringe Enstone visual circuit or recognise the conflict with the SF25.

Regulations, Processes, Procedures and Compliance were assessed as **ineffective** because the A109 pilot did not avoid the pattern of traffic formed by aircraft in the Enstone visual circuit.

Tactical Planning and Execution was assessed as **ineffective** because the A109 pilot did not sufficiently avoid Enstone, which is marked on charts and notified in the UK AIP.

Situational Awareness of the Conflicting Aircraft and Action were assessed as **ineffective** because although the A109 pilot should have been generically aware of likely traffic at Enstone airfield, neither pilot had specific situational awareness of the other.

Electronic Warning System Operation and Compliance were assessed as **ineffective** because SF25's FLARM was not able to detect the A109. The A109 pilot did not report whether they had a Collision Warning System fitted or if it had alerted the pilot to the presence of the SF25.

See and Avoid were assessed as **partially effective** because the SF25 pilot only saw the A109 late and took emergency avoiding action. The A109 pilot did not see the SF25.
