AIRPROX REPORT No 2019099

Date: 13 May 2019 Time: 1430Z Position: 5408N 00117W Location: Vale of York

PART A: SUMMARY OF INFORMATION REPORTED TO UKAB

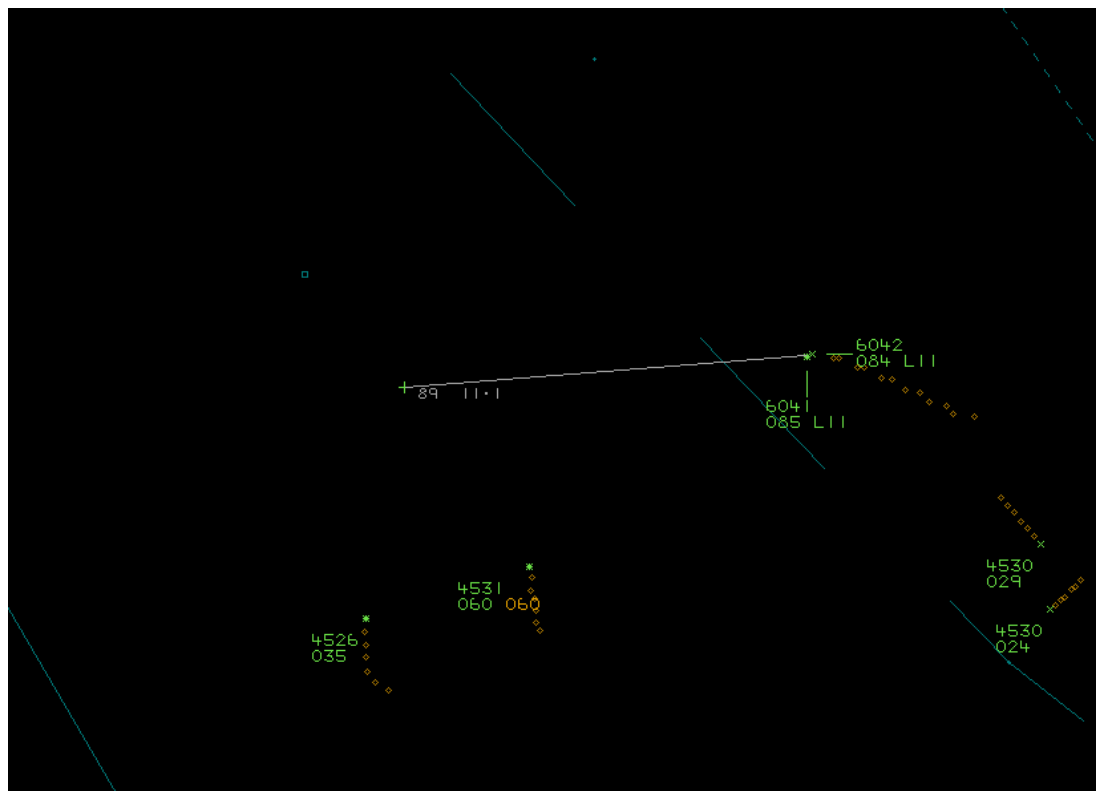
Figure 1 -First Primary Contact

Only 4mins elapsed from the time the Hawks reported ready for recovery to Leeming and the Airprox occurring. Analysis of the radar replay showed that a primary radar return (which was possibly one of the gliders involved) was on the screen for 25secs in total (for 10secs and 15secs). During this first exposure, the Swanwick(Mil) controller was passing Traffic Information on an aircraft 7nm southwest indicating FL60 (later identified as a Tucano). The second exposure coincided with the Hawk Lead requesting an update on the Traffic Information passed.

Figure 1 depicts the point at which a primary radar contact is visible for 10secs. The appearance of this contact coincides with Swanwick (Mil) passing Traffic Information to the Hawks on the 4531 Squawk.

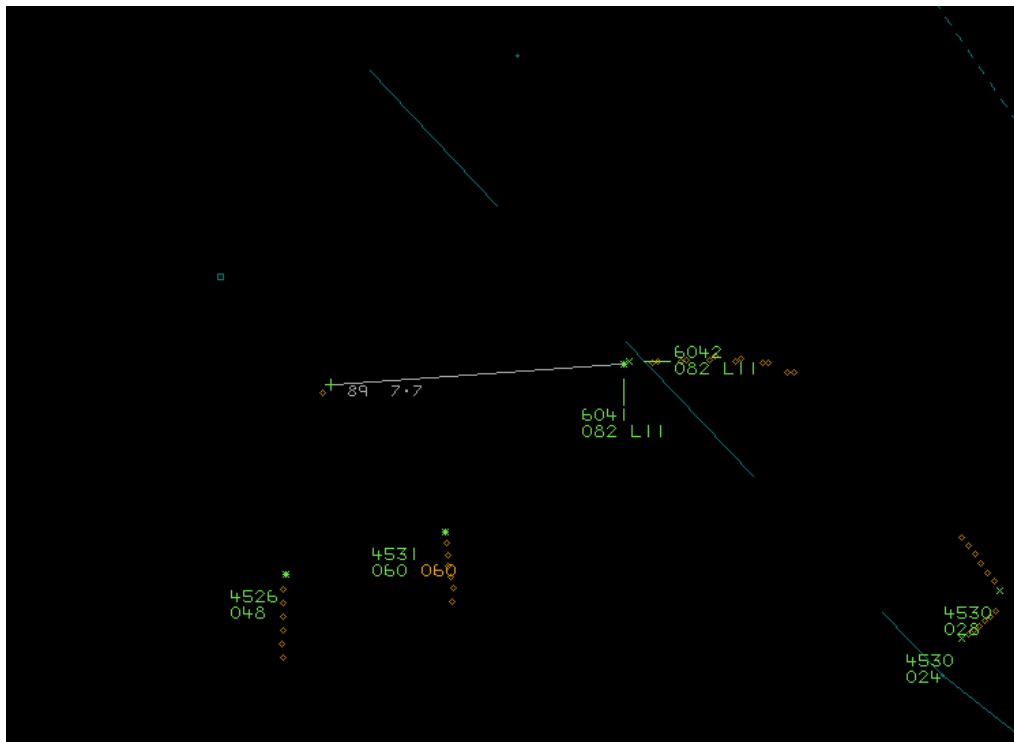
Figure 2 – Second Primary Contact

Figure 2 depicts the point at which a primary radar contact is visible for 15secs. During this time, the Hawk Lead is requesting an update on the Traffic Information passed.

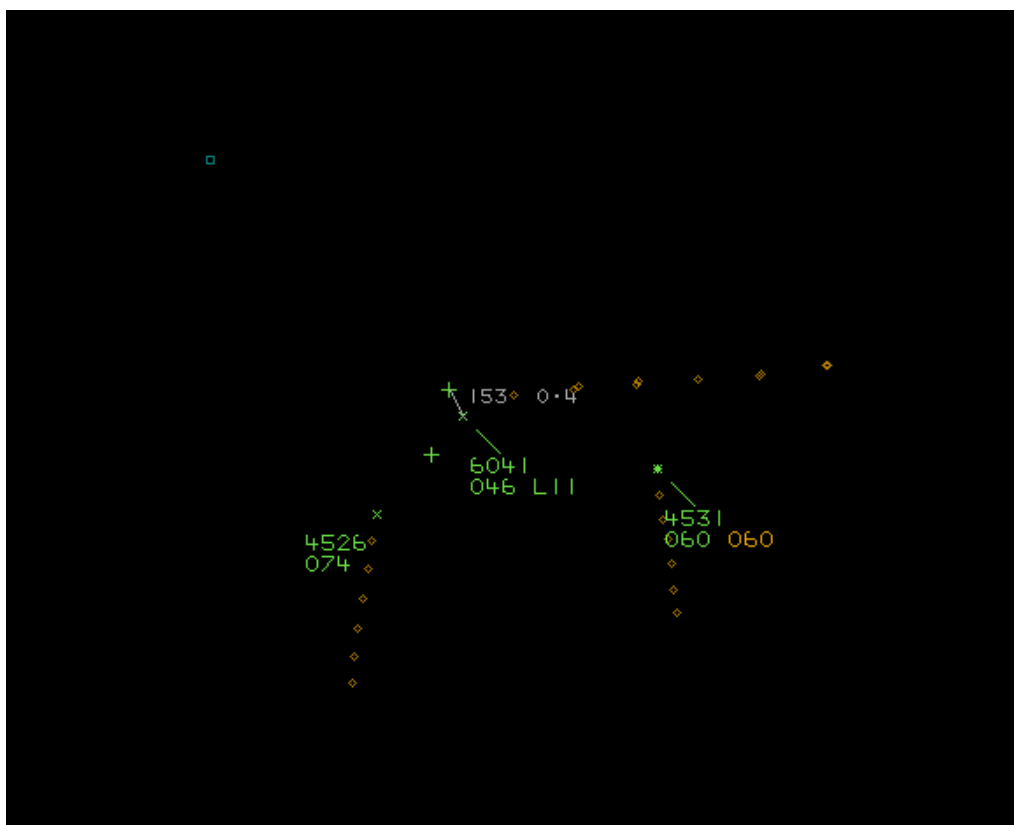
Figure 3 - CPA

The Hawk lead reported issuing a 'Break Left' instruction to avoid a glider and this manoeuvre can be seen on radar. This turn is coincident with the appearance of two primary radar contacts but the Radar Analysis Cell is unable to determine if one of the returns is actually the second Hawk.
