AIRPROX REPORT No 2019136

Date: 05 Jun 2019 Time: 1353Z Position: 5400N 00025W Location: Driffield

PART A: SUMMARY OF INFORMATION REPORTED TO UKAB

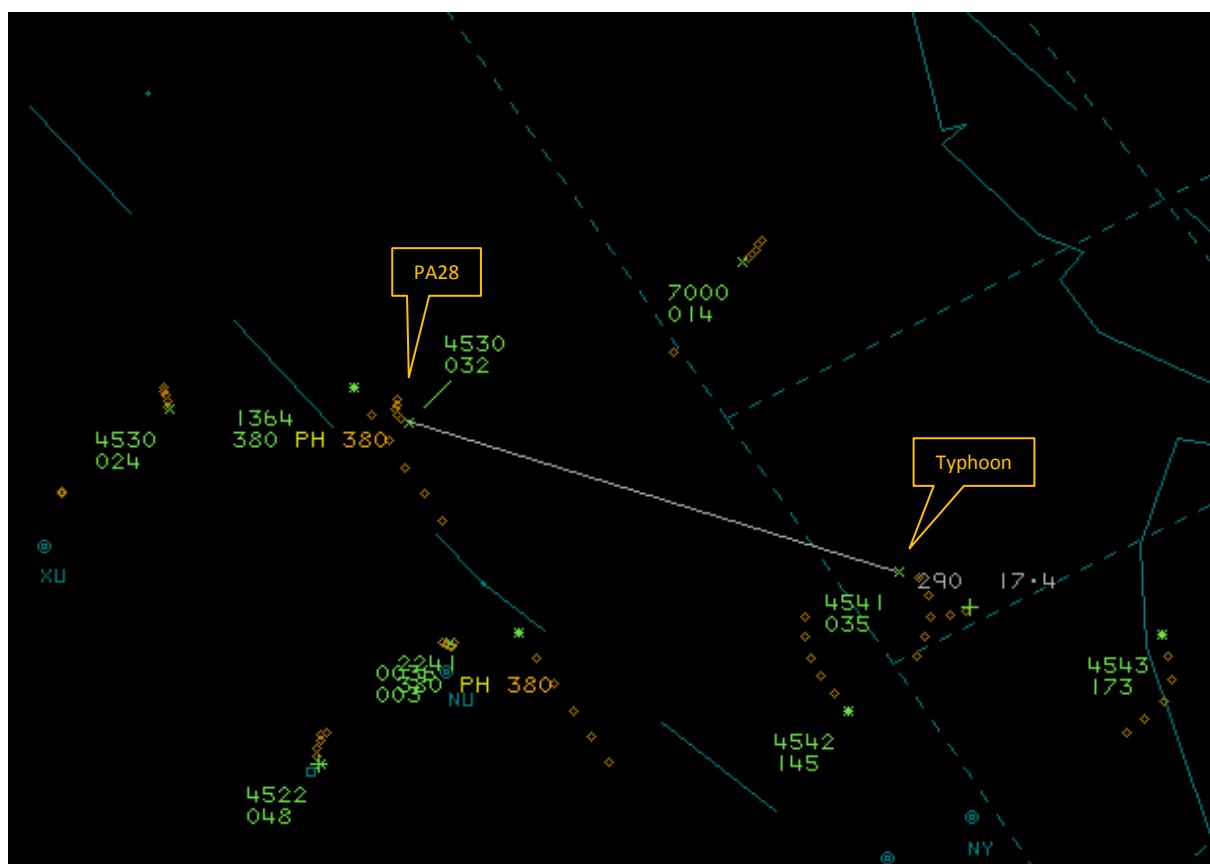
Figure 1

After reaching Castle Howard, the PA28 pilot took up a south-easterly heading (toward the exercise area). The Linton LARS Controller was working five aircraft at the time of the incident (analysis of the radar replay shows 4x Basic Service and 1x Traffic Service) and intensity has been assessed as medium to high due to almost constant R/T transmissions in the 8mins prior to this incident. The Linton Zone Controller was working three aircraft (all taking part in the exercise) and assessed their workload as medium but with a low complexity. At this point, separation between the aircraft was 17.5nm and 300ft (Figure 1).

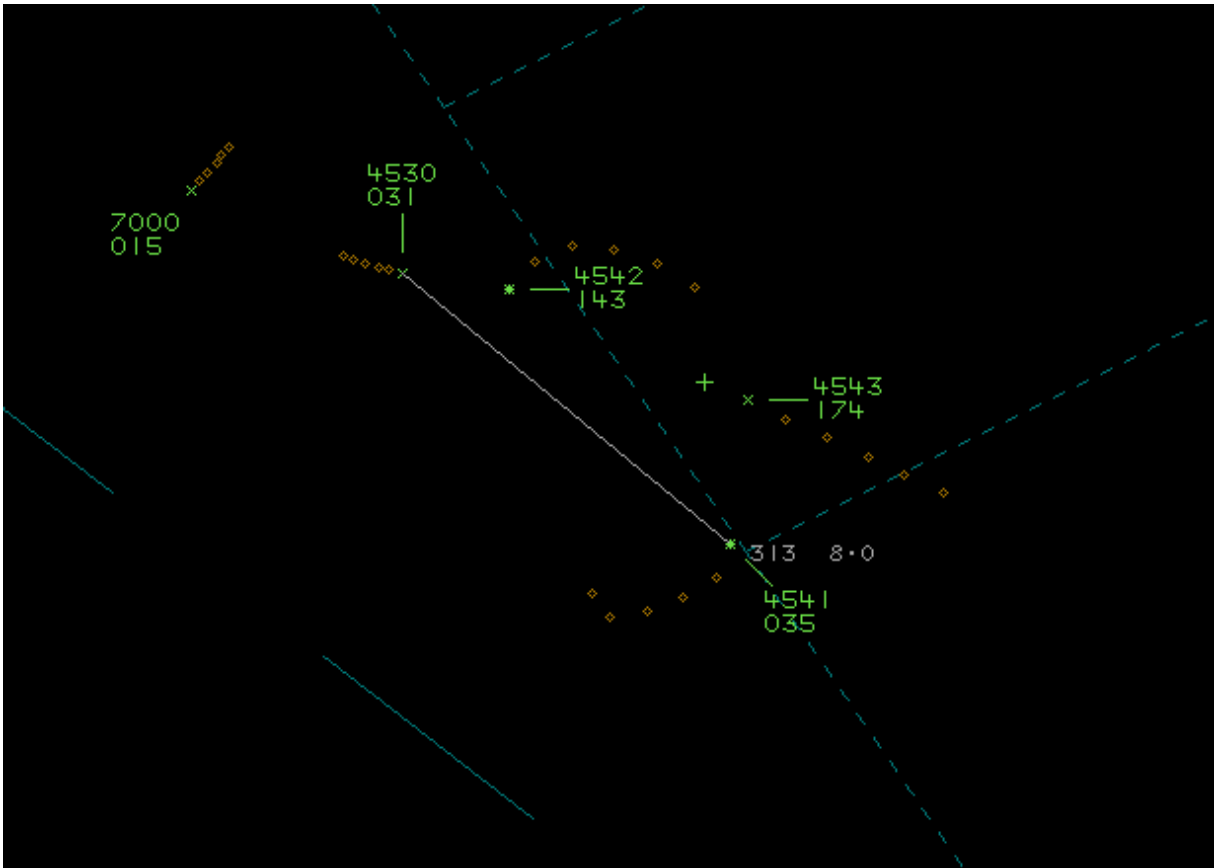
Figure 2

The Zone Controller passed Traffic Information to the Typhoon pilot on the PA28 at 1349:02. At the same time, the Linton LARS Controller was ascertaining the intentions of another aircraft on frequency which was operating 50nm north west of the incident location. Separation at this point was 8nm and 400ft (Figure 2).

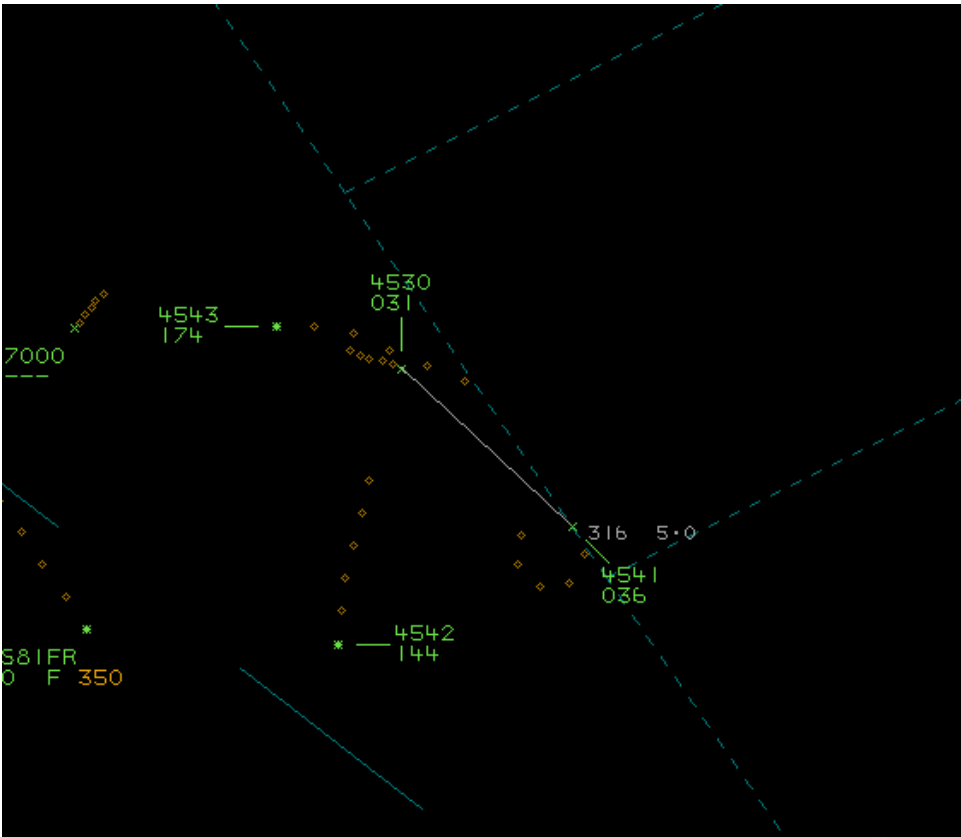
Figure 3

Traffic Information was passed to the Typhoon pilot for a second time at 1350:11 and, after some clarification, the pilot acknowledged the call. Separation at this point had decreased to 5nm and 500ft. (Figure 3).

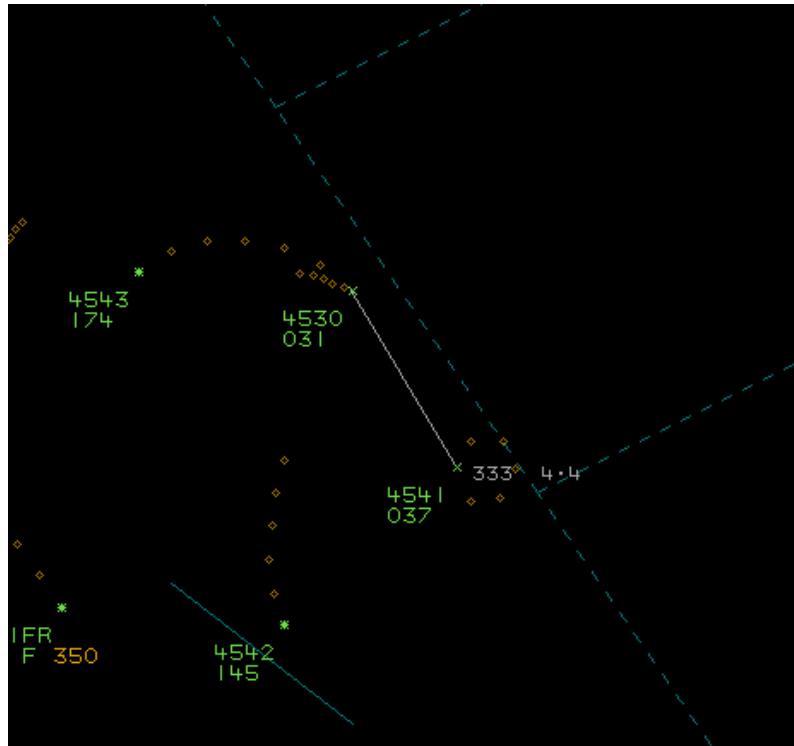
Figure 4

Traffic Information was passed to the Typhoon pilot for a third time at 1350:31 (Figure 4). As the Typhoon was in a left-hand orbit, separation remained almost constant and at this point was 4.4nm and 600ft.

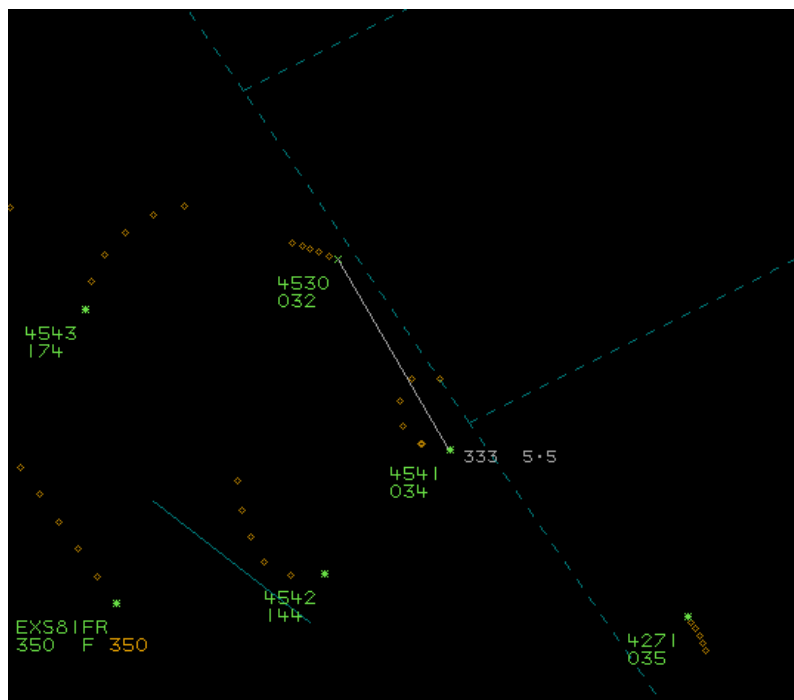
Figure 5

The Typhoon pilot requested an update on the Traffic Information at 1351:38 (Figure 5), and this was concurrent with the Linton LARS Controller passing a warning to the PA28 about the fast-jet activity. At this point both the PA28 and Typhoon pilots reported visual with each other. Separation had increased to 5.5nm and 200ft.

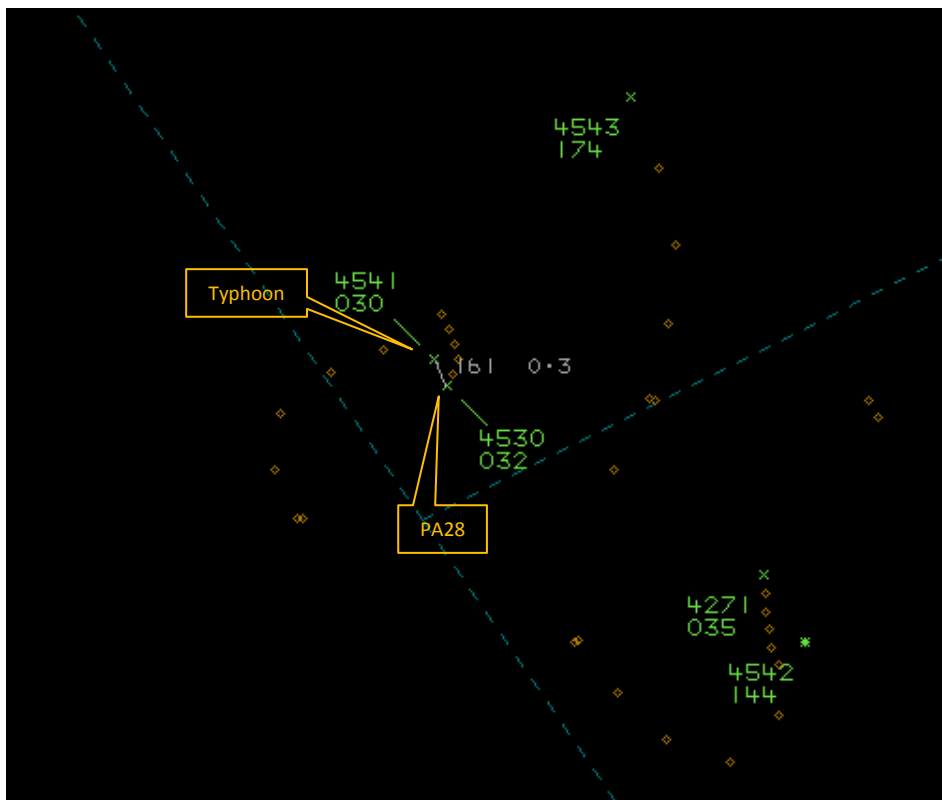
Figure 6 - CPA

The Typhoon pilot reversed his turn and commenced a right-hand orbit and, at 1353:03, again requested an update on the position of the PA28 which was provided by the Linton Zone Controller. Over the next 40secs the Linton Zone Controller provided two further updates on the position of the PA28 and the Typhoon reported visual again following the second. Traffic Information was passed on a conflictor 5nm south east and this was concurrent with CPA and the Typhoon reporting that it had come within an estimated 75-100m of the PA28. CPA occurred at 1353:43 and was measured at 0.3nm and 200ft.
