AIRPROX REPORT No 2019152

Date: 21 Jun 2019 Time: 1242Z Position: 5146N 00007W Location: 1NM N BPK

PART A: SUMMARY OF INFORMATION REPORTED TO UKAB

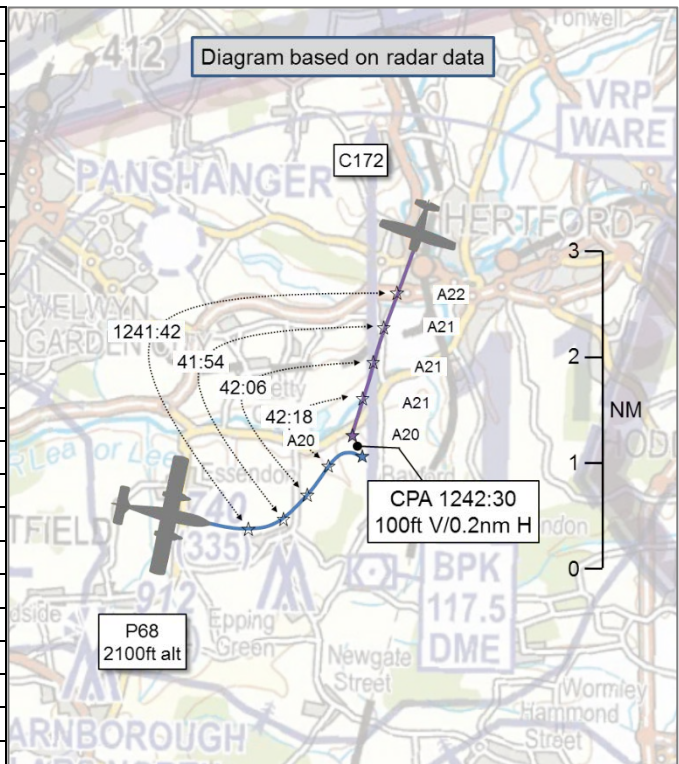
Recorded	Aircraft 1	Aircraft 2
Aircraft	P68	C172
Operator	Civ Comm	Civ FW
Airspace	London FIR	London FIR
Class	G	G
Rules	VFR	VFR
Service	Basic	None
Provider	Stansted	N/A
Altitude/FL	2100ft	2000ft
Transponder	A, C, S	A, C
Reported		
Colours	White, blue	White
Lighting	NK	Nav
Conditions	VMC	VMC
Visibility	>10km	>10km
Altitude/FL	2100ft	2200ft
Altimeter	QNH (1020hPa)	NK
Heading	050°	185°
Speed	105kt	114kt
ACAS/TAS	Not fitted	Not fitted
Separation		
Reported	0ft V/<1nm H	100ft V/1nm H
Recorded	100ft V/0.2nm H

An Airprox was reported when a P68 and a C172 flew into proximity 1NM north of the BPK VOR at 1242Z on Friday 21st June 2019. Both pilots were operating under VFR in VMC, the P68 pilot in receipt of a Basic Service from Stansted and the C172 pilot not in receipt of a FIS.
