**AIRPROX REPORT No 2019154**

Date: 23 Jun 2019 Time: 1055Z Position: 5012N 00127W Location: 12nm N GARMI

**PART A: SUMMARY OF INFORMATION REPORTED TO UKAB**

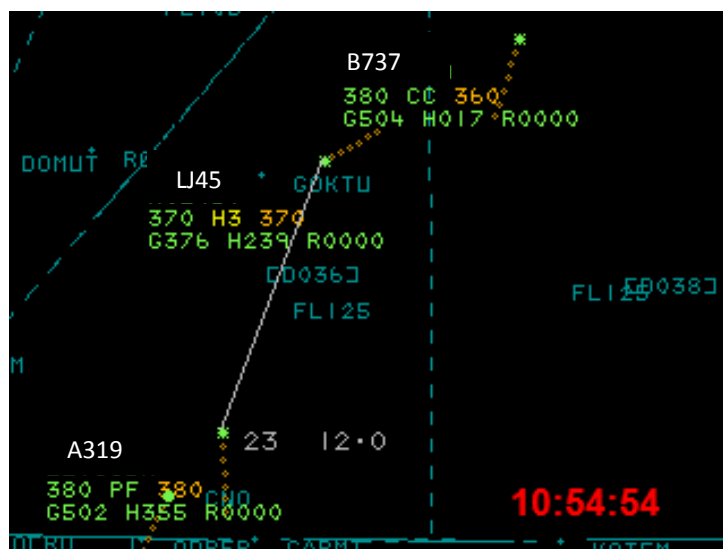
Figure 1.

At 1054:54 (Figure 1), the S20-22T assessed the LJ45 and, in attempting to make the exit coordination level of FL390, climbed it to FL390 whilst within the confines of S19 and without coordination with the S18/19T. The LJ45 was approximately at the midway point of S19 airspace.

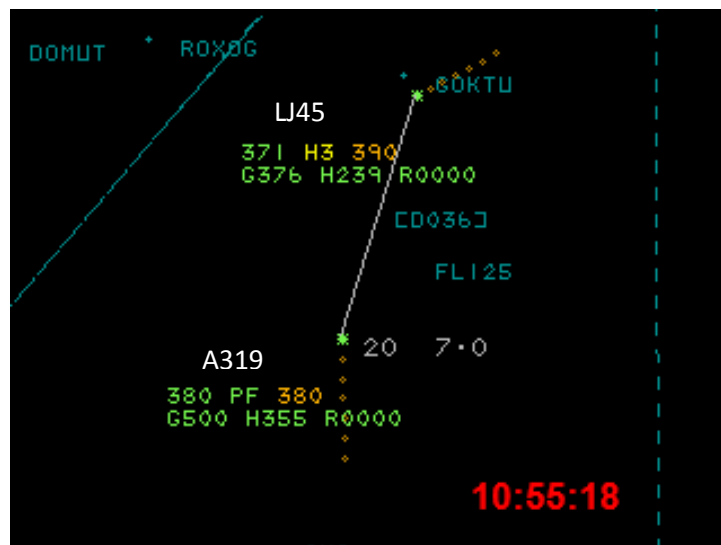
Figure 2.

At 1055:18 (Figure 2), the S20-22T issued "avoiding action turn right immediately heading 270 degrees" to the LJ45 pilot.

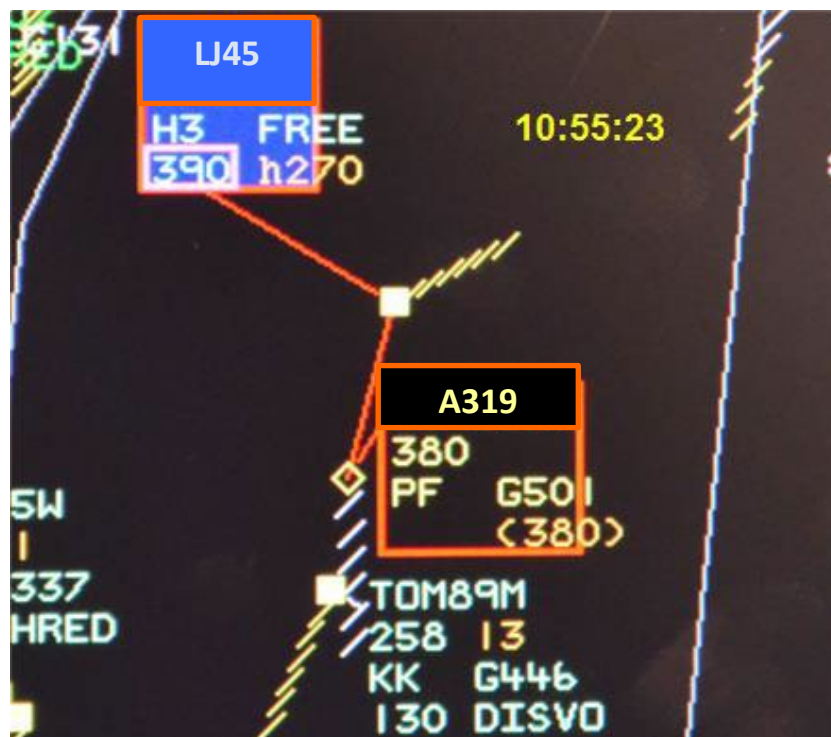
Figure 3.

At 1055:27 (Figure 3), the S20-22T requested that the LJ45 pilot reduce his rate of climb; red STCA was displayed as the LJ45's Mode S indicated FL372; and the A319's Mode S was FL380. The S18/19T SM showed 1nm/30 sec. There was nothing showing in the S20-22T SM for this conflict.

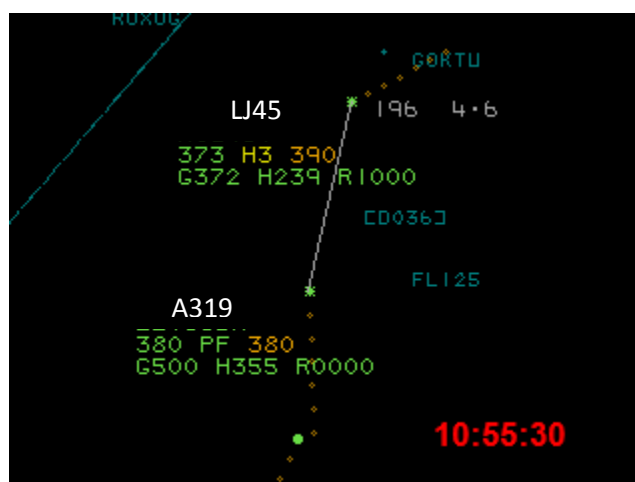
Figure 4.

At 1055:30 (Figure 4), the S18/19T issued the A319 pilot with an avoiding action turn heading 050° with Traffic Information on the conflicting traffic. Range and bearing was given.

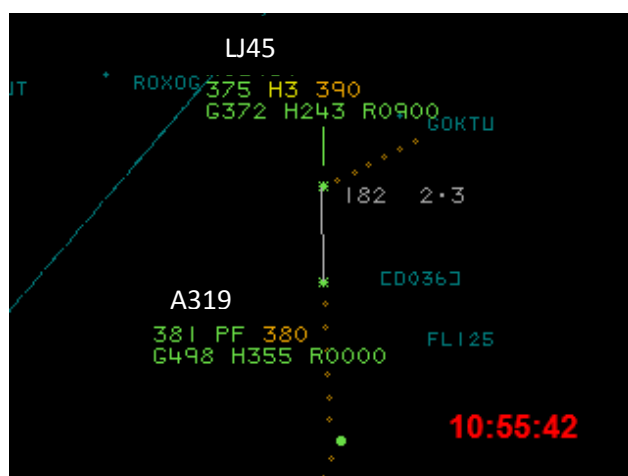
Figure 5.

Minimum vertical separation occurred at 1055:42 (Figure 5), and was recorded on the LTCC Multi-Track Radar as 2.3nm and 600ft. [UKAB note: The required separation minima was 5nm horizontal or 1000ft vertical].

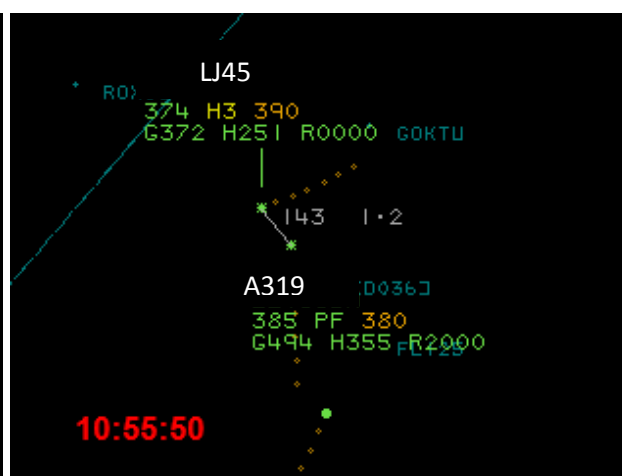
Figure 6 .

Vertical Separation of 1000ft was restored at 1055:50 (Figure 6), as the A319 passed FL385 in the climb and the LJ45 descended through FL374 at a range of 1.2nm. At 1055:55, the A319 became a recognised track on the S20-22T display.
