AIRPROX REPORT No 2019159

Date: 24 Jun 2019 Time: 1809Z Position: 5046N 00150W Location: Beaulieu

PART A: SUMMARY OF INFORMATION REPORTED TO UKAB

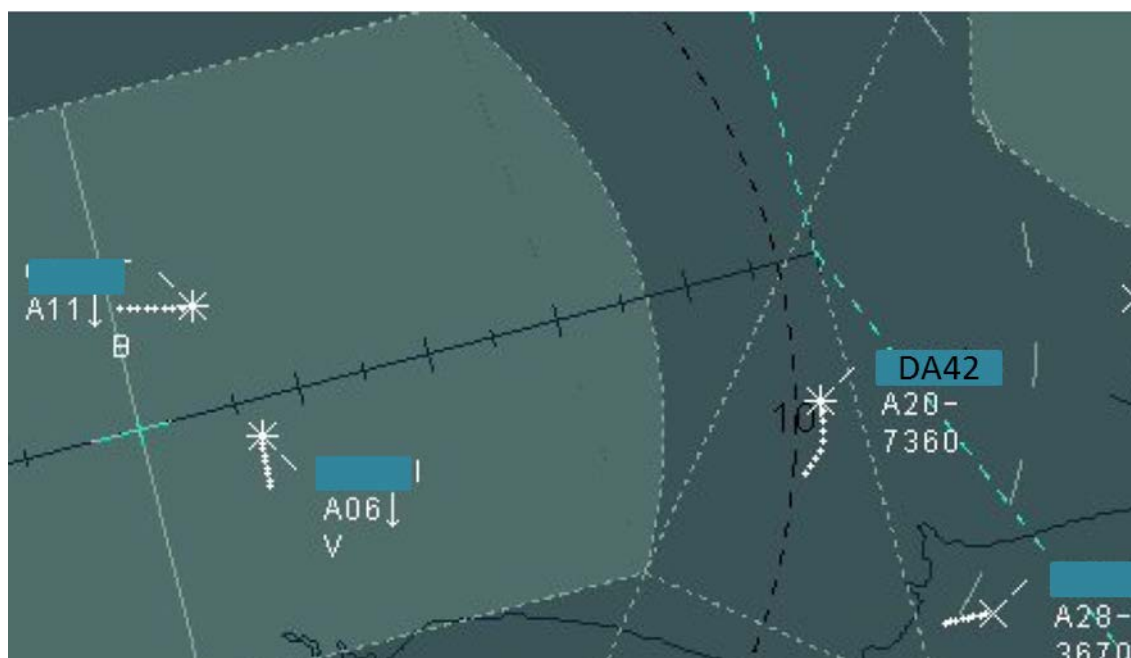
Figure 1

A screenshot of the Bournemouth radar, as used by the Bournemouth controller, is at Figure 1. The DA42 can be seen on the radar, indicating 2000ft. The paraglider does not display on the radar.

The DA42 was being vectored for an ILS approach for RW26, the aircraft was at 2000ft. 9nm to the southeast of the airfield it was turned onto a heading of 350° base leg and given a range check of 11nm. At 1809, the pilot advised that they were breaking off as they had a paraglider on the nose 50ft below them. The radar replay has no contact visible in the area, which is to be expected given that the conflict aircraft was believed to be a paraglider. The pilot was given the option to climb by the Bournemouth Radar controller but the pilot advised that they were turning away, shortly after that he reported the paraglider was now behind them and they were resuming the original heading.

The base of the airway in the position of the incident is 2000ft and the DA42 was therefore flying at the base level with the paraglider likely flying 50ft outside of controlled airspace. This is a known area of transiting traffic which generally route between Stoney Cross towards Beaulieu or the reverse route. Due to the adjacent Solent airspace, controllers are normally aiming for an 8nm final for RW26 to ensure separation from inbound and outbound Solent traffic, and generally at 2000ft at the base. The descent profile for the ILS commences descent from 2000ft at 6nm or 8nm for 2500ft. Following discussion with Unit Assessors, it is recommended that when vectoring aircraft within Area C and D they should be vectored at 2500ft to ensure that they are 500ft above the base of controlled airspace in accordance with MATS Pt 1Section 1: Chapter 7 para 9:
