AIRPROX REPORT No 2019161

Date: 26 Jun 2019 Time: 2201Z Position: 5120N 00151W Location: IVO Salisbury Plain

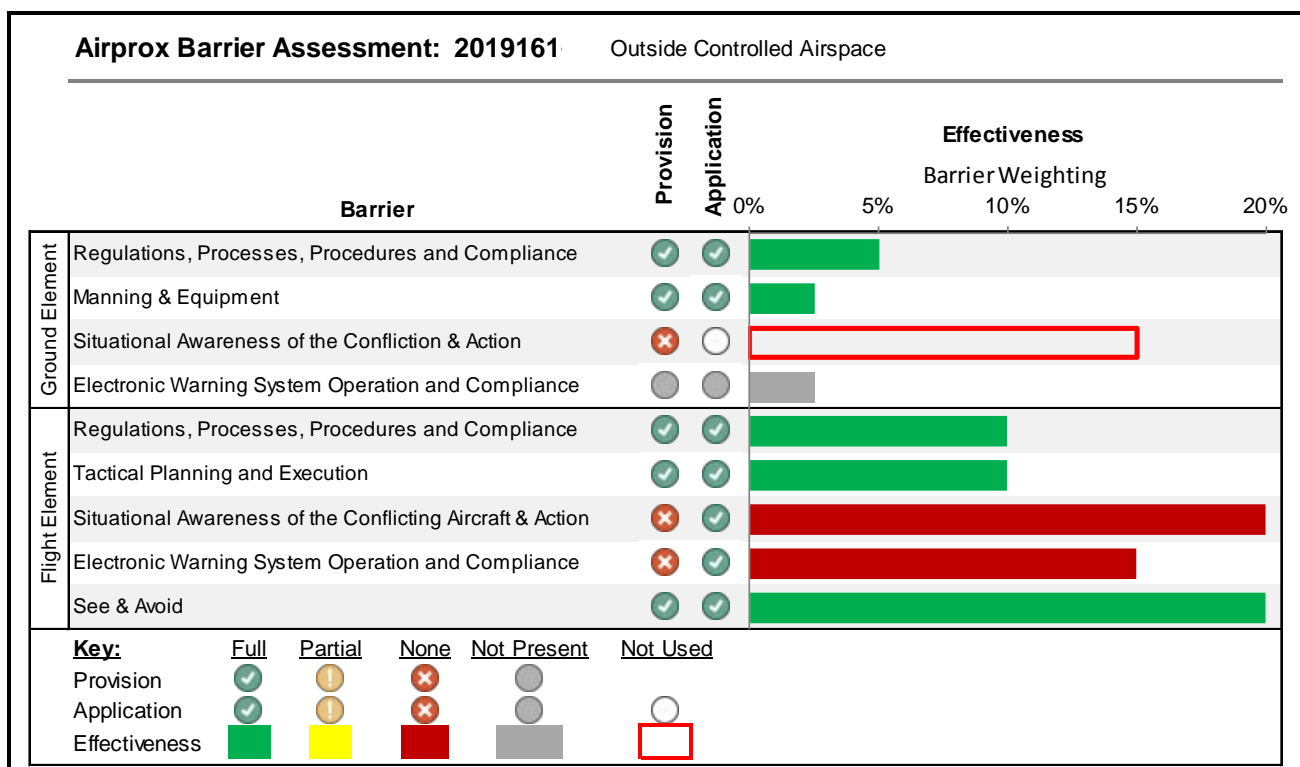
Situational Awareness of the Conflicting Aircraft and Action were assessed as **ineffective** because the C130 pilot did not have any prior situational awareness about the other aircraft.

Electronic Warning System Operation and Compliance were assessed as **ineffective** because the C130's TCAS could not detect the non-squawking other aircraft.
