**AIRPROX REPORT No 2019188**

Date: 10 Jul 2019 Time: 1255Z Position: 5233N 00020E Location: SW Marham

**PART A: SUMMARY OF INFORMATION REPORTED TO UKAB**

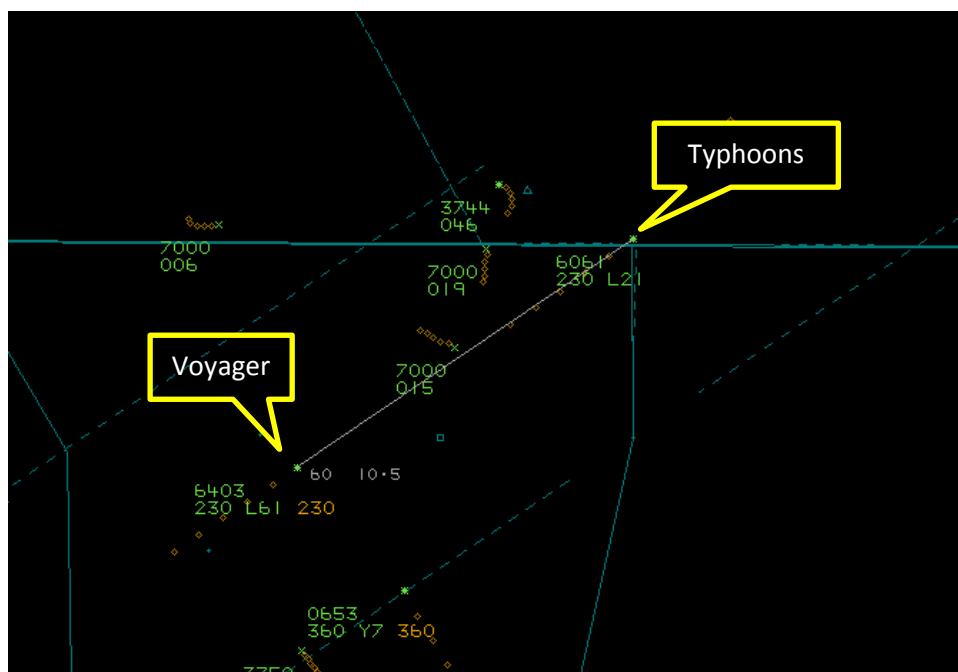
Figure 1

The Typhoons departed the Wescott RC at 1253:04 and were handed over to Swanwick(Mil) East Controller Two. At this point the Voyager was still under the control of Swanwick(Mil) South-West. Both aircraft were at FL230, heading in the same direction and were separated by 10.5nm.

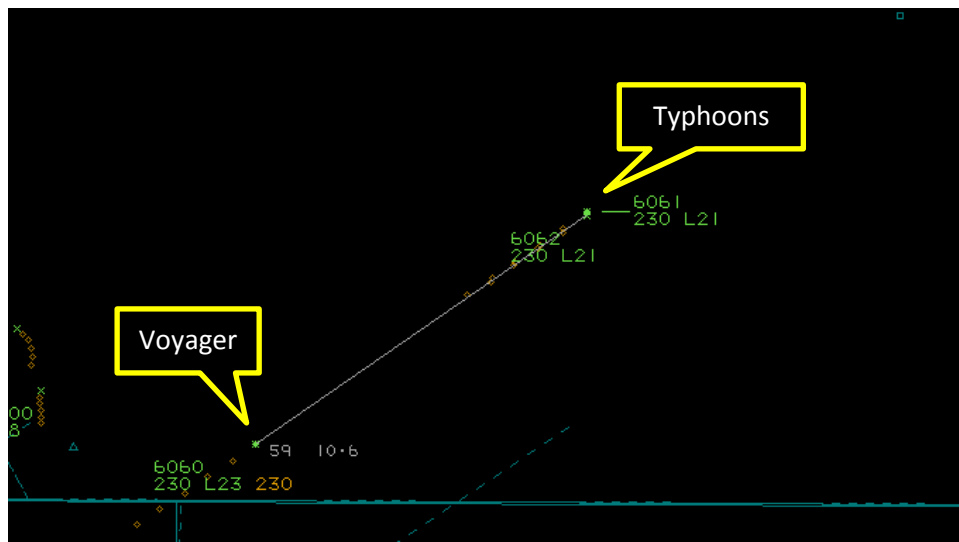
Figure 2

On leaving the Wescott RC, the Voyager established contact with Swanwick(Mil) Controller One (who was undergoing training and was being supervised by an OJTI) and requested a transit at FL230 due to weather. Because a transit at FL230 would also mean a crossing of airway Y70, Swanwick(Mil) Controller One began to scan for potential conflicting traffic on the airway. At almost the same time, Swanwick(Mil) Controller Two approved the Typhoon request to general handle in a block of airspace 5-24,000ft and issued an individual squawk to the incident Typhoon. Separation at this point remained 10.5nm.

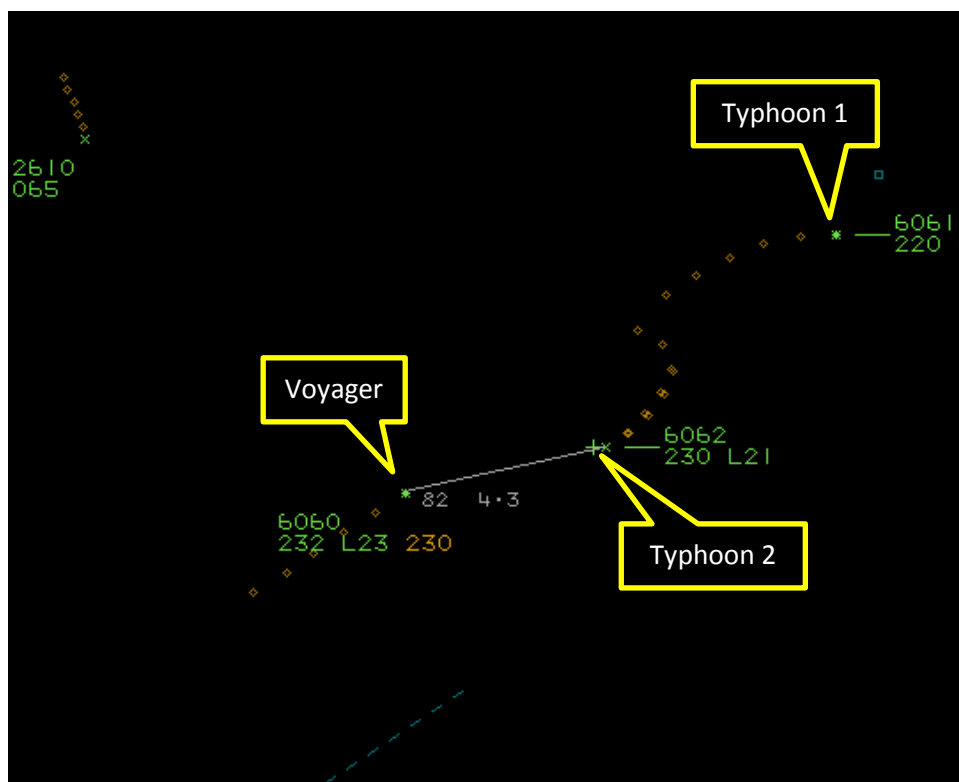
Figure 3

The incident Typhoon pilot reversed their heading in preparation for their exercise and, at 1254:54, Swanwick(Mil) Controller Two issued Traffic Information to the Typhoon who reported visual with the Voyager. Just prior to this Traffic Information, the Voyager reported manoeuvring following a TCAS RA. Although separation at this point was 4.3nm and 200ft there was a recorded closing speed of 746kts.

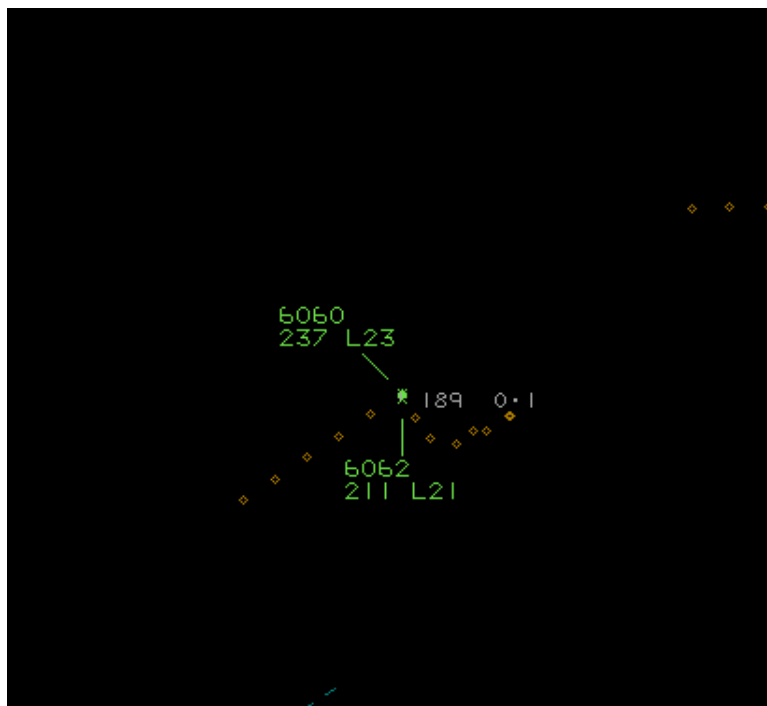
Figure 4 CPA

Following the Traffic Information, and coincident with the TCAS RA climb instruction, Typhoon 2 initiated a descent at approximately 6000ft/min. As the lateral separation decreased to one mile, vertical separation was 2300ft. CPA occurred as the radar returns merged and showed a vertical separation of 2600ft.
