## AIRPROX REPORT No 2019187

Date: 07 Jul 2019 Time: 0945Z Position: 5133N 00018W Location: London

### PART A: SUMMARY OF INFORMATION REPORTED TO UKAB

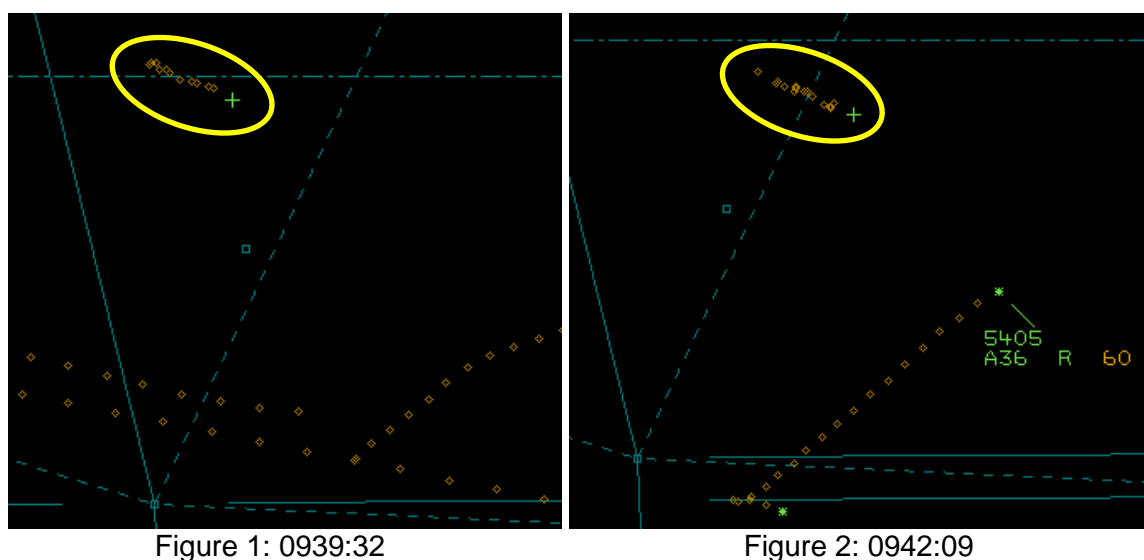
Figures 1 and 2 show the radar recording of the unknown track that caused pCAIT to alert.

anomalous propagation (anaprop) due to temperature, pressure or water vapour effects on atmospheric refractive index. On the one radar that did display the primary returns, it was quite clearly identifiable as a track, with a consistent southeasterly progression (see Figure 1). Overall, members felt that this was sufficient to assert that the returns were most likely generated by an aircraft rather than anaprop, although this could not be conclusively determined.
