**AIRPROX REPORT No 2019192**

Date: 09 Jul 2019 Time: 1050Z Position: 5153N 00210W Location: Gloucestershire Airport

**PART A: SUMMARY OF INFORMATION REPORTED TO UKAB**

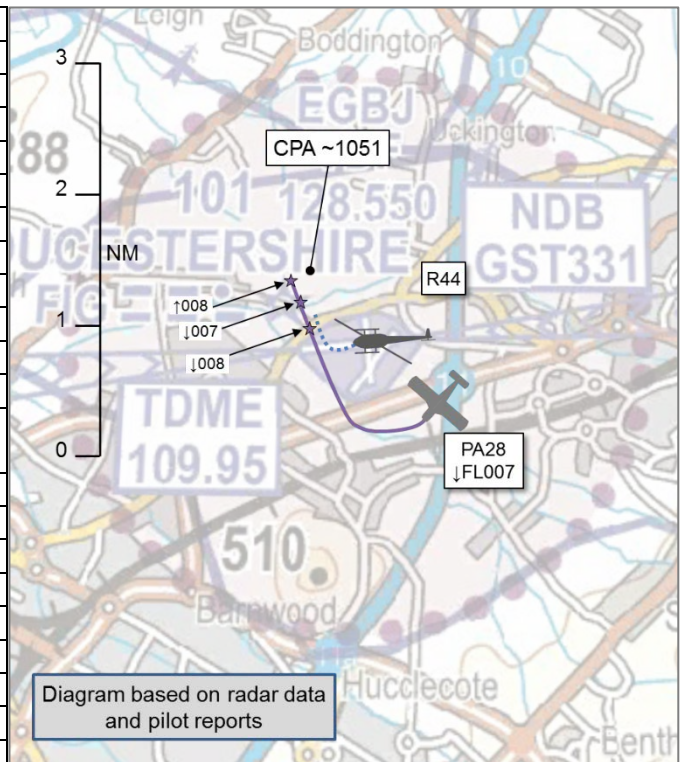
**THE R44 PILOT** reports that he was conducting a PPL circuit-training flight using RW27R. They climbed into the crosswind leg, having just passed the golf course, and were passing through 650ft for 750ft when he noticed an aeroplane overtaking them at about 800ft. He immediately stopped his climb, let the aeroplane go ahead and then, after making a more accurate assessment of its height and checking their own pressure setting, reported it to the Tower. The Tower controller acknowledged with a ‘Roger’, but didn’t pass any further transmissions to the aeroplane, he then called the Tower again to inform them that he would be declaring an Airprox. Once on the ground he called ATC and was told the other aircraft was performing an overhead join for the fixed-wing circuit at 1000ft. The helicopter circuit is 750ft and he opined that fixed-wing aircraft below 1000ft was a constant problem at Gloucester, noting that the helicopters taking off cannot easily see fixed-wing aircraft joining from the south (deadside), causing a rapidly closing conflict. The area around the golf course was a particular hot-spot with helicopters climbing out often unaware of aircraft joining above, therefore they are completely reliant on the aircraft being at the correct level. To reduce the risk over the last year the helicopter training school had reduced circuit height to 600ft; however, certain exercises warrant 750ft.

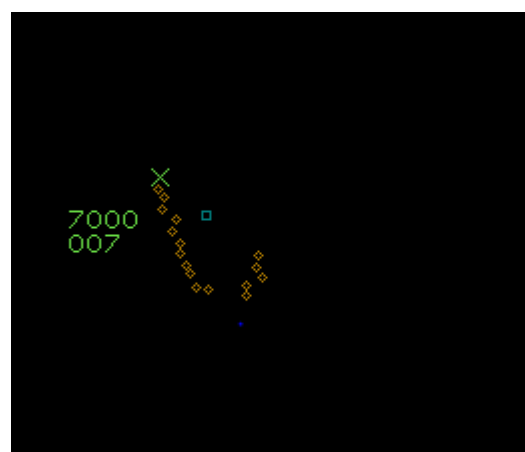
Figure 1 - 10:50.54

The Airprox occurred at approximately 10:50.54 (Figure 1). Only the PA28 was displayed on the Area Radar recording at this time and can be seen in the crosswind position indicating FL007. The QNH was 1022hPa, a difference of +9hPa from the SPS of 1013hPa. Applying a conversion from SPS to QNH ( $9 \times 27\text{ft} = 243\text{ft}$ ) results in the aircraft being at an altitude of 943 feet. The Aerodrome elevation at Gloucester is promulgated in the UK AIP as 101 feet resulting in a height of approximately 842ft QFE.
