AIRPROX REPORT No 2019207

Date: 12 Feb 2019 Time: 1902Z (Night) Position: 5152N 00001E Location: 2NM SW Stansted Airport

PART A: SUMMARY OF INFORMATION REPORTED TO UKAB

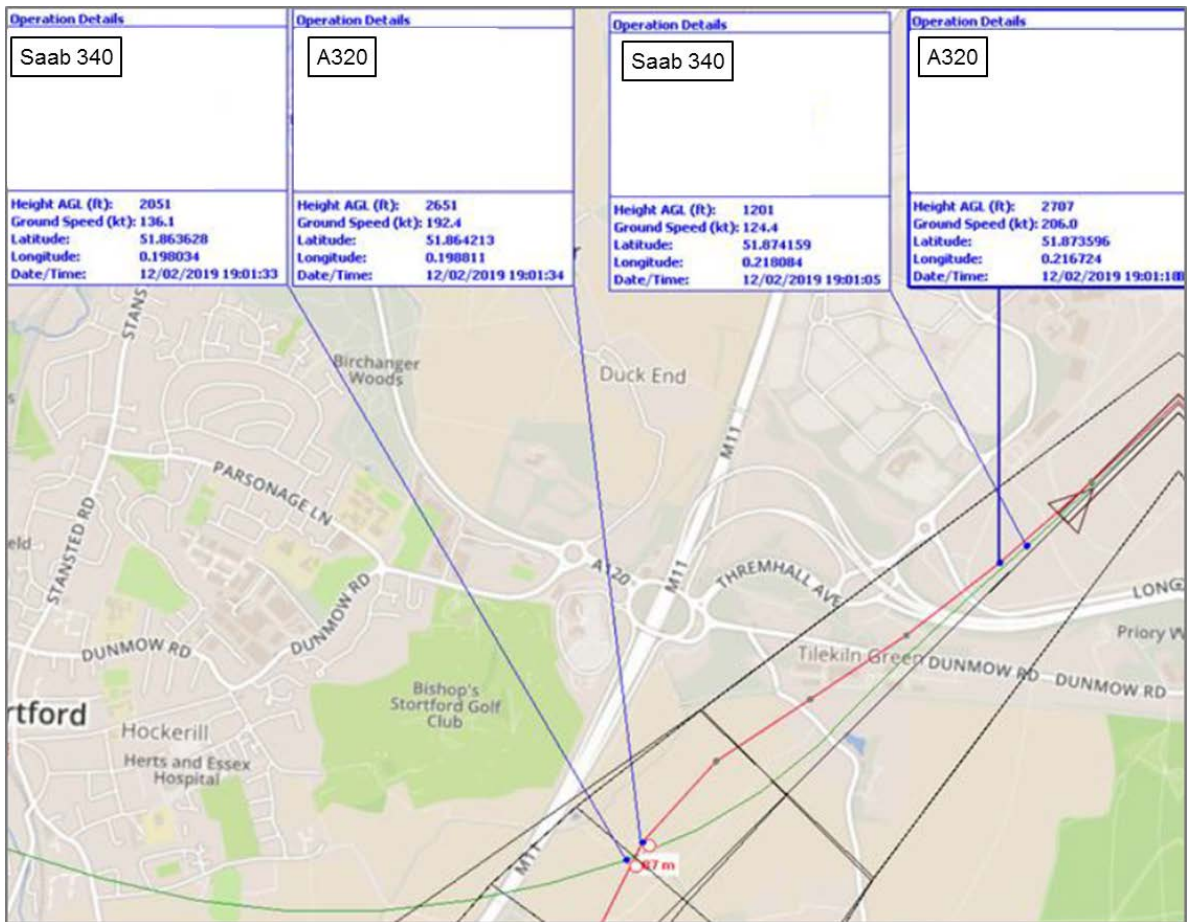
The radar and ATC transponder data from both aircraft was analysed. A digest of the analysis showing the closest point of approach is shown in Figure 1. The aircraft passed 87 m apart laterally and 600ft vertically. A 3D representation is at Figure 2.

Figure 1
ATC Radar Information

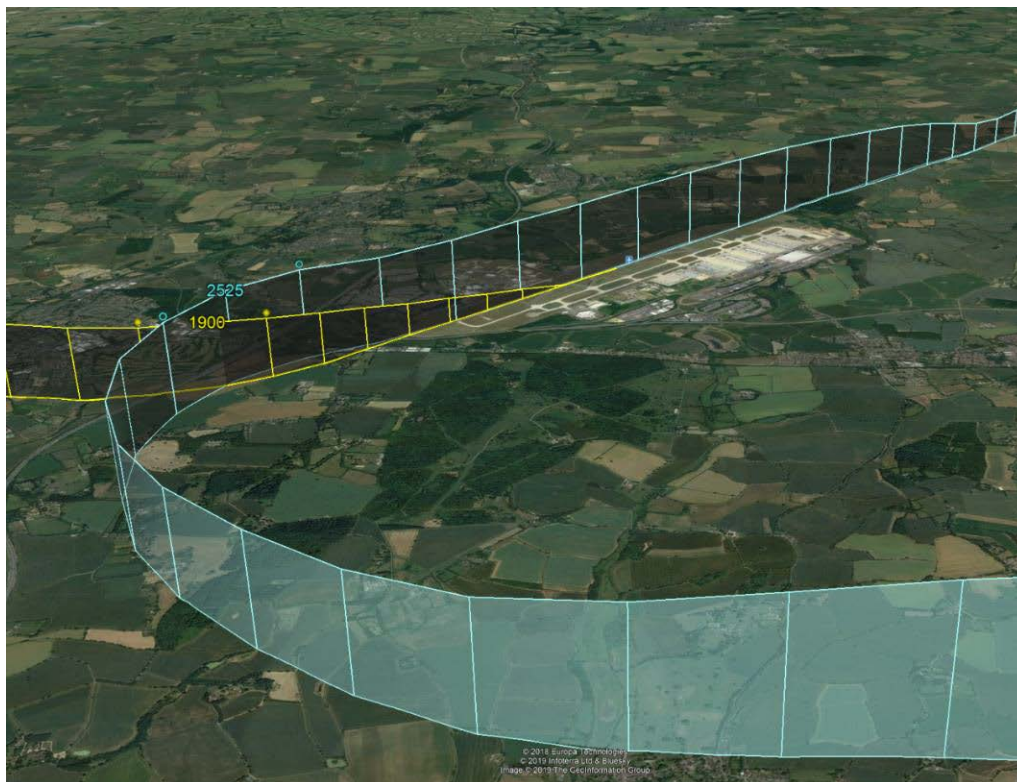
Figure 2
3D Tracks with the red arrow indicating the direction of travel
[Saab 340 C/S] in yellow, [A320 C/S] in blue with altitudes based on 1013 mb

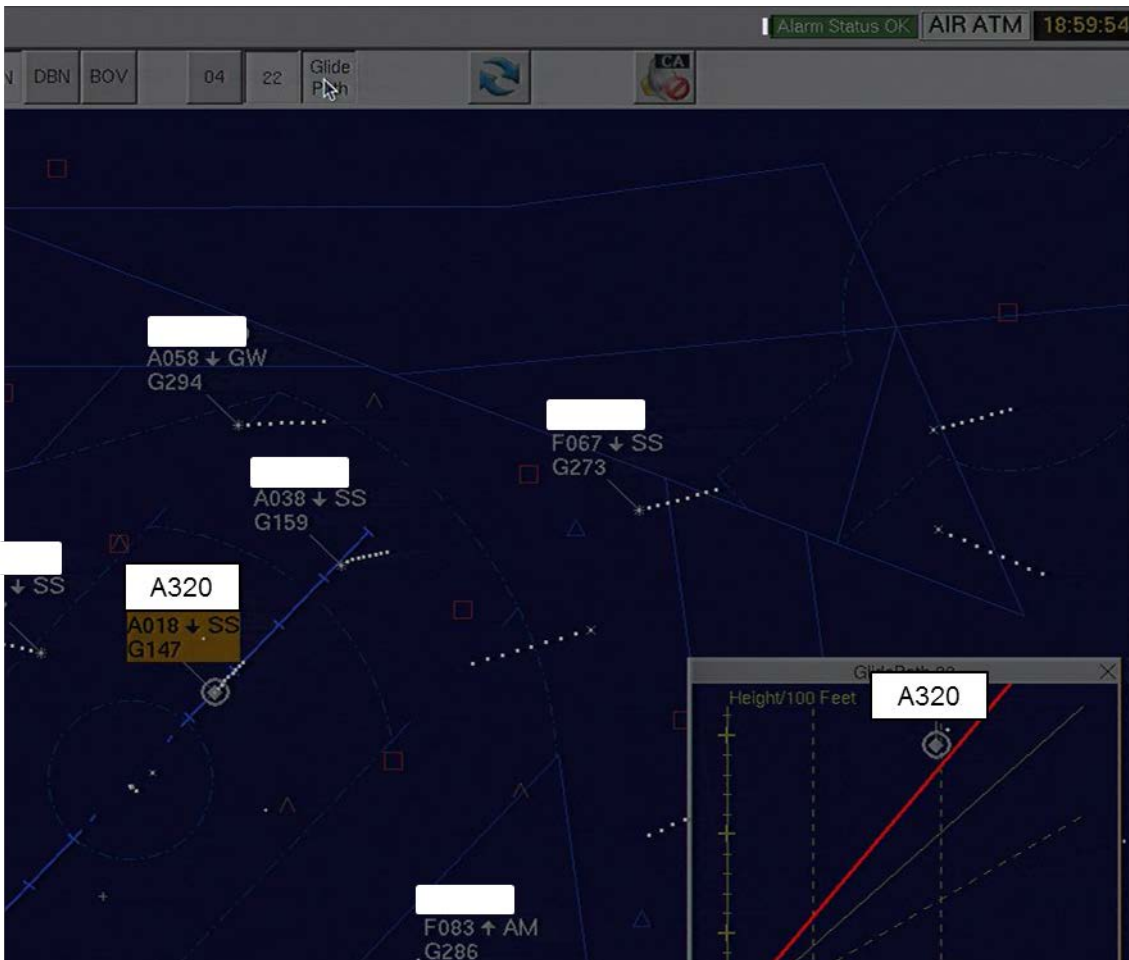
18:59:02	[Saab 340 C/S]	Tower [Saab 340 C/S] we're ready to depart here
18:59:04	AIR	[Saab 340 C/S] Tower thank you. Expedite line up via Romeo 1. Traffic four and a half miles.
18:59:09	[Saab 340 C/S]	Expediting line up [Saab 340 C/S]
18:59:21	AIR	[Saab 340 C/S] from Romeo 1 cleared immediate take off, runway 22, 210 degrees, niner knots
Note		[See Figure 3 below]
18:59:28	[Saab 340 C/S]	Cleared immediate take off [Saab 340 C/S] [See Figure 4 below]
[18:59:54]		[A320 C/S] AFDAS alarm indicating too high [See Figure 5 below]

Figure 5 [A320 C/S] AFDAS too high

As the flight began to intercept the ILS the FMS had been set with a 2000ft altitude capture, as they approached 2000ft the rate of descent reduced. In attempting to rectify this the pilot flying interacted with the Autopilot in such a way as to cause the aircraft to start climbing, Mode S briefly shows a selection of 15000 is made see figure 8 above. The flight briefly climbs to 2400ft before starting to descend again see figure 5.

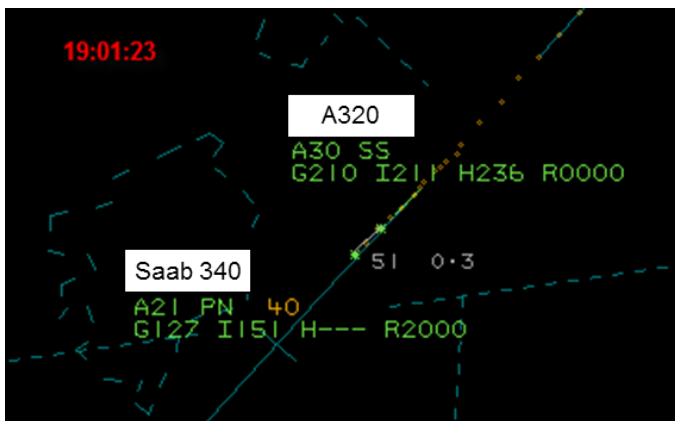
Figure 8 Radar separation lost

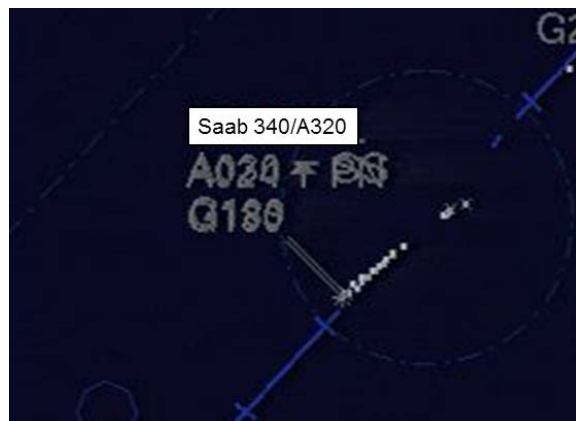
19:01:18	TC	<i>I just got a go – I got up very shortly but he didn't take the turn</i>
19:01:20	AIR	<i>Right I've turned the [Saab 340] 290 degrees</i>
19:01:22	TC	<i>Ok, alright ta</i>
19:01:22	AIR	<i>Alright thank you ta [See Figure 8 below]</i>
19:01:28	AIR	And [Saab 340 C/S] continue the right turn now heading stop the climb altitude 3000 feet
19:01:34	[Saab 340 C/S]	and stop the climb at 3000 feet [Saab 340 C/S] [See Figure 9 below]

Figure 9 19:01:34
[Saab 340 C/S] instructed to stop climb

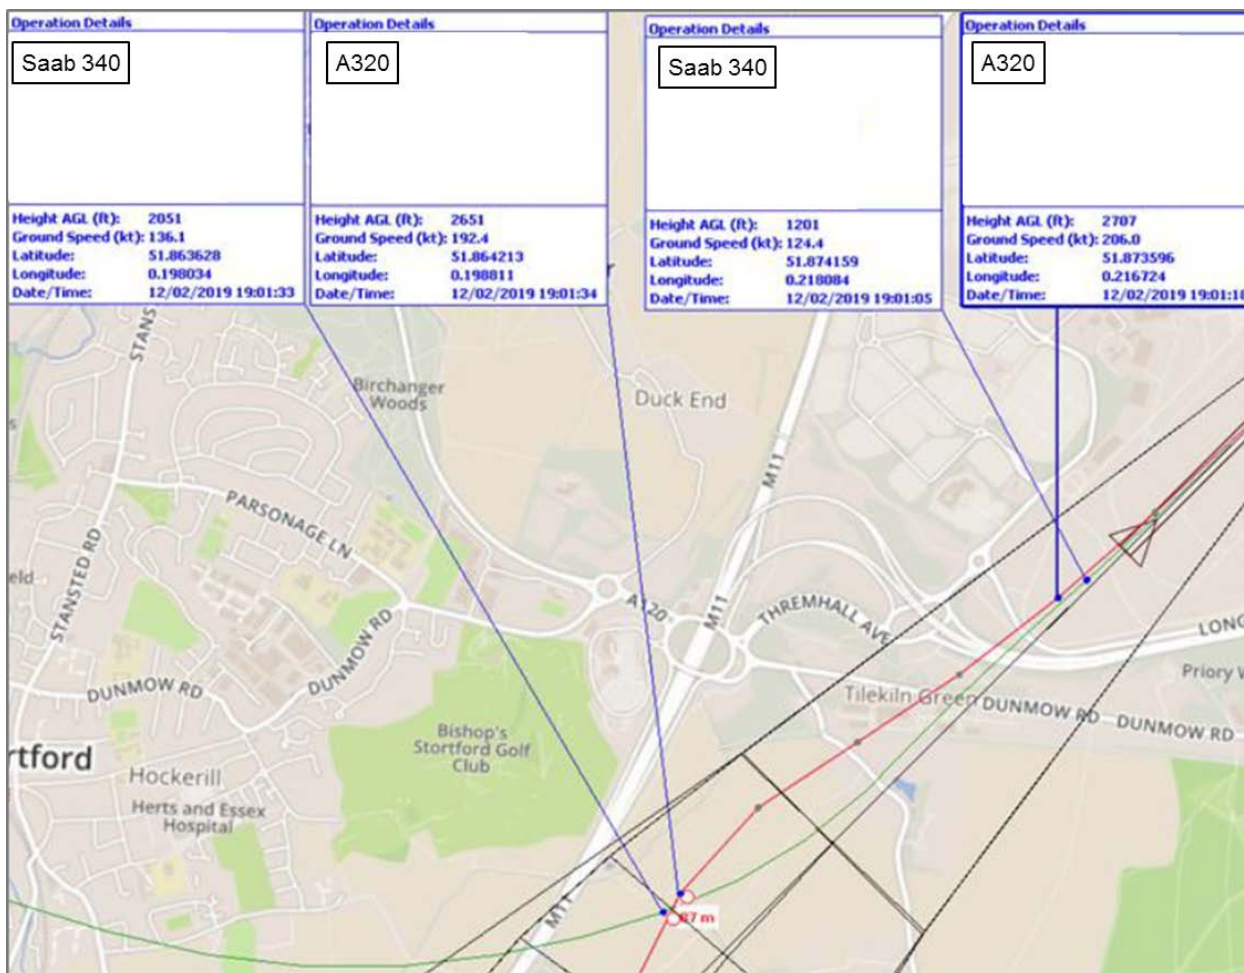
[Figure 10] below from the Airport Noise monitoring facility indicates that the [Saab 340 C/S] was marginally ahead as the tracks cross when [A320 C/S] starts to make the left turn.

Figure 10 Airport NTK plot

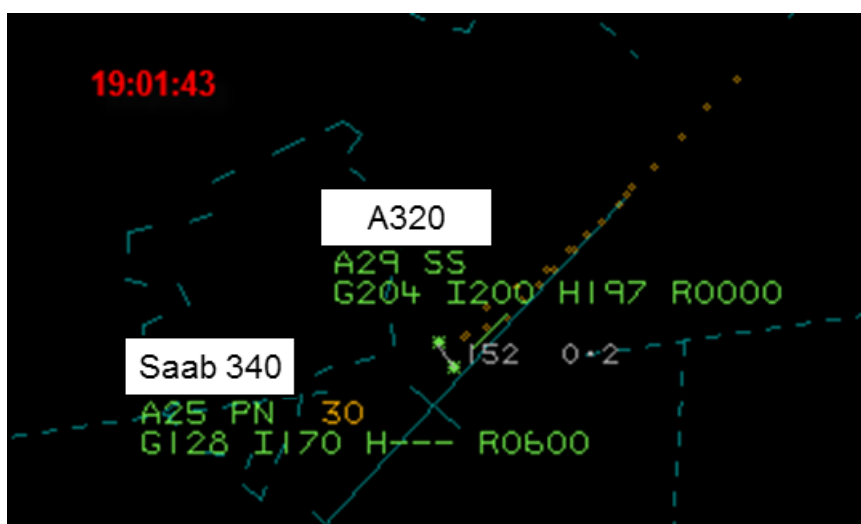
19:01:35	SS INT	[A320 C/S], there's traffic in your, just underneath you in your twelve o'clock, turn left now heading of zero niner zero degrees, it is avoiding action, climb to altitude four thousand feet
19:01:45	[A320 C/S]	Four thousand feet and left heading zero niner zero [See Figure 11 below]

Figure 11 Minimum separation

TC GS advised separation was 0.26 mile and 500' at the closest point. [of separation loss]

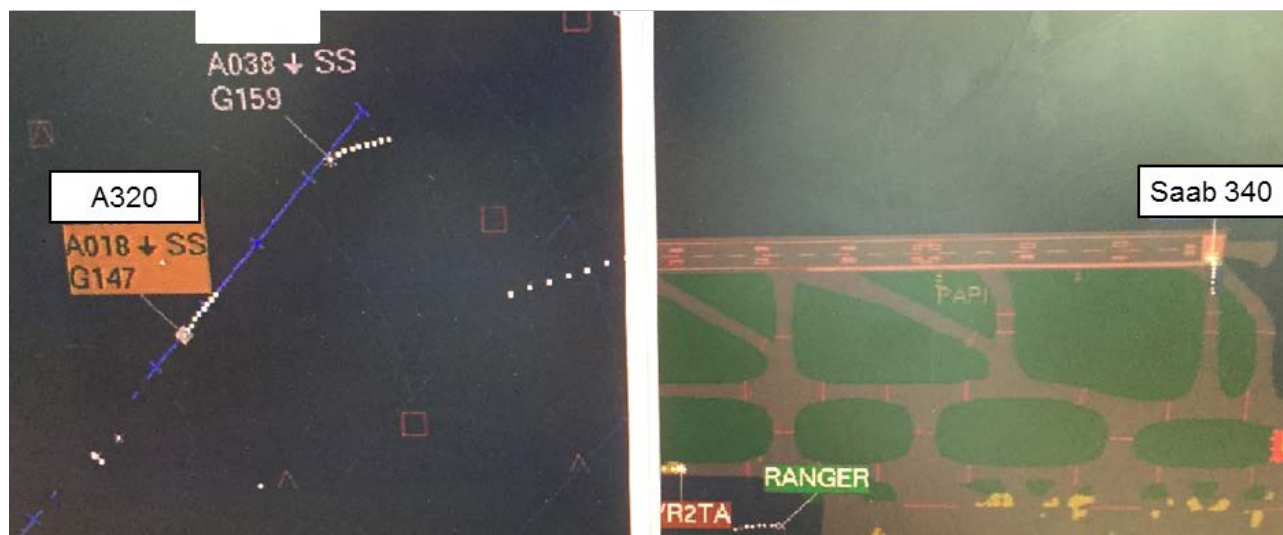
Figure 12

At the time that [A320 C/S] activates AFDAS, [Saab 340 C/S] is just lining up on the runway centreline. [Figure 12]

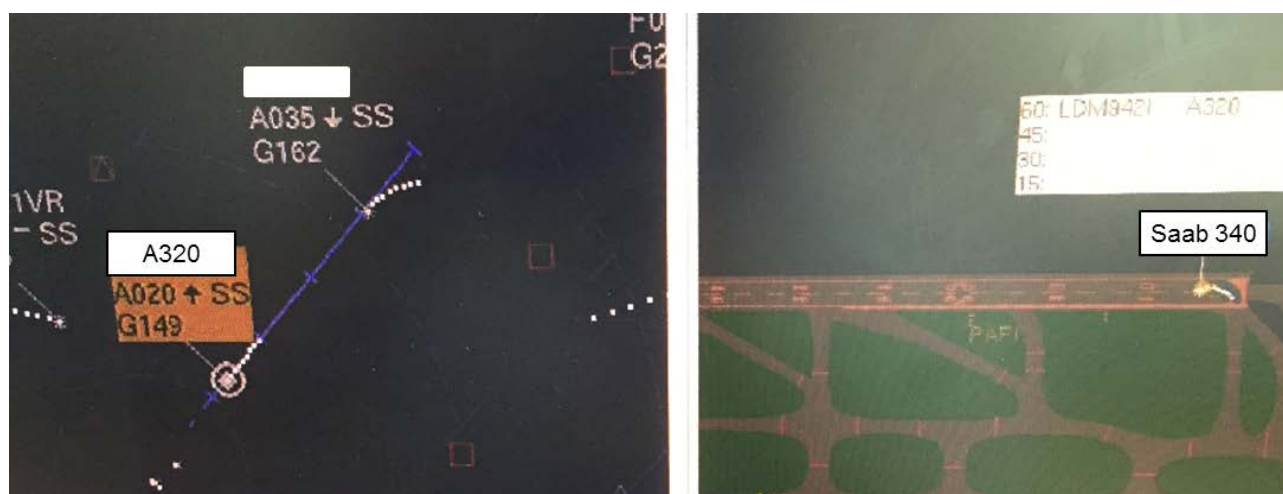
Figure 13

[Figure 13] below indicates the position of both aircraft as the [A320 C/S] calls going around. The AIR controller's mental picture meant they believed that [Saab 340 C/S] was further into the take-off roll.

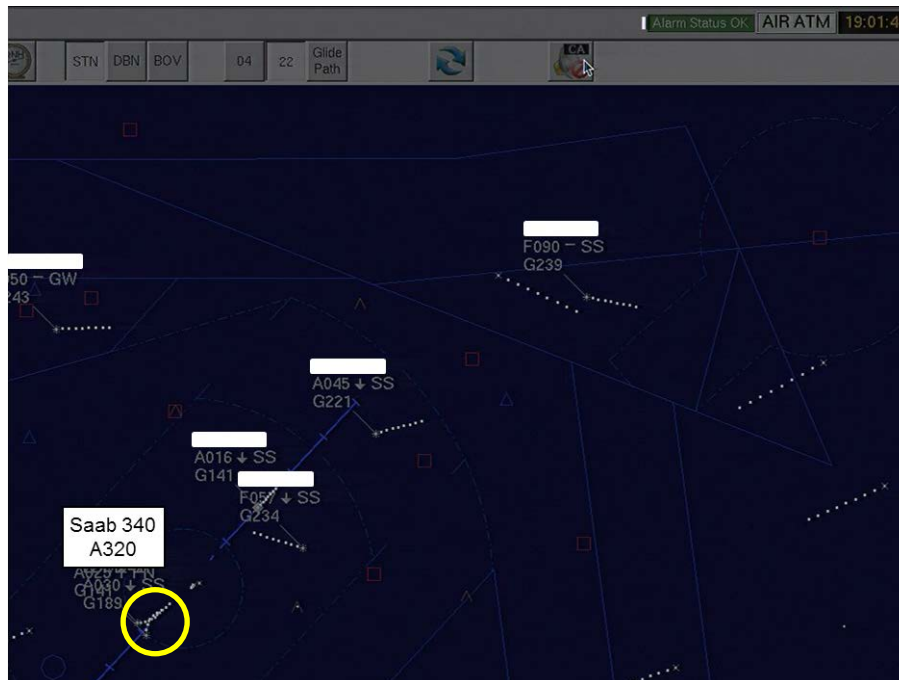
Unsure of what the [A320 C/S] was doing the AIR controller immediately issued a right turn to a heading of 290 for the [Saab 340 C/S] in an attempt to gain separation [see Figure 14]. It is believed from the [Saab 340 C/S] ASR that the aircraft was below 2500ft at this point. The AIR controller stated that they had not considered using any form of vertical separation, rather they instructed [Saab 340 C/S] to stop climb at 3000ft, aware that the initial climb altitude was 4000ft which would mean they would climb through the [A320 C/S]. Prior to instructing the [Saab 340 C/S] to stop climb at 3000ft the aircraft was observed to be climbing at a rate of 2000ft per minute, after acknowledging the instruction to stop climb at 3000ft the rate of climb reduces to 600ft per minute. It is considered that this action unintentionally helped to provide a greater degree of separation between the two aircraft.

Figure 14 both aircraft turning away
