AIRPROX REPORT No 2019221

Date: 02 Aug 2019 Time: ~1420Z Position: 5105N 00147W Location: Old Sarum

PART A: SUMMARY OF INFORMATION REPORTED TO UKAB

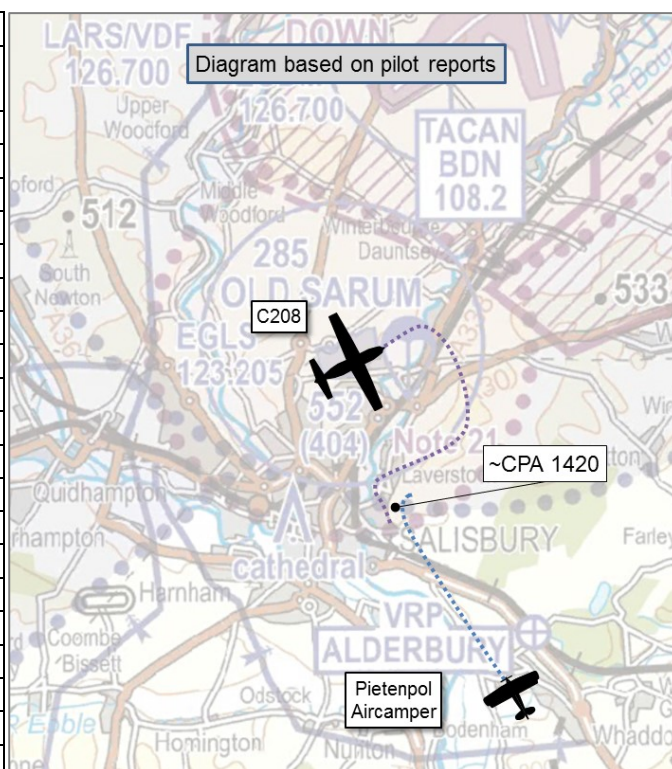
Neither aircraft is visible on the radar recording therefore the diagram is based only on the pilot reports. Old Sarum AIP entry does not provide specific instructions for departing aircraft, these can be found via the Old Sarum website, as below:
