**AIRPROX REPORT No 2019263**

Date: 01 Sep 2019 Time: 1542Z Position: 5111N 00103W Location: Lasham Gliding Site

**PART A: SUMMARY OF INFORMATION REPORTED TO UKAB**

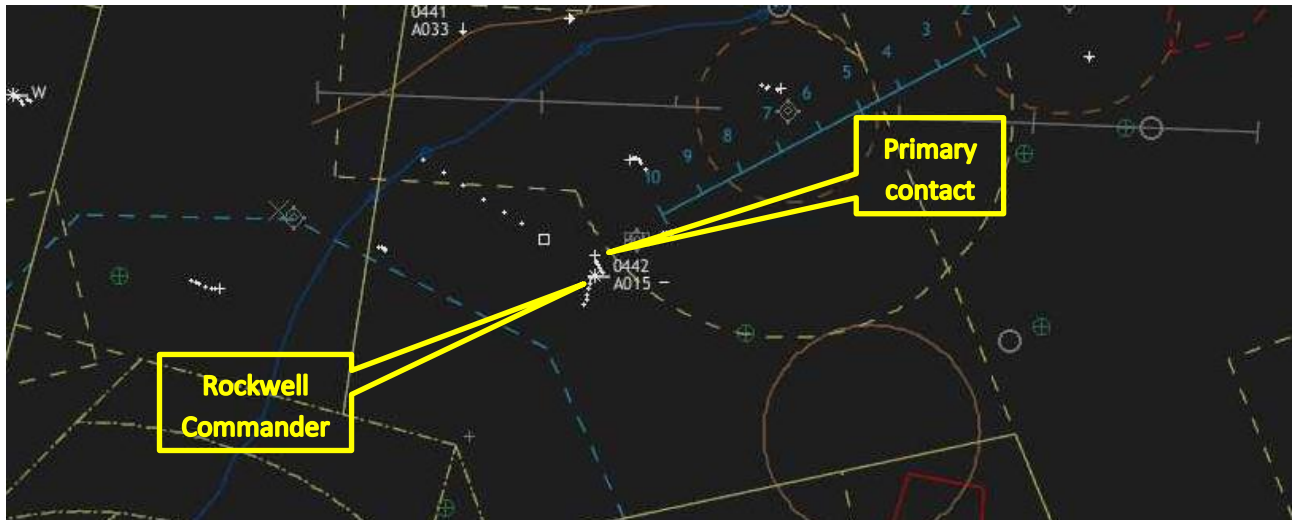
Figure 1 – 1541:33

15:41:15 - "Rockwell Commander C/S, unknown contact north of your position, north/north east of your position, 1nm on your nose northbound, no height or type, may be a glider".

15:41:21 - "Yeah, Rockwell Commander C/S keeping a lookout".

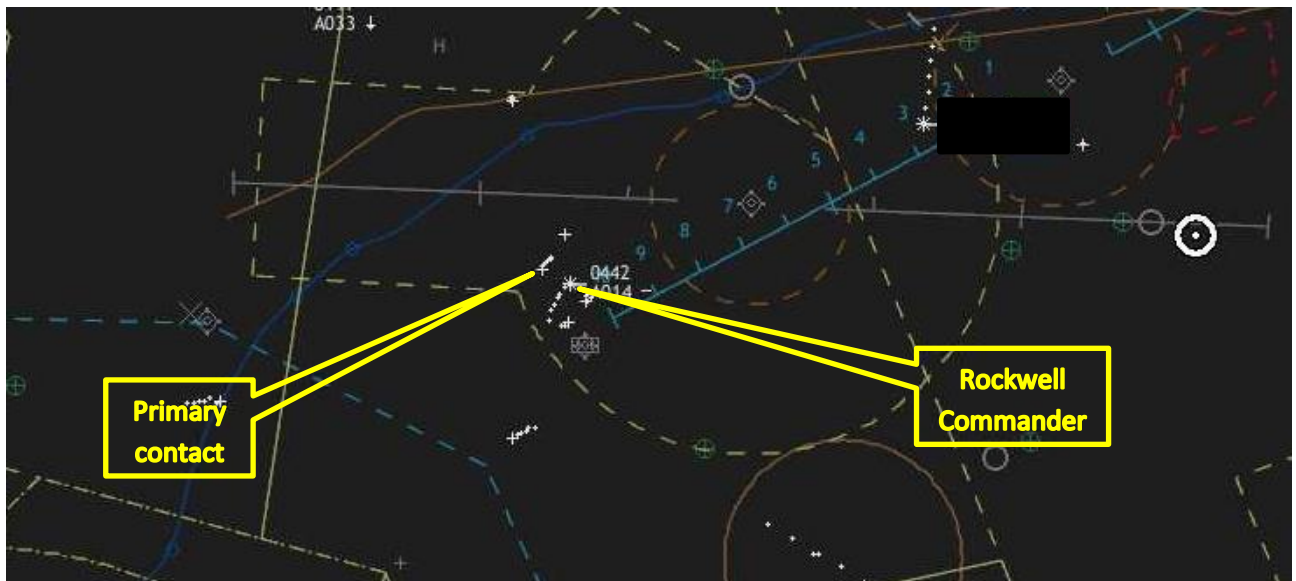
Figure 2 – 1542:41

15:42:39 - "Rockwell Commander C/S, unknown contact west/north west of your position, 1nm southbound, no height".

15:42:45 - "Rockwell Commander C/S keeping a good lookout".

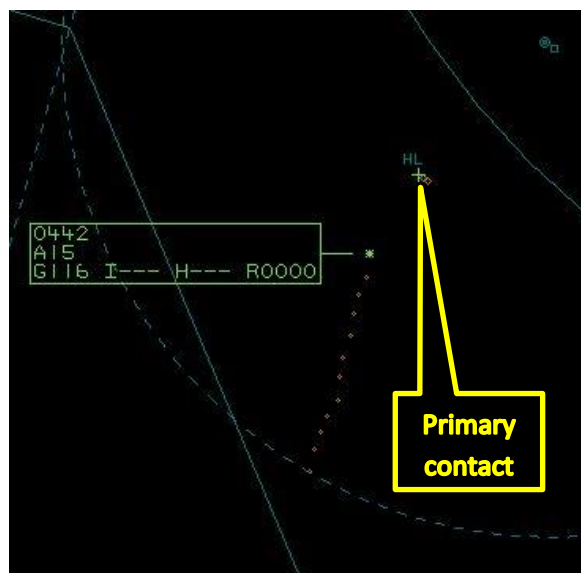
Figure 3 – NATS radar screenshot at 1541:14

The NATS radar shows the Rockwell Commander (squawk 0442) approaching the vicinity of Lasham from the south at an altitude of 1500ft. There is a brief appearance (for three radar sweeps) of a primary return in the area of the Ventus CT (see Figure 3); it is assumed that this is the return on which the Farnborough LARS controller issues Traffic Information to the pilot of the Rockwell Commander. This primary radar return fades at 1541:14. It cannot be stated whether or not this primary return is the Airprox glider or a different aircraft.
