AIRPROX REPORT No 2019269

Date: 12 Sep 2019 Time: 1117Z Position: 5223N 00051W Location: 5nm W of Kettering

PART A: SUMMARY OF INFORMATION REPORTED TO UKAB

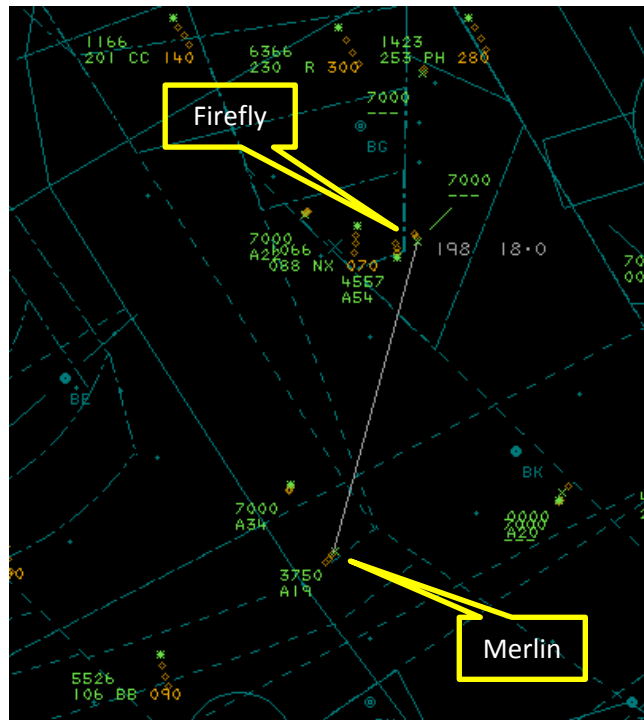
Figure 1 – 1110

The Merlin pilot free-called Wittering Approach requesting a Basic Service and passed details of their transit. Although Wittering is not established as a LARS unit, controller workload and anticipated workload was low so the Service was provided. Separation between the Merlin and Firefly was 18nm.

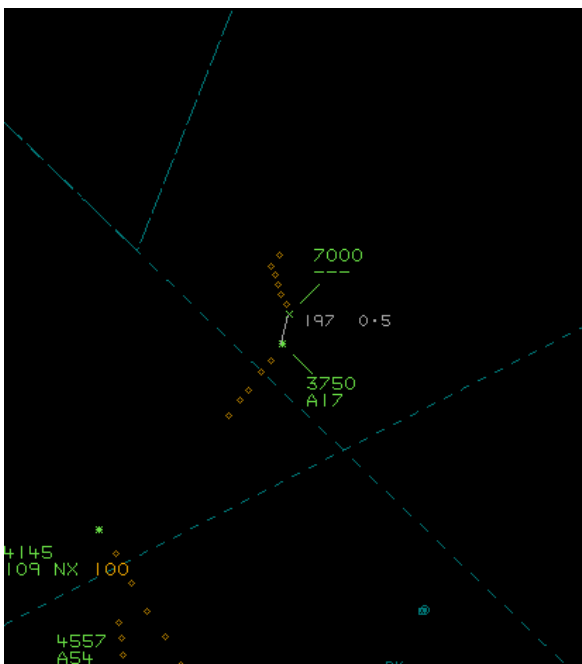
Figure 2 – 1116:51

The Wittering Approach Controller passed Traffic Information to the Merlin pilot at 1116:51, noting the Firefly was north, $\frac{1}{2}$ nm, no height information. In response to this call, the Merlin pilot reported the Airprox.

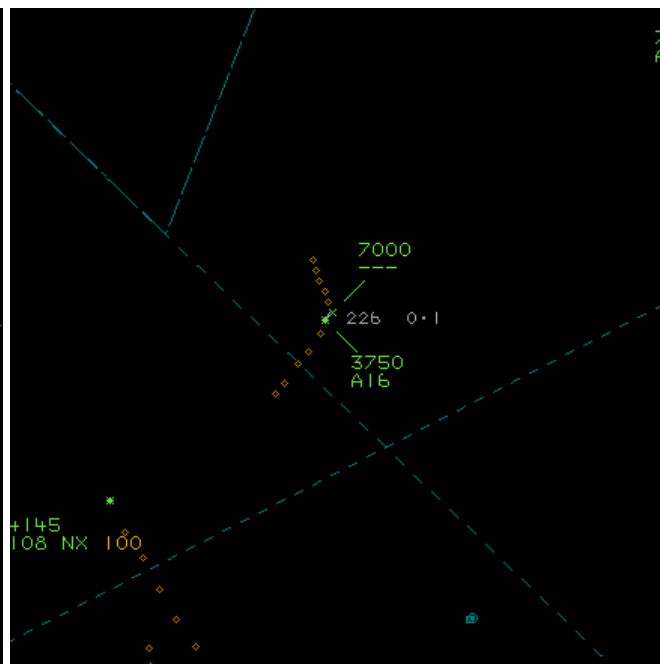
Figure 3 – CPA 1117:01

The Merlin pilot reported taking an avoiding action descent and turn to the left which can be seen on the radar replay. This turn resulted in a CPA of 0.1nm. The Wittering Approach Controller was providing a Basic Service and, under the terms of that Service, is not mandated to pass Traffic Information unless the controller believes a definite risk of collision exists. In this instance, the lack of a Mode C on the Firefly meant that it was impossible for the controller to identify if a definite risk of collision existed but, by passing Traffic Information, they discharged their duty-of-care appropriately in this incident.
