AIRPROX REPORT No 2019303

Date: 16 Oct 2019 Time: 1348Z Position: 5159N 00215W Location: 7NM NW Gloucester

PART A: SUMMARY OF INFORMATION REPORTED TO UKAB

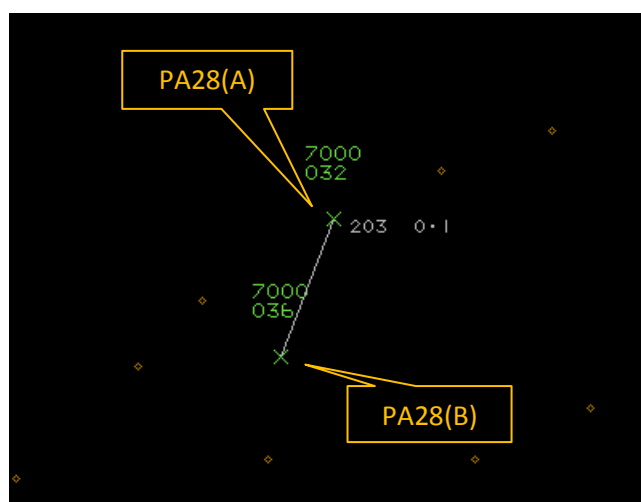
Figure 3 - 1348:48 CPA

At 1348:48 CPA occurred, with the aircraft separated by 0.1NM laterally and 400ft vertically (Figure 3).

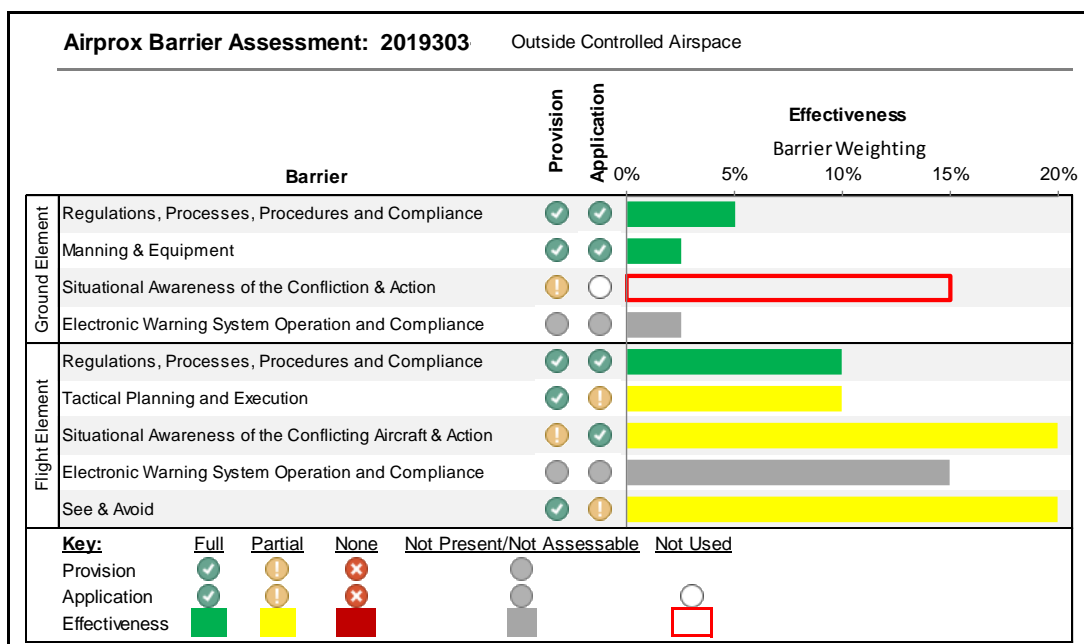
In assessing the effectiveness of the safety barriers associated with this incident, the Board concluded that the key factors had been that:

Tactical Planning and Execution was assessed as **partially effective** because the PA28(A) pilot could have adjusted his altitude to remain clear of the manoeuvring aircraft.

Situational Awareness of the Conflicting Aircraft and Action were assessed as **partially effective** because neither pilot knew the intentions of the other.

See and Avoid were assessed as **partially effective** because, although there was 400ft between the 2 aircraft, the PA28(A) pilot could have increased the vertical separation.
