## AIRPROX REPORT No 2019318

Date: 19 Nov 2019 Time: 1505Z Position: 5110N 00144W Location: Boscombe Down

### PART A: SUMMARY OF INFORMATION REPORTED TO UKAB

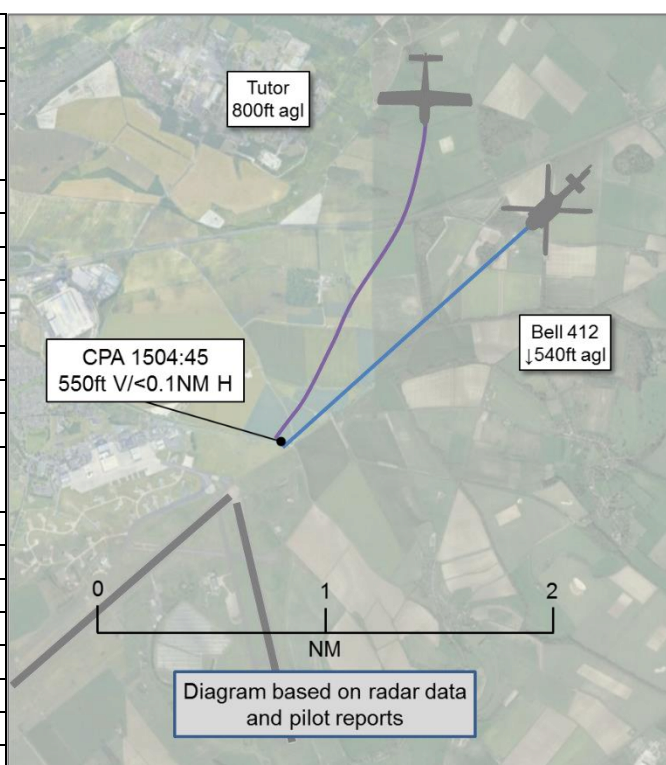
The radar trace from the PAR has been used to deduce the ground track of both aircraft as depicted in the diagram at the top of page 1 of this report. The Bell 412 and Tutor pilots shared an equal responsibility for collision avoidance and not to operate in such proximity to other aircraft as to create a collision hazard.<sup>1</sup> An aircraft operated on or in the vicinity of an aerodrome shall conform with or avoid the pattern of traffic formed by other aircraft in operation.<sup>2</sup>

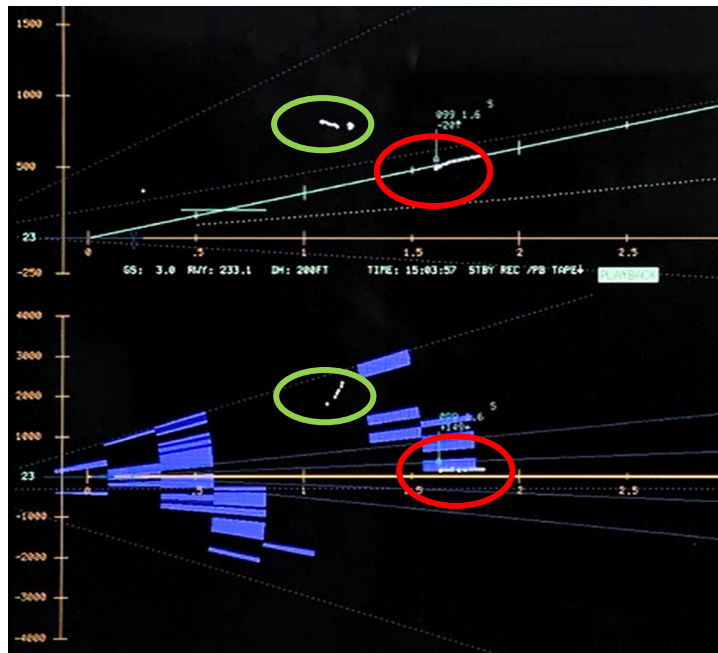
Figure 1 – Tutor first shows on PAR

Figure 1 shows the Bell 412 (red circle) at 1.7NM from the runway threshold, in receipt of a clearance, aware of and visual with the Tutor (green circle). This is the first point at which the Talkdown controller would have seen a radar return on the Tutor (although he was aware that it was conducting a go-around).

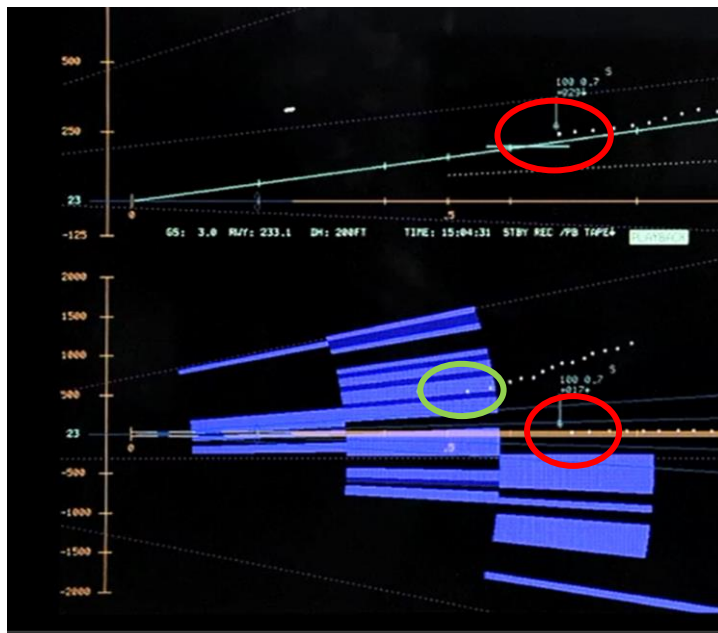
Figure 2 – B412 approaching decision height

The Tutor radar return disappeared from radar (in elevation) shortly after this and did not reappear until the Bell 412 was 0.75NM from touchdown and approaching decision height. The Bell 412 pilot reported being visual with the Tutor throughout.

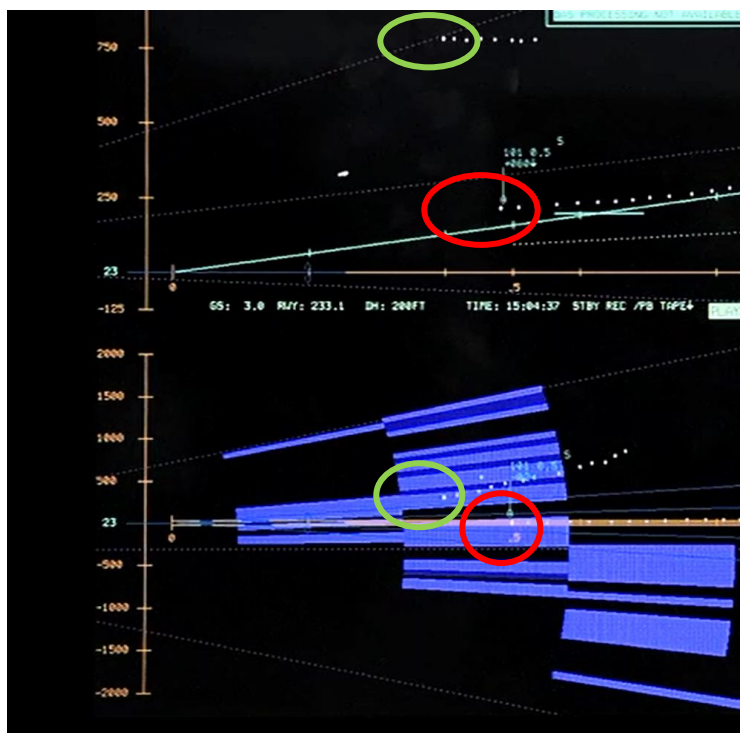
Figure 3 – Radar CPA

The Bell 412 pilot reported not initiating a climb at decision height due to the proximity of the Tutor, and this is shown on the radar replay. The last point both aircraft show on radar gives a CPA of 0.1NM and 550ft, although allowing the replay to run-on shows a lateral separation of 200ft.

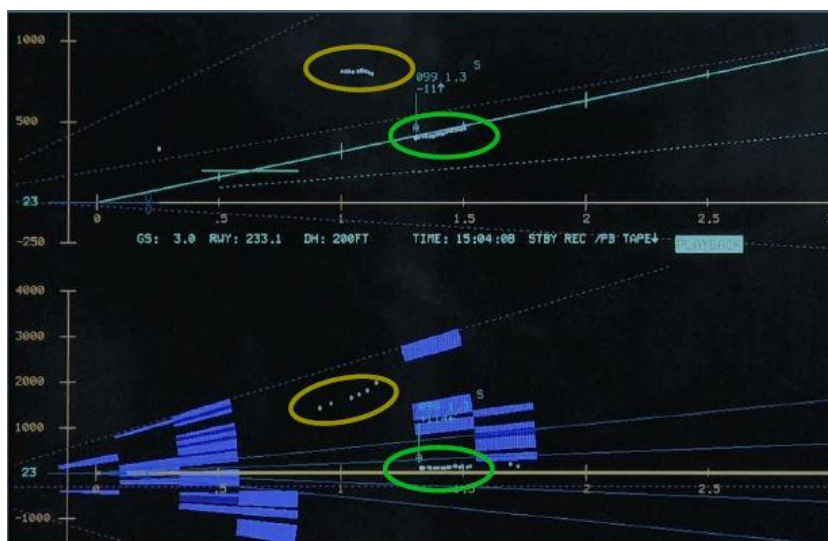
Figure 4 below shows the vertical and horizontal approach to RW23; [the Bell 412] (identified in green) can be seen on its instrument approach tracking the vertical and horizontal glidepaths, at 400ft and 1.25NM and [the Tutor] (identified in yellow) at 800ft circuit height and approximately 0.5NM ahead, turning in front of [the Bell 412] to align with RW23.
