**AIRPROX REPORT No 2018050**

Date: 12 Apr 2018 Time: 1218Z Position: 5358N 00215W Location: 2nm SE RIBEL

**PART A: SUMMARY OF INFORMATION REPORTED TO UKAB**

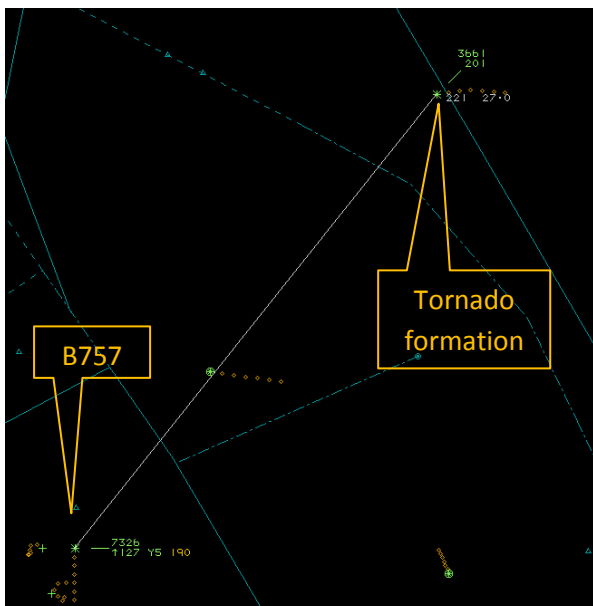
Figure 1 – 1215:53.

The Warton Radar controller initiated coordination with the Scottish controller at 1215:53 (Figure 1). The coordination agreed was that the Tornado formation would maintain FL200 on the current track and the B757 would fly not above FL190.

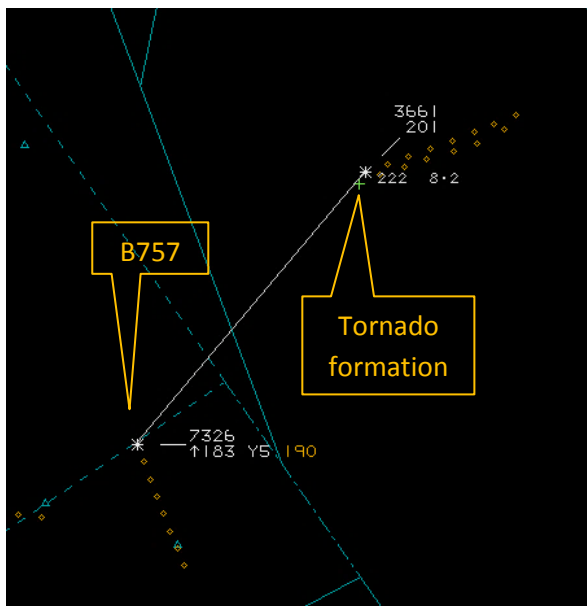
Figure 2 – 1217:46.

At 1217:46 (Figure 2) the Scottish controller instructed the B757 pilot: “B757 [C/S] maintain Flight Level one nine zero on reaching, there is traffic currently in your two o’clock range of eight miles, right to left, it’s a thousand feet above your clear level crossing.”

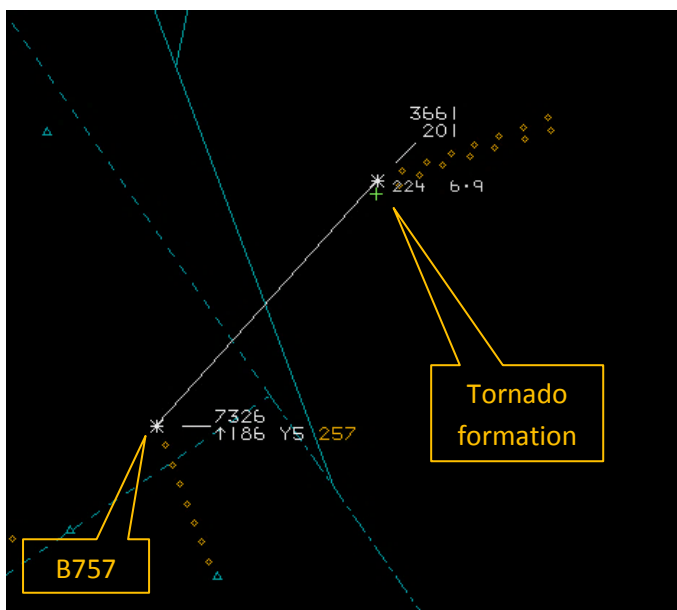
Figure 3 – 1217:55.

The Selected Flight Level (SFL) of the B757 changed to FL257 at 1217:55 (Figure 3).

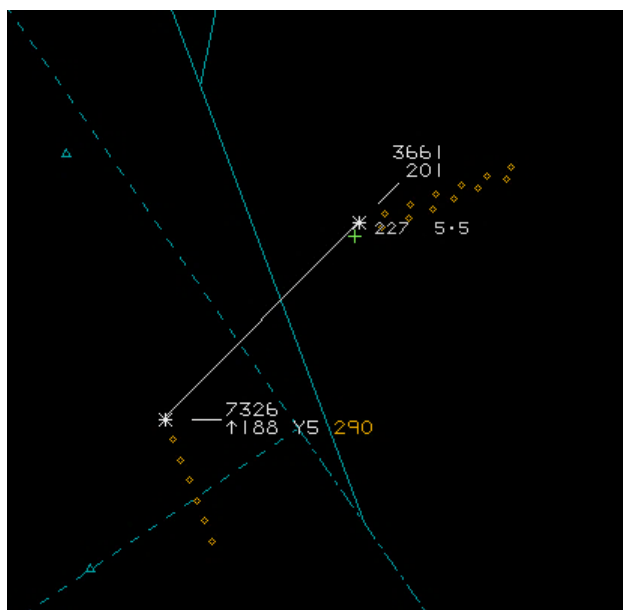
Figure 4 – 1218:03.

At 1218:03 (Figure 4) the radar indicated that the SFL of the B757 had reached FL290. At the same time, the Warton Radar controller passed the climb-out instructions to the Tornado formation for after the completion of the SRA and stated that this would be a single frequency approach and departure. The pilot read back the climb out instructions and asked the controller to repeat the last part of the instruction.

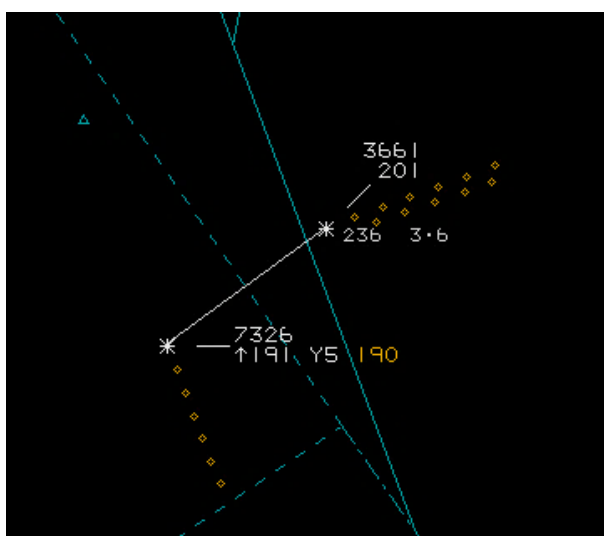
Figure 5 – 1218:05.

The replay indicated that the SFL of the B757 had returned to FL190 at 1218:05 (Figure 5), but the radar indicated that the aircraft was still climbing.

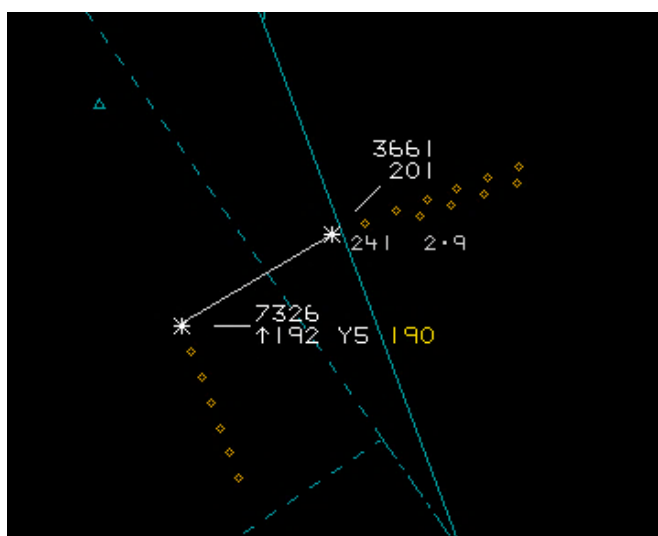
Figure 6 – 1218:19.

The radar indicated that the B757 was at FL192 and the aircraft was continuing to climb at 1218:19 (Figure 6).

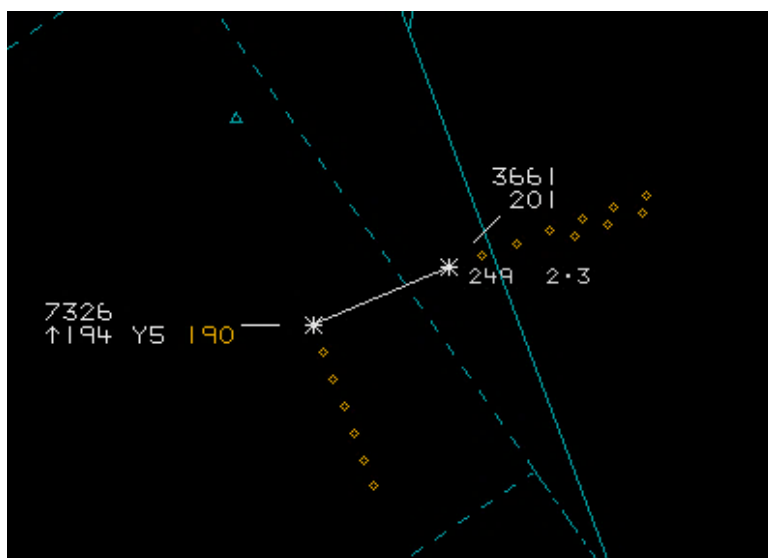
Figure 7 – 1218:23.

The radar indicated that the B757 passed FL190 at 1218:23 (Figure 7). At this point the radar displayed the aircraft’s level as FL194 and indicating that the aircraft was still climbing.

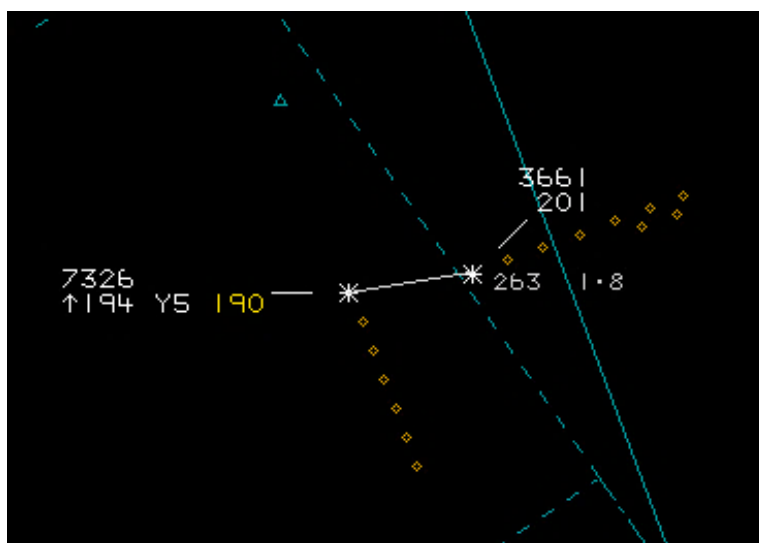
Figure 8 – 1218:28.

The Warton Radar controller issued avoiding action to the Tornado formation at 1218:28 (Figure 8): “[Tornado C/S] avoiding action turn left heading one nine zero degrees, traffic was twelve o’clock in fact right two o’clock now range of three miles northbound er five hundred feet below.”

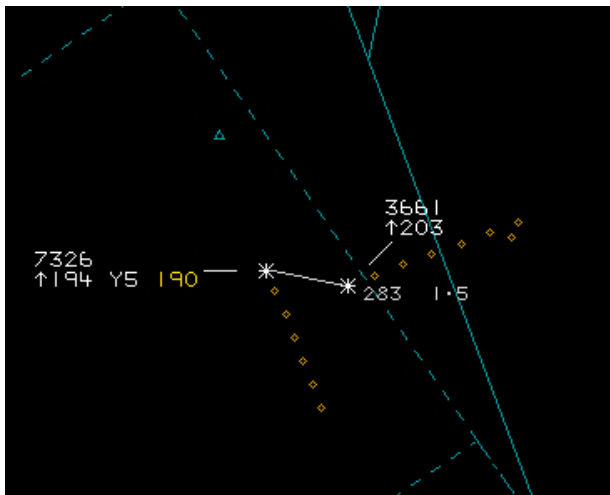
Figure 9 – 1218:31.

CPA occurred at 1218:31 (Figure 9) with an indicated separation of 1.5nm horizontally and 900ft vertically. At this point the radar indicated that the Tornado formation had started to climb.

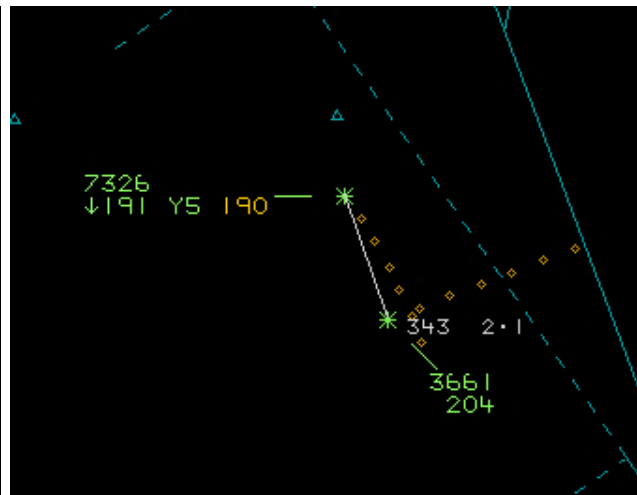
Figure 10 – 1218:43.

At 1218:43 (Figure 10) the B757 pilot reported level at FL190.

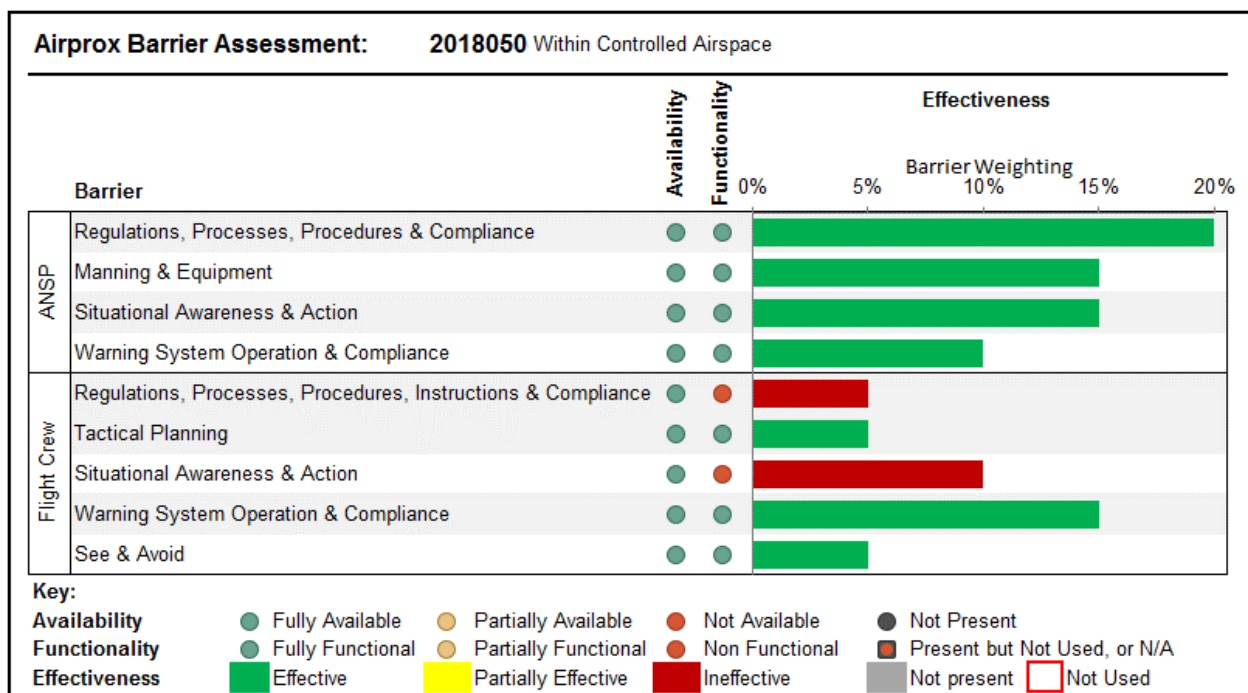
In assessing the effectiveness of the safety barriers associated with this incident, the Board concluded that the key factors had been that:

**Regulations, Processes, Procedures, Instructions and Compliance** were assessed as **ineffective** because the B757 pilot climbed above his cleared level and did not read back what he believed was a climb clearance.

**Situational Awareness and Action** were assessed as **ineffective** because the B757 pilot did not use the information provided by ATC and/or TCAS about the Tornado formation and climbed above his cleared level.
