**AIRPROX REPORT No 2018080**

Date: 11 May 2018 Time: 0825Z Position: 5243N 00038W Location: 8nm NW Wittering

**PART A: SUMMARY OF INFORMATION REPORTED TO UKAB**

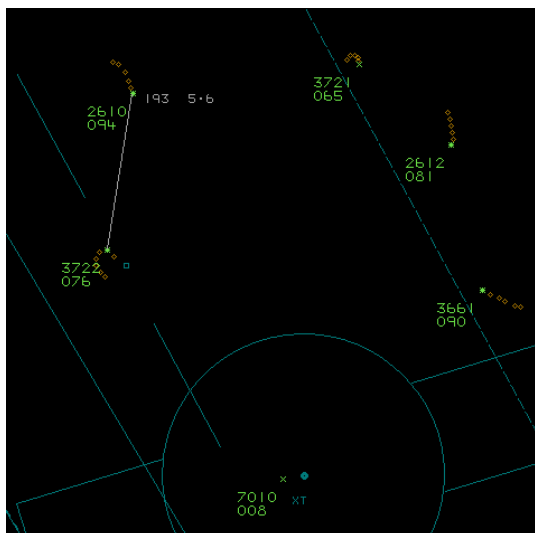
Figure 1

Figure 1, at 0820:11, was the first instance of Traffic Information on the Prefect being passed by Wittering Approach to the Tutor pilot. The Traffic Information was accurate but the Tutor pilot reported that he was not visual with the other aircraft.

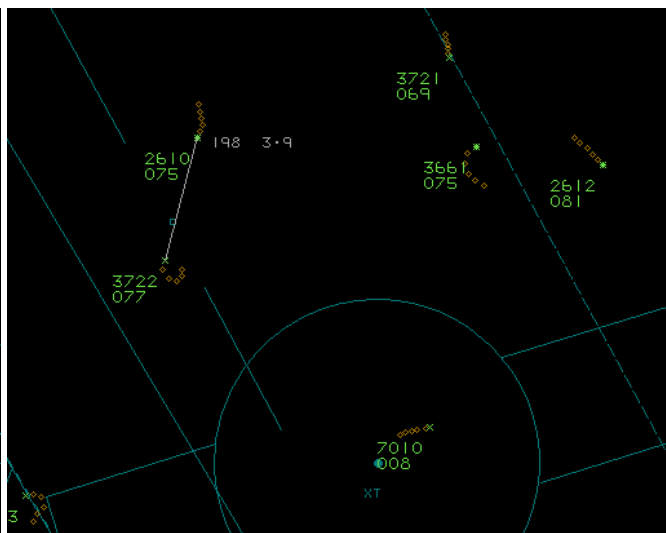
Figure 2

(Tutor 3722, Prefect 2610)

Both aircraft maintained 5nm separation until the Tutor pilot commenced a right-hand turn on to north, timed at 0822:32 and depicted in Figure 2. Accurate Traffic Information was passed by the Cranwell Departures Controller to the Prefect pilot although he did not report visual with the Tutor until 0824:29.

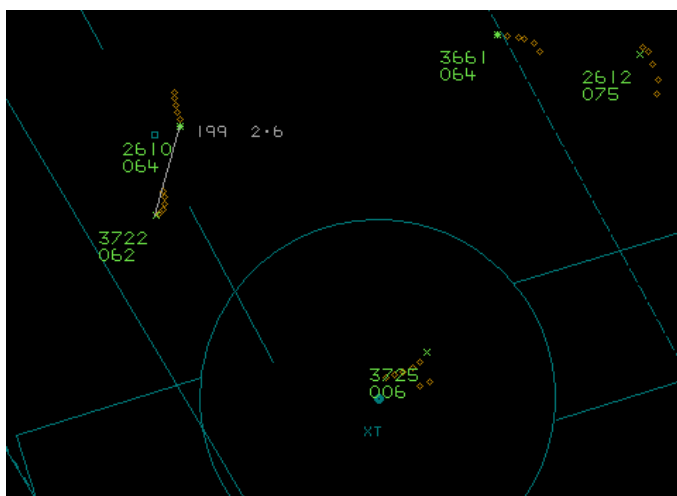
Figure 3

During this period the Wittering Approach Controller conducted a landline call, answered two other radio transmissions and conducted a console handover. As a result, Traffic Information was not passed to the Tutor pilot until 0824:06 as shown in Figure 3.

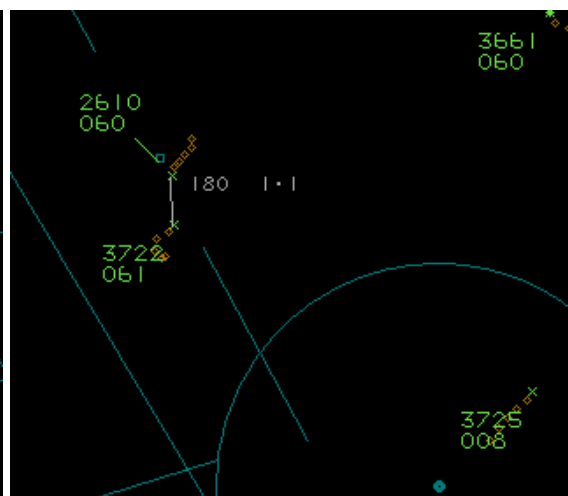
Figure 4

At 0824:35, some 2sec after the previous Traffic Information was passed, the Wittering Approach Controller passed further Traffic Information to the Tutor pilot, following which the pilot reported visual with the Prefect. Some 6sec previously, the Prefect pilot had reported visual with the Tutor to Cranwell Departures. The Traffic Information and the Tutor pilot's report noted the separation as about  $\frac{1}{2}$ nm. The radar replay did not show the separation decreasing below 1.1nm and the Prefect pilot stated he had seen the Tutor at  $\frac{1}{2}$ nm lateral and 1000ft vertical separation.
