AIRPROX REPORT No 2018111

Date: 23 May 2018 Time: 1045Z Position: 5116N 00015W Location: 1.5nm NW Reigate

PART A: SUMMARY OF INFORMATION REPORTED TO UKAB

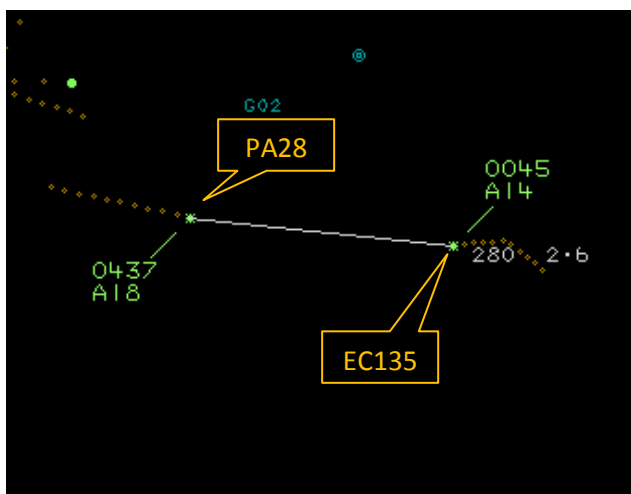
Figure 1 – 1048:48

At 1048:48 (Figure 1), the EC135 turned to track west. The EC135 turned again to track east and CPA subsequently occurred at 1049:42 (Figure 2) with the radar indicating 0.1nm and 400ft between the aircraft.
